Town of Princeton
Needs Assessment & Four
Buildings Master Plan
Summary Report
March 2018

3.1 Existing Conditions Report: Bagg Hall

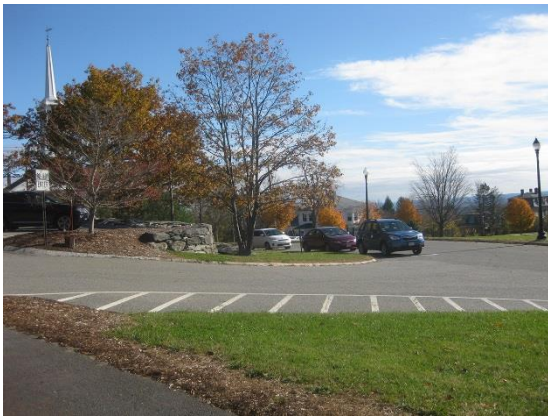
- C ■ Existing Granite Curbing still in good condition. May consider reusing or resetting if improvements are proposed that require adjusting road layouts or paving. Phil Connors reports that some sections are a problem due to snow removal operations.

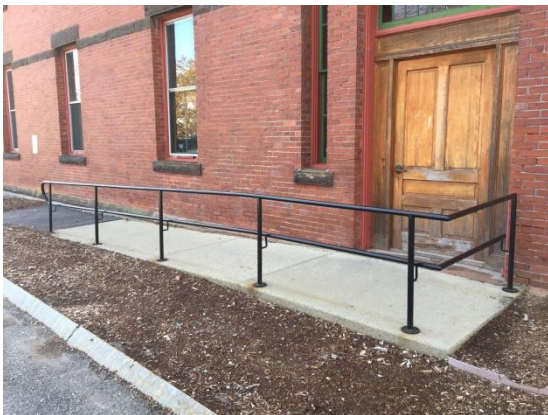
The existing building includes a sloped walkway leading to a door at grade. There is also a semi-accessible toilet room on the 1st Floor. The remainder of the building is generally not accessible.

- B ■ The slope of the existing walkway leading to the accessible side entrance door was not measured, however if it exceeds 5%, handrails on both sides of the ramp are required (521 CMR 24). The existing accessible toilet room is not compliant as there is insufficient clear floor space in front of the toilet (must extend out a minimum of 42" in front of the toilet) and the side grab bar is less than 42" long (521 CMR 30.7.2 & 30.8).

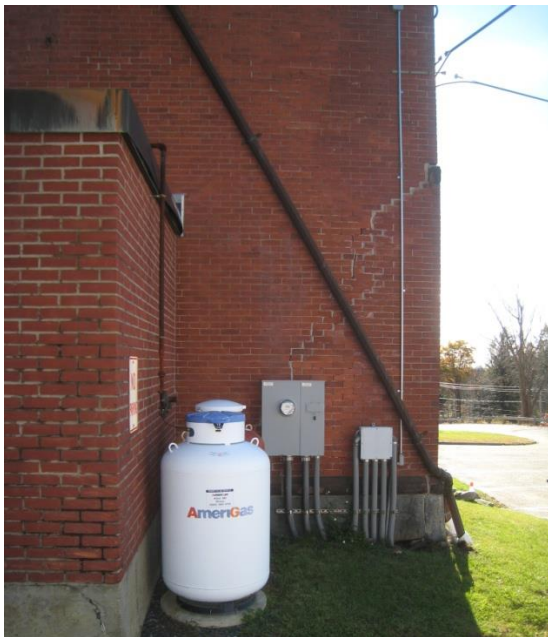
Walls:

- B ■ Significant settlement crack at northwest corner that requires repair and west wall requires more thorough examination
- B ■ Some brick repointing is needed
- A ■ Efflorescence and spalling of bricks and sandstone on east facade is noticeable - should be seen as an emergency repair, as bricks could fall onto persons using the handicapped entrance

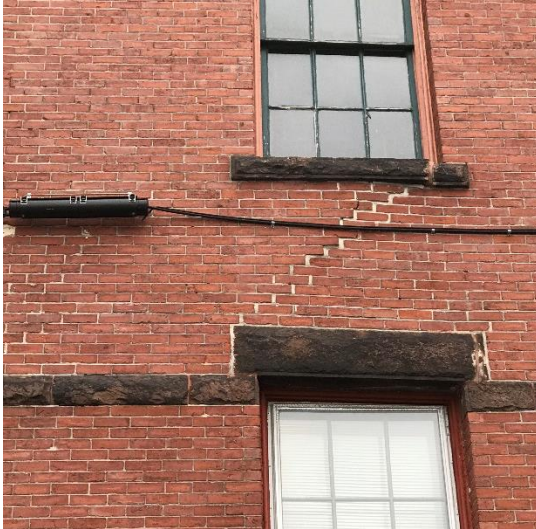
A ■ Settlement of West Wall

Ground water is running down the hill and has been infiltrating the east foundation wall and continued through the building to the west foundation wall. This water movement has resulted in a hole in the east foundation wall and undermining of the west foundation wall near the door to the exterior. The undermining of the west wall has caused extensive cracking in both the north and west wall.

Drainage should be installed to prevent the water from continuing through the basement. After the water has been redirected around the building, the opening in the east foundation wall should be infilled. The base of the west foundation wall near the doorway should be exposed to confirm that the wall is bearing on soil and that the water has not washed it away. Once the foundation wall has been determined to be stable, the cracked brick masonry should be dismantled and reset on the north and west elevations. It should be noted that it is not feasible or necessary to dismantle and reset the wall to be level. Because of this there will still be a slant to some of the masonry elements after the repairs are completed.

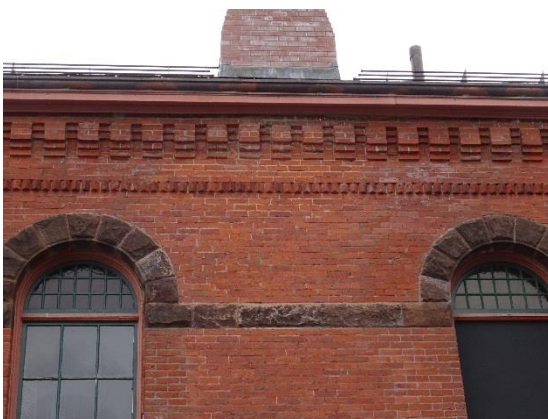
A ■ Potential Damage to Brick Corbel

The brick corbel at the top of the exterior walls was not accessible during our site visit but is an area that is vulnerable to deterioration from water damage.

Additional investigation should be completed from a lift to allow for a close inspection of the brick corbel. The brick masonry should be tapped on with a hammer to locate loose brick masonry. Where the masonry is found to be loose, the brick corbel should be dismantled and reset.

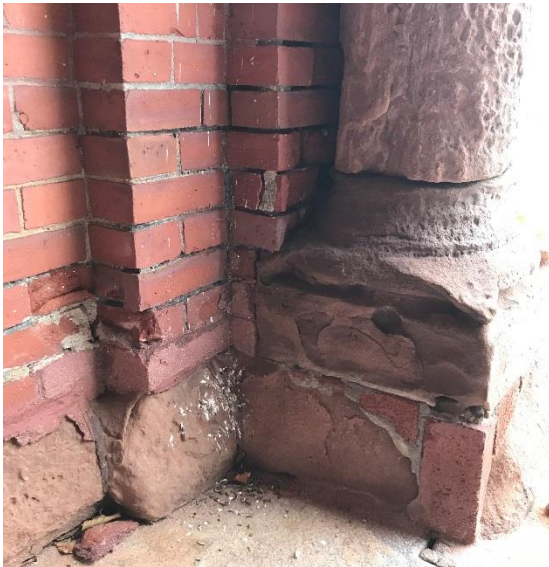
C ■ Deteriorated Brownstone

The brownstone units at the front portico are in varying states of deterioration from the salts used to prevent ice on the stairs and entry. Presently the damage is cosmetic but eventually the wall could be undermined as the deterioration continues. It can be difficult to properly repair brownstone units, and the repairs will have a limited life. The worst of the deteriorated stones should be replaced before the deterioration becomes a structural issue.

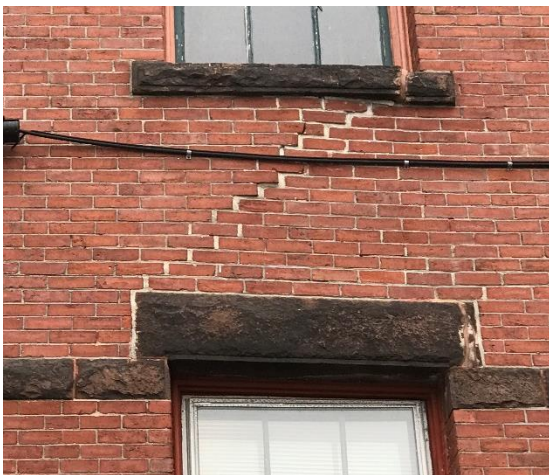
A ■ Cracked Stone Units

There are cracked stones on the west elevation from the settlement described above. The cracked stones should be pin repaired or replaced during the repair of the surrounding masonry.

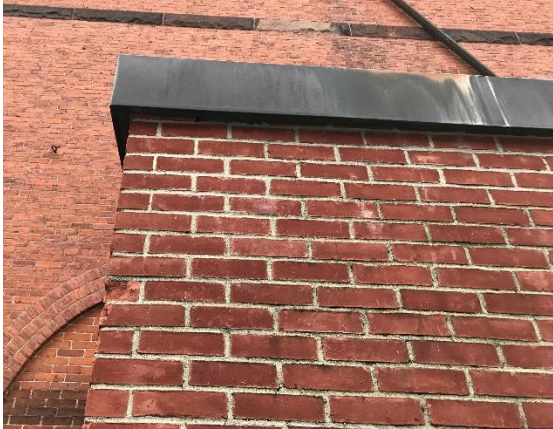
B ■ Loose Brick Units

There are a couple of loose brick units at the upper northwest corner under the flashing of the safe addition on the north elevation. The loose brick units should be removed and reset.

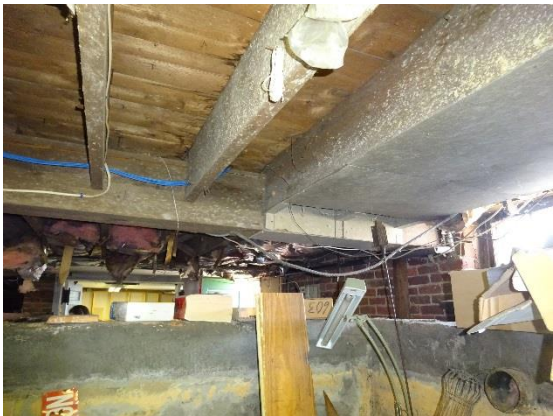
B ■ Settlement of West Wall

The settlement of the west wall, described above, has caused the first and second floor beams in the area of the settlement to deflect. This movement has resulted in greatly sloped floors. There are also cracks in the plaster from this settlement.

The first floor beam does not appear to be damaged from the deflection of the west end. An attempt can be made to raise the beam end to create a more even floor but it is unlikely to be restored to its original state. After the drainage, foundation and exterior masonry repairs are completed, along with any adjustments to the beams, the cracked plaster should be repaired.

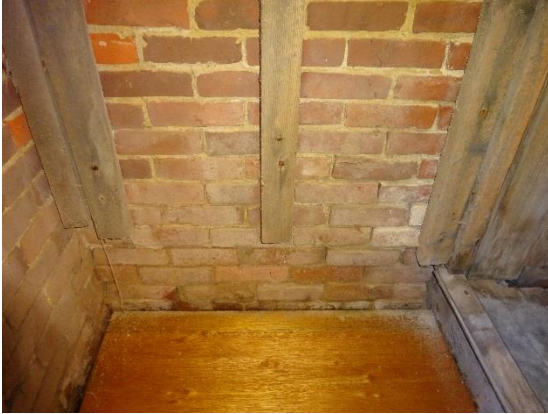
C ■ Deteriorated Masonry

There are eroded mortar joints in both the brick and stone foundation and spalled brick units, this can be seen at both the foundation walls and interior piers. The exposed brick masonry in the northeast stairway also has eroded mortar joints and spalled bricks. In the upper turret room there is a crack in the interior brick masonry wall that is supported by steel beams. The eroded mortar joints should be cut and pointed with a compatible mortar and the worst of the spalled bricks replaced. The cracked masonry should be dismantled and reset.

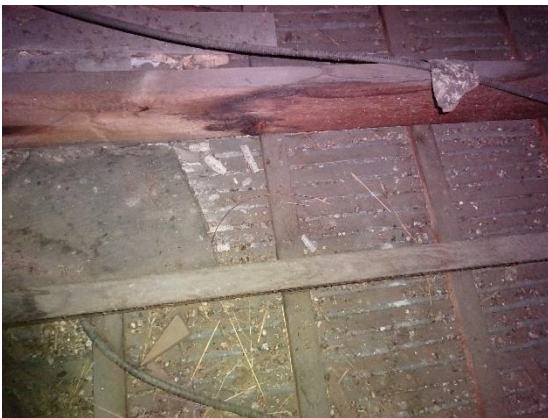
A ■ Damaged Plaster Keys

The back side of the second floor ceiling plaster could be reviewed. Lath and plaster ceiling and wall finishes is installed by pushing the plaster through the spaced between the lath boards. The plaster that extends past the back face of the lath is known as “keys”. It appears in some areas that the keys do not extend fully through the lath and may be damaged. The damaged and missing keys could result in the plaster becoming separated from the lath and falling. The connection between the lath and plaster should be reinforced. This work should be completed by plaster specialists.

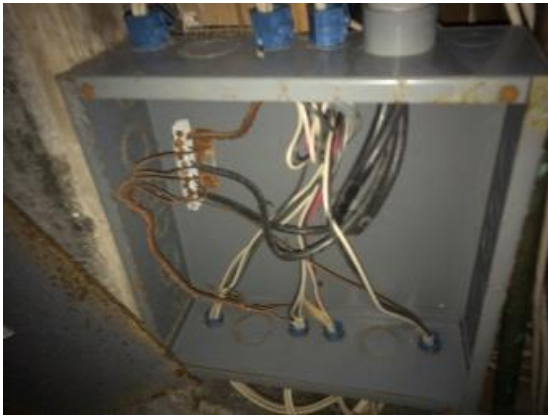
Exposed Junction Boxes:

- A ■ Coverplates for junction boxes to be closed.

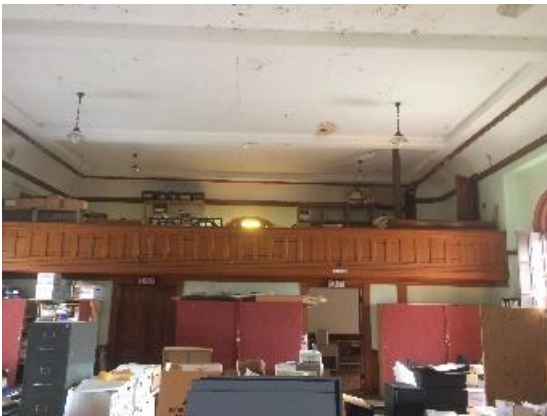
Minimal Coverage of F/A Devices:

- A ■ Replace Fire Alarm System, means of egress lighting and signage and add initiating devices: smoke, heat, CO and pull stations per code.

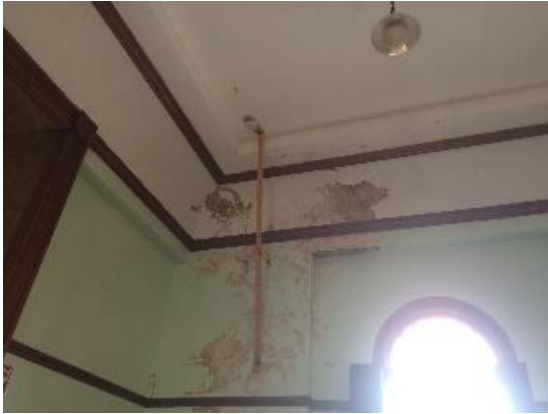
Security and F/A:

- A ■ Replace Fire Alarm System initiating devices: smoke, heat, CO and pull stations per code.

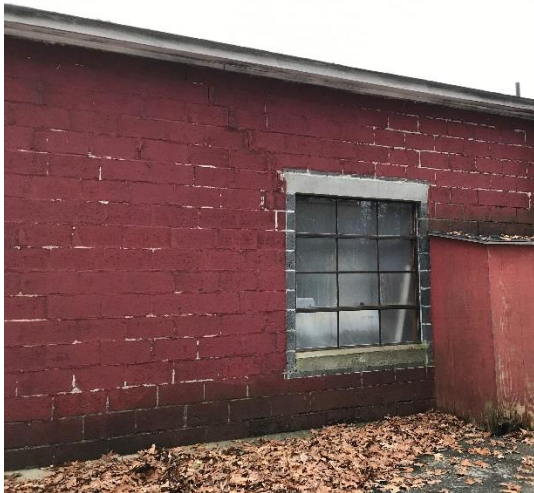
B ■ Eroded mortar joints

The damaged mortar joints should be deeply cut and pointed or grouted as much as the limiting thicknesses of the face shells will allow. Unfortunately, because the concrete blocks are hollow, cutting too deeply will expose the inner cores and the repointing mortar will slough into the holes unless a backer rod is used. If the weakening runs further into the wall thickness, the unsupported masonry above the cut joints may shift. Therefore, this work will need to be done incrementally. This is a Priority Level 2 item.

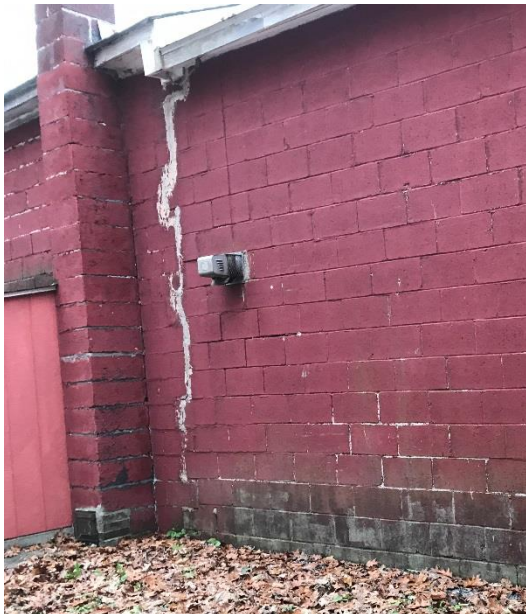
C ■ Vertical crack at rear

This can be done in several ways:

- By removing interior finishes to expose the inner face of the wall and deeply cutting and pointing from the interior and exterior using backer-rods.
 - By removing and re-setting the concrete blocks along one or both sides of the cracks from the exterior.
- or
- By incrementally cutting through the entire thickness of the wall and installing grout filled lozenge type sock anchors from the outside of the wall and then pointing outer surface (this is a proprietary system that this office has developed).

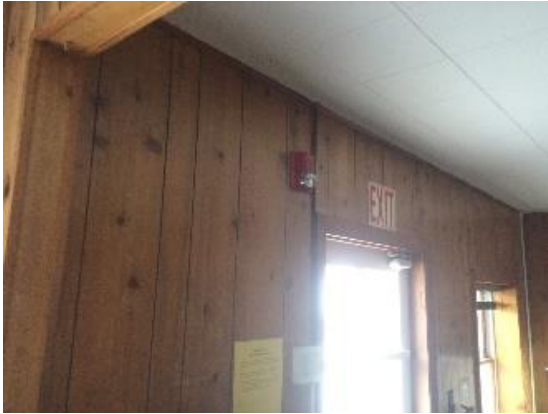
Building Emergency Signaling and Egress Lighting and Signage:

- A ■ Replace Fire Alarm System, means of egress lighting and signage and add initiating devices: smoke, heat, CO and pull stations per code.

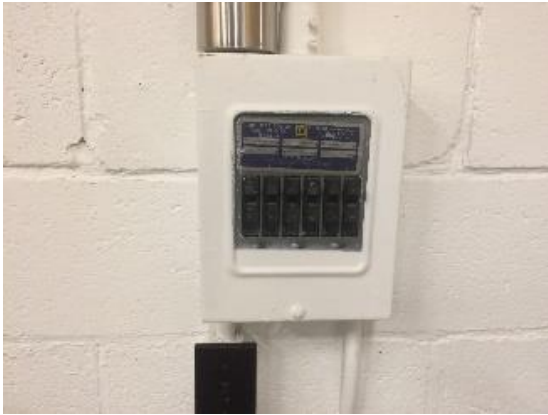
Load Center:

- A ■ Antiquated Load center recommended for replacement.

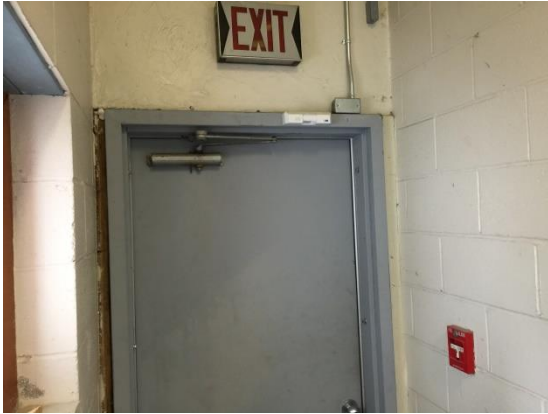
Exit Signs & Emergency Lighting

- B ■ The building exit signs that appear capable of illumination but were not illuminated during the site visit. Existing signs must be repaired or replaced with signs having adequate battery back-up as required for new construction in any renovated areas.

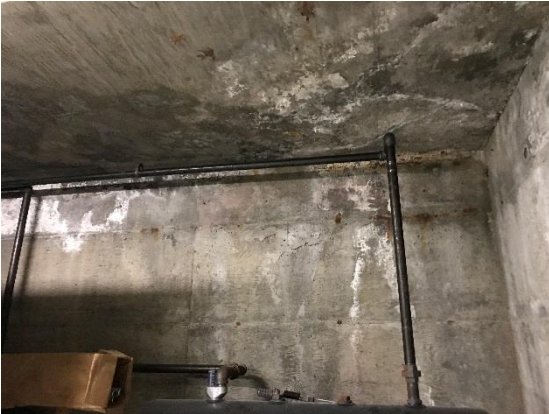
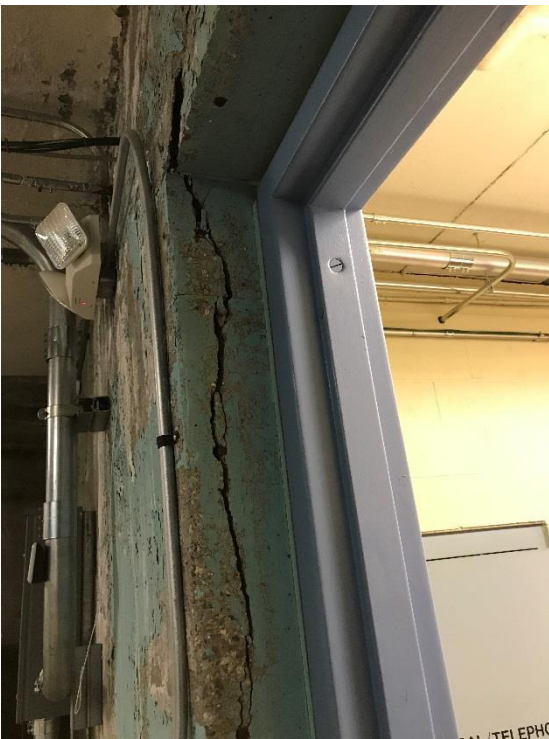
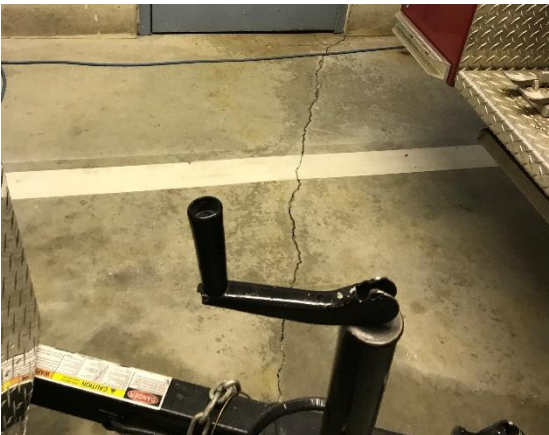
B ■ Ingress of water running downhill from rear

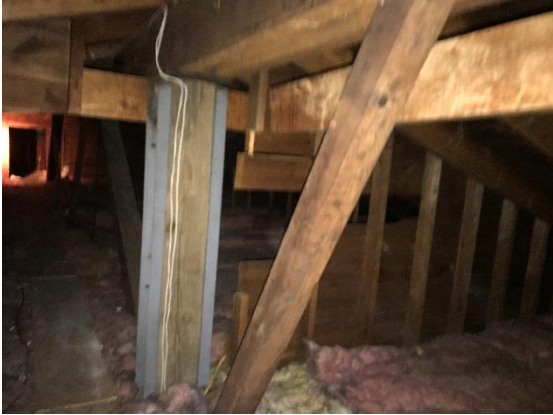
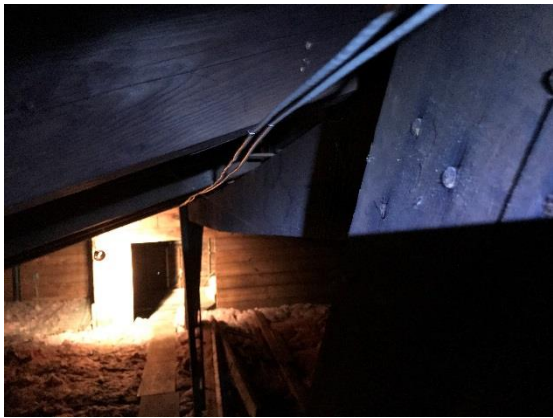
clamping channel columns. Unfortunately, while this helps lift one end of the truss and shorten the span, the truss's top chord is still grossly undersized for the compression and bending load on it, and remains deflected by several inches, allowing the roof's ridgeline to sag noticeably and the eaves to bow out.

Because of the importance of the spaces below, the extreme deformation that has occurred and the potential severity of winter snow, this should be considered an URGENT condition.

The entire truss must be significantly reinforced, or even sistered or replaced. This could be most efficiently achieved bolted steel members that are assembled and connected in place. The roof ridge should be jacked upward during the installation and the ceiling removed and the eaves pulled in.

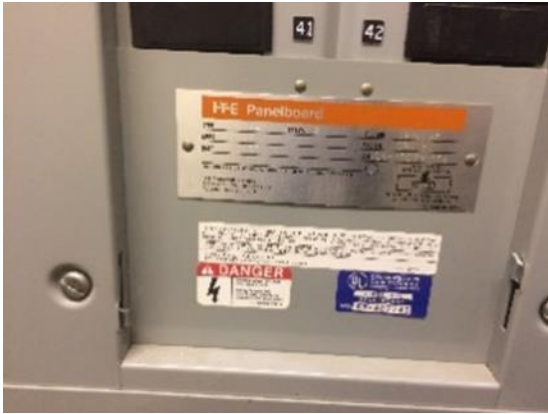
Load Center Upper Floor:

- C
- Sample of updates being made to load centers.

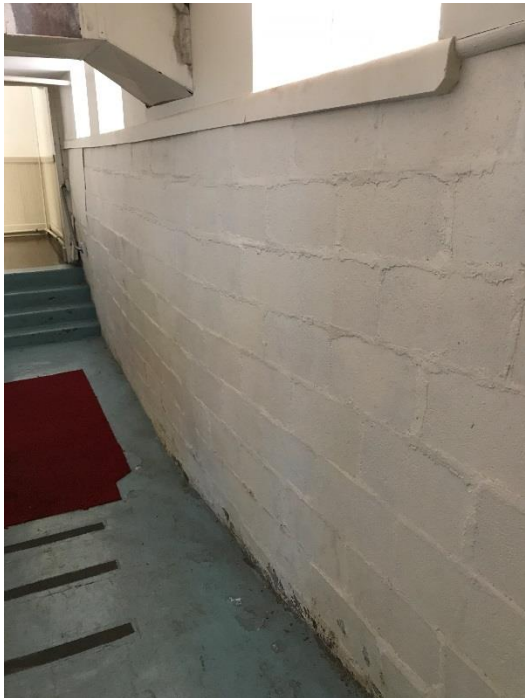
B ■ Separating basement wall surface

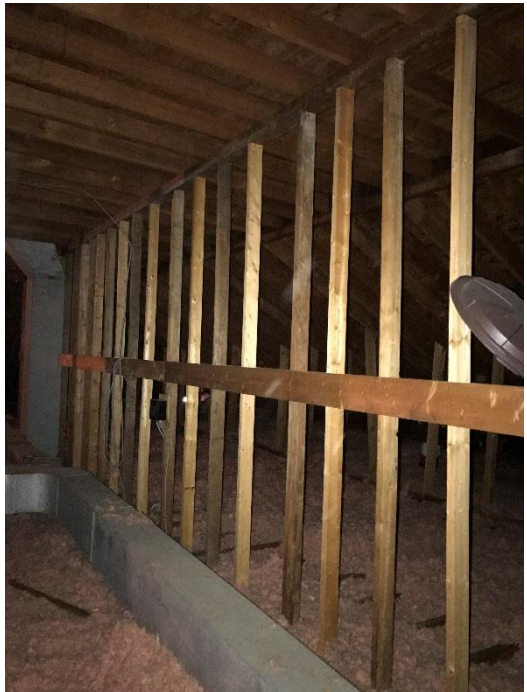
The bottoms of many of the rafters are notched midspan at the original portions left and right roof slopes. This was probably done to accept purlin that was never installed. The rafters should either be reinforced by sistering or the missing purlin should be added.

B ■ Undersized roof framing

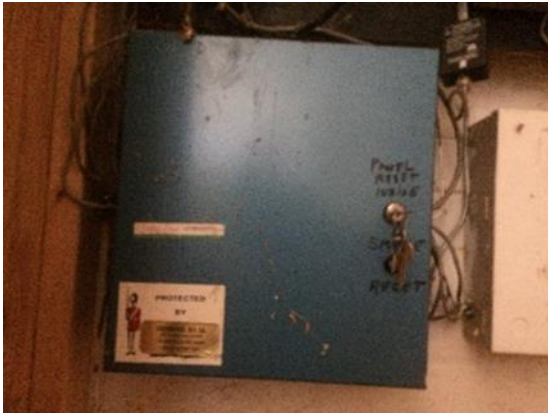
Security – F/A Relay Panel:

- A ■ Replace relay panel with radio master box.

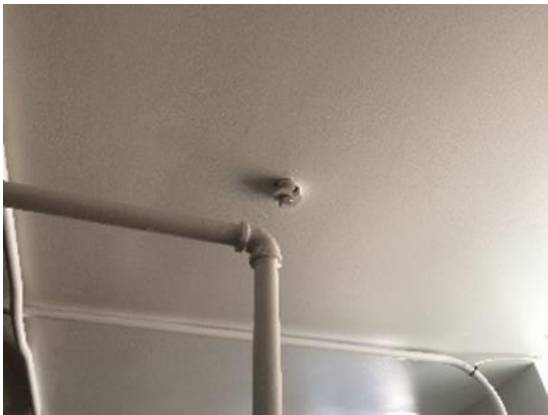
Button-Style heat Detection:

- A ■ Replace Fire Alarm System initiating devices: smoke, heat, CO and pull stations per code.
