Mechanics Hall – East Princeton, MA

Prepared for: Friends of Mechanics Hall
Prepared by: JD McCarthy, Inc.
Report Date: November 15, 2013

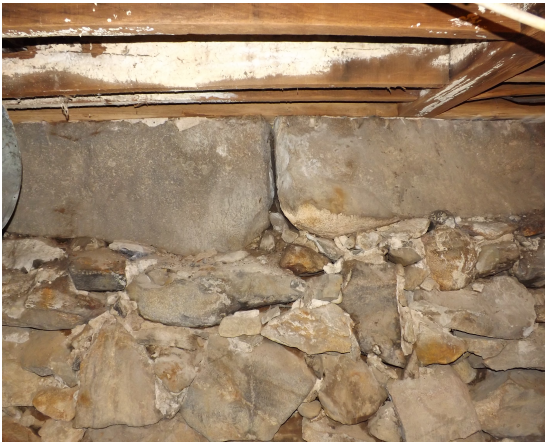
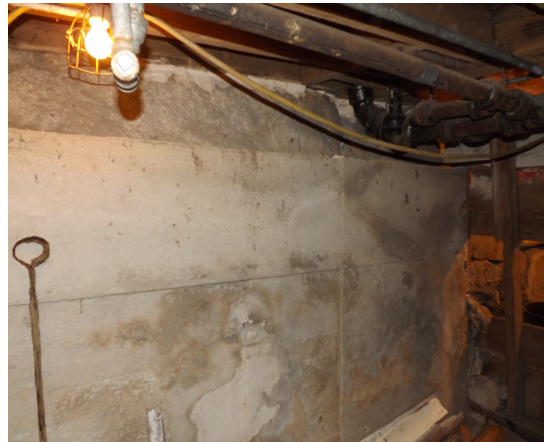
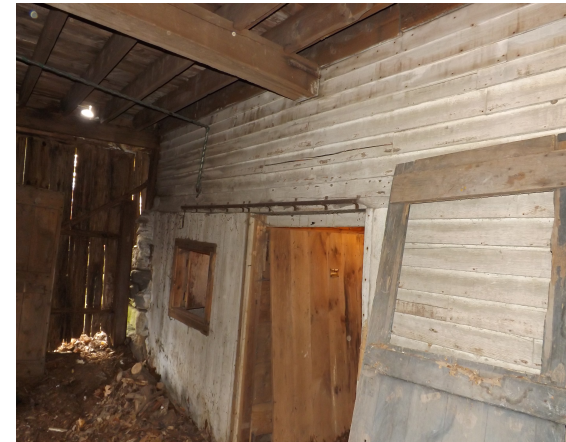
Three existing current conditions: original stone foundation, poured concrete reinforcement and inadequate/non-existing foundation.

The original stone foundation appears to be in relatively good condition, but upon initial inspection, it is presumed to require some repair to maintain structural integrity and to minimize infiltration of water. Some areas in need have already been addressed with poured concrete and other areas, where the foundation is currently non-existent, will require the addition of a new foundation section to provide proper structural support.

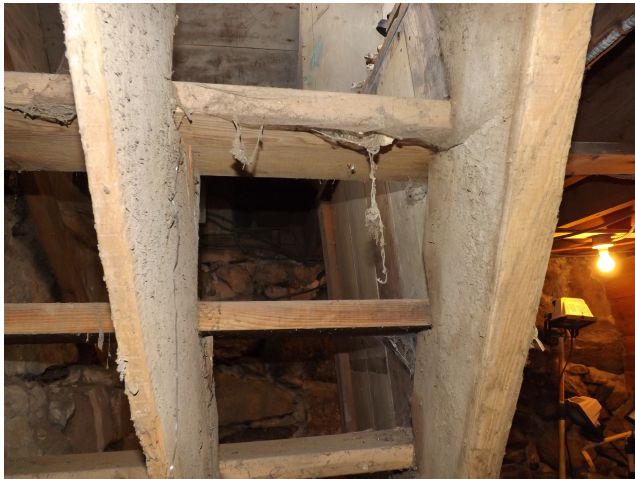
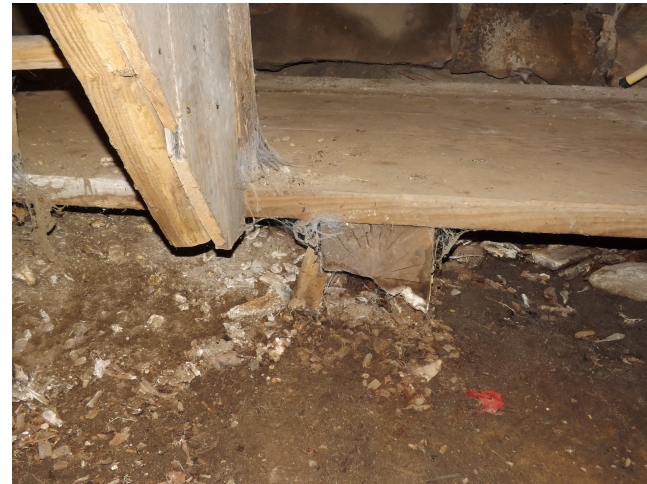
Floor: Current basement floor is original earth floor. Perimeter drains, vapor barriers and the addition of a poured concrete floor are recommended to create improved functionality for mechanical systems, storage and moisture control.

Stairs: Stairs leading from main floor to basement are in need of a complete rebuild, due to compromised structural components.

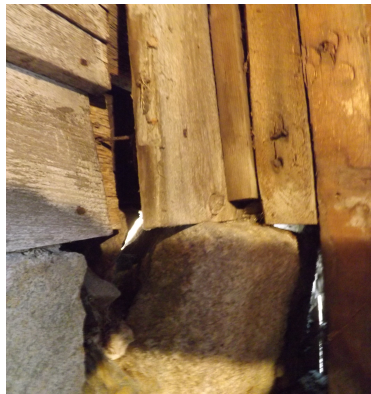
Framing: Sills and girders are constructed of original 8x8 timbers. Upon initial inspection, existing interior girders appear to be in sound structural condition.

Many of the visible sills appear to be in sound condition as well; however, two areas were identified as being in need of repair at the Northeast and Southeast corners of the main structure, where the sills are visibly deteriorated at the corner post intersection. Additionally, portions of the sills that are not currently visible can not be evaluated until the removal of exterior sheathing takes place.

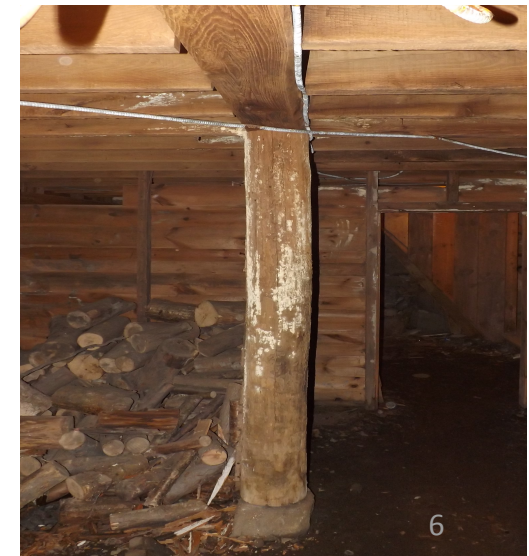
Floor joists are constructed of 2x8 timbers running West to East, spaced 16" on center. Joists are notched and connected at the supporting girders in notched pockets, commonly referred to as a butt cog joint. The maximum joist span is 112" and is expected to conform to current building code, subject to approval of the structural engineer. The girders are supported by 10" diameter round, timber posts that do not appear to be on any footings. Footings will need to be added to provide proper support.

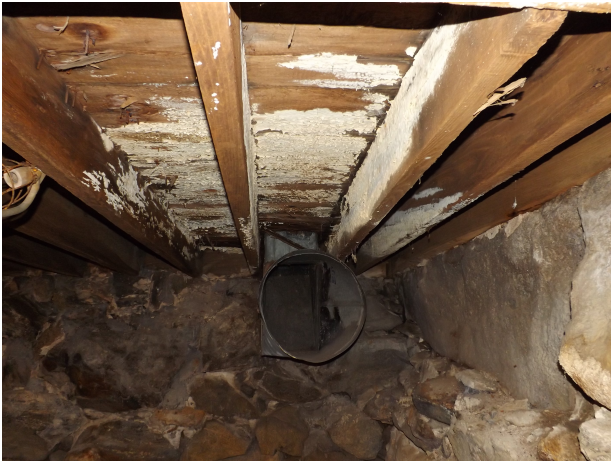
An area of damage in the Northwest corner contains compromised structural elements including apparent moisture damage to joist, girder and sill components. The damage appears to be contained to an area of four joist bays, approximately 6' in length.

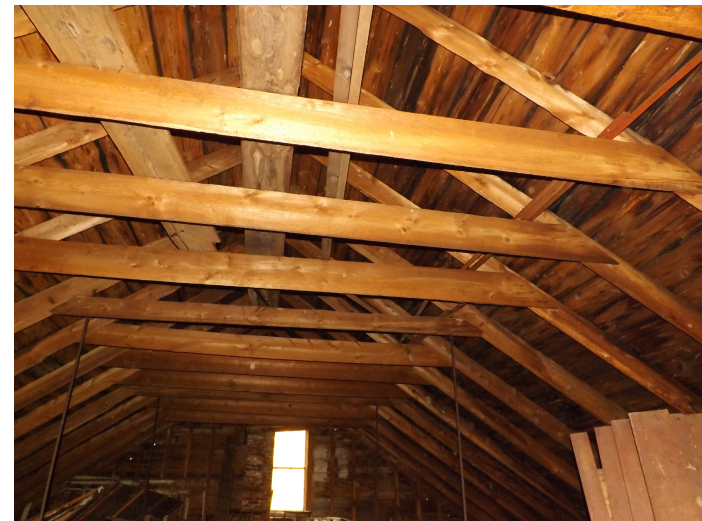
The attic consists of original 2x8 roof rafters and original roof sheathing. Aside from some visibly compromised sheathing and two missing collar ties, the roof system appears to be in sound structural condition.

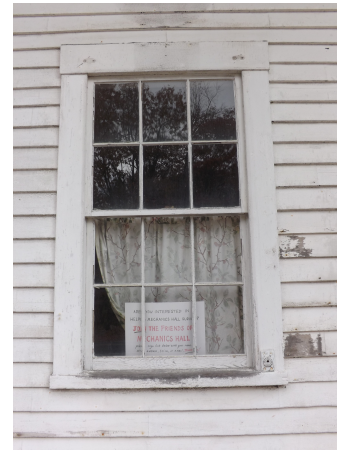
The existing six over six wood framed original windows with single pane glass, appear to be structurally sound. Some glazing will need to be replaced on specific units as well as application of proper weather sealing to ensure peak performance. The surface is in need of a coat of paint at this time.

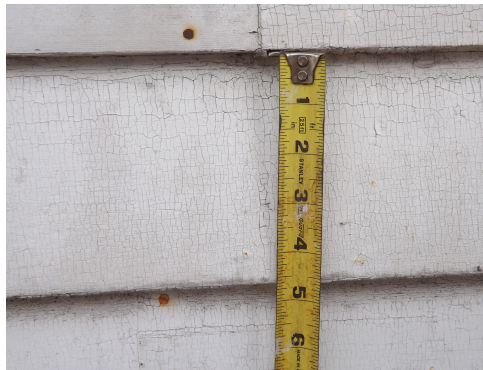
The exterior of the structure is covered in original clapboard siding. The wood appears to be sound at this stage, but the existing paint is not providing adequate protection. Without a coat of paint, the wood will deteriorate quickly.

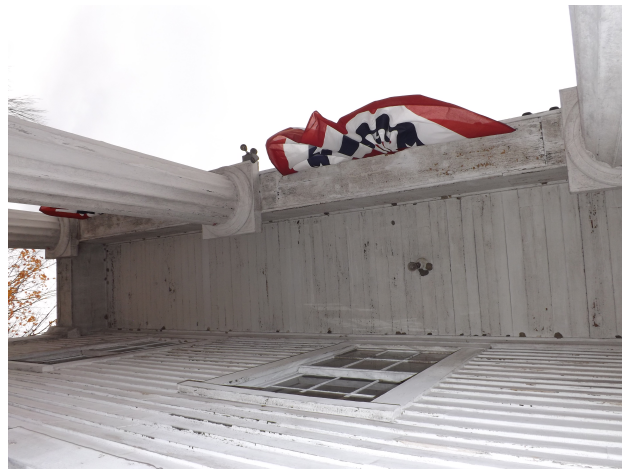
Similar to windows and siding, the vast majority of exterior trim elements appear to be in sound condition, but will require a coat of paint to ensure longevity.

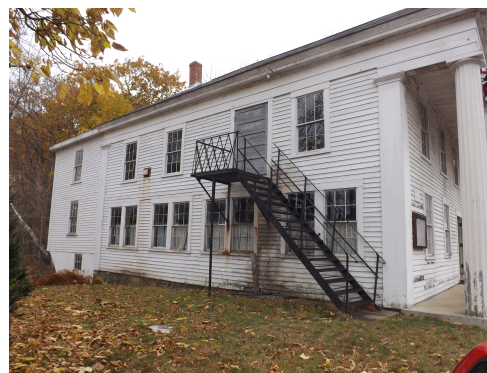
A steel fire escape exists on the North side of the structure, connecting the second floor to the ground level. The fire escape appears to be sound, but could benefit from a coat of paint for protection. Furthermore, additional investigation will be needed to determine if this access point will meet the current building code requirements for a second egress from the second floor.

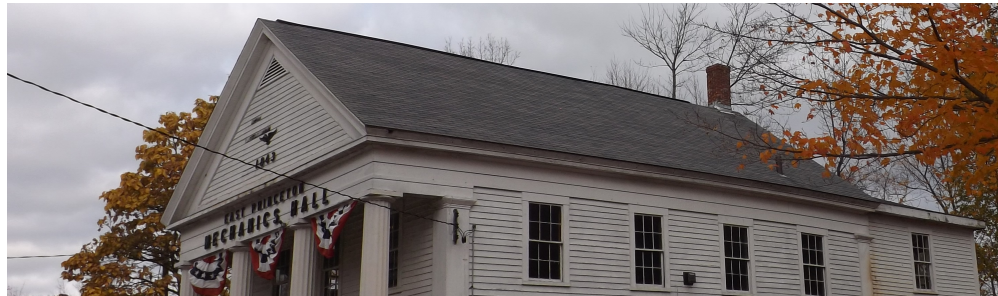
The main structure roof is a three tab asphalt shingle material. Most manufacturers warranty about thirty years on similar products. It is estimated that the current roof is approximately 20 – 25 years old and nearing the end of its lifespan. The roof on the back portion of the existing structure is a rolled rubber product, which appears to be functional and of a similar age.
