# Rehabilitation of Mechanics Hall

A Major Qualifying Project By

Mechanics Hall is an historic building built in 1852 in Princeton, Massachusetts. The project goal was to develop a plan to bring Mechanics Hall into compliance with current building code requirements. A field inspection was performed to gather data used to develop a Building Information Model. Due to the extensive use of building code, a Code Review was developed, along with a design and cost estimate for two proposed uses. The results were presented to the Friends of Mechanics Hall.

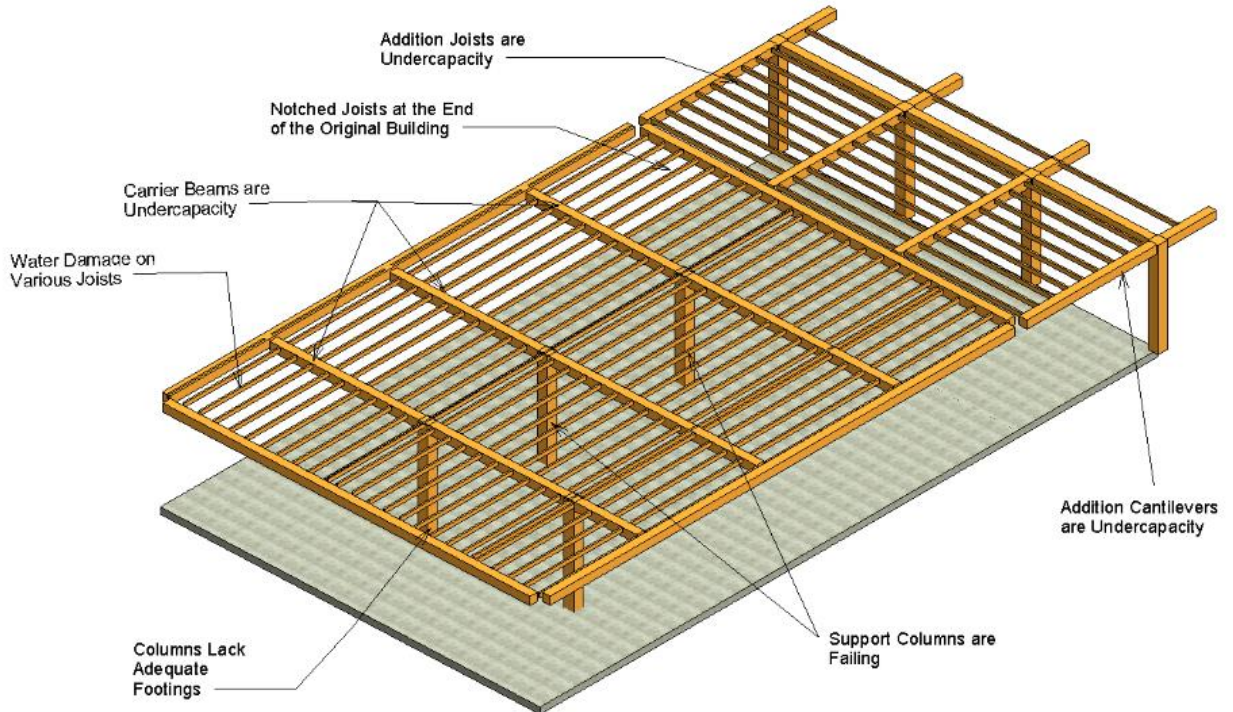
Figure 11: Mechanics Hall Frame Damages

The entire addition except for the floor decking and the columns will need strengthening to support the required loads. The joists in the addition span a longer length than the joists in the main building, which causes enough additional stress to render the joists inadequate to handle the required bending stress. The cantilevered carrier beams require reinforcement for bending and shear. The loading on the internal span of the carrier beam is so great that the cantilevered section of the beam is pushed upward rather than downward. This creates the perception that the cantilevered section can support greater loads with a lower deflection. The areas of concern for the entire Mechanics Hall frame can be seen in Figure 11.

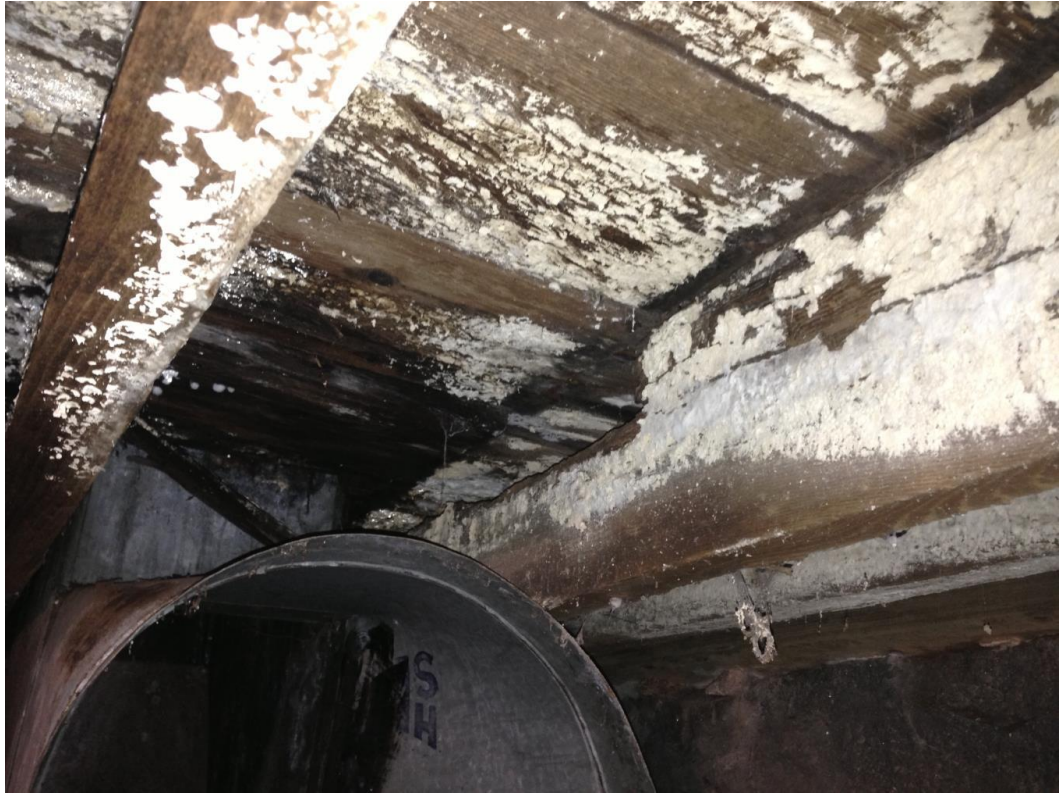
The analysis that produced the results displayed in Section 5.2.1 was completed under the assumption that every structural member was in good condition with a full cross section. That is not the case with Mechanics Hall. Many of the beams in the Main Building have sustained heavy water damage. The joists in the southern bay between the South foundation wall and the South carrier beam have sustained significant water damage and have experienced large amounts of mold and decay (Figure 12). Various joists in the middle two bays are rotted and either sustained water damage or apparent insect damage (Figure 13). Select joists between the South and Middle Carrier Beam have been cut and bent to accommodate a small pipe near the western foundation wall (Figure 14 and 15).

Figure 12: Wet, moldy, rotting joists and floor decking under the South Bay.

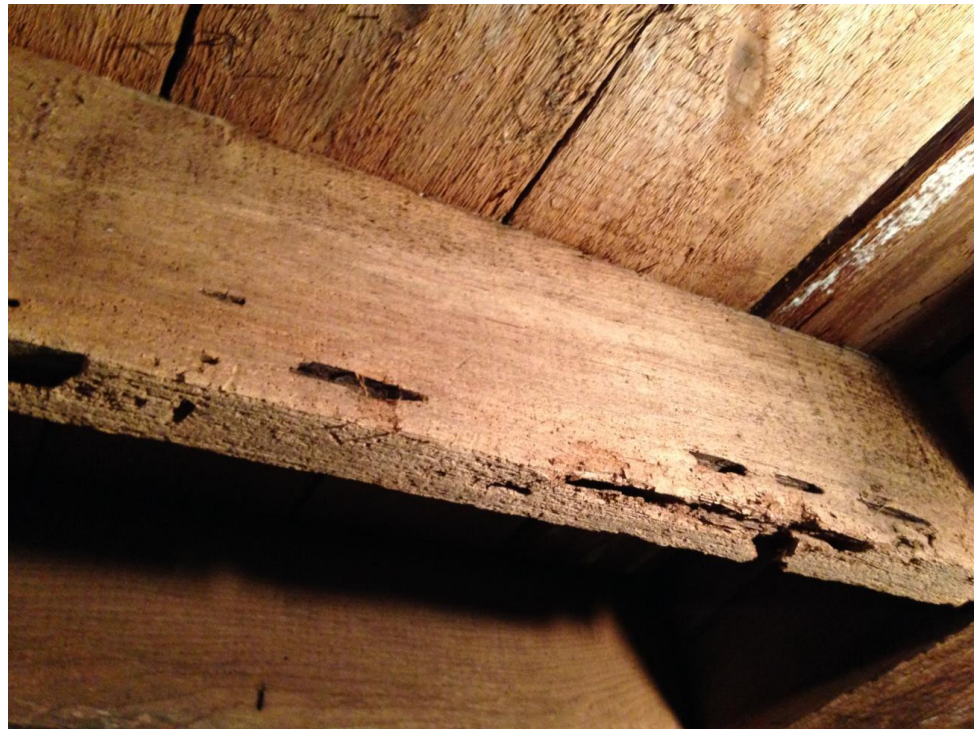
Figure 13: Decaying joist with mold on the floor decking.

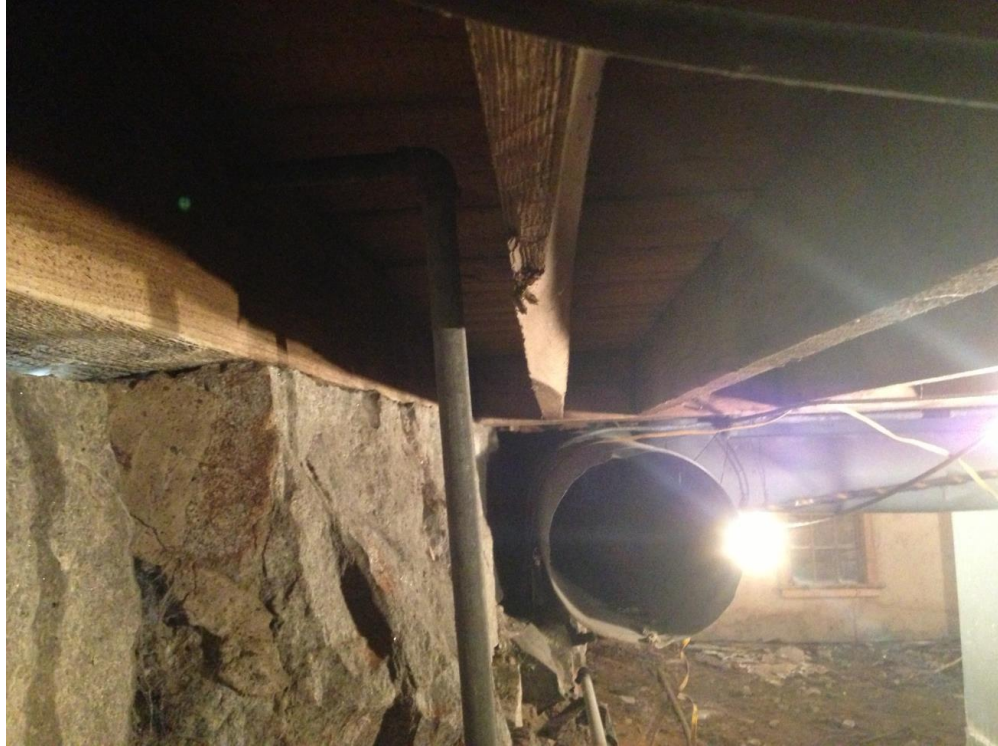
Figure 14: Warped, cut joist in between Carrier Beams A & B - Side View.

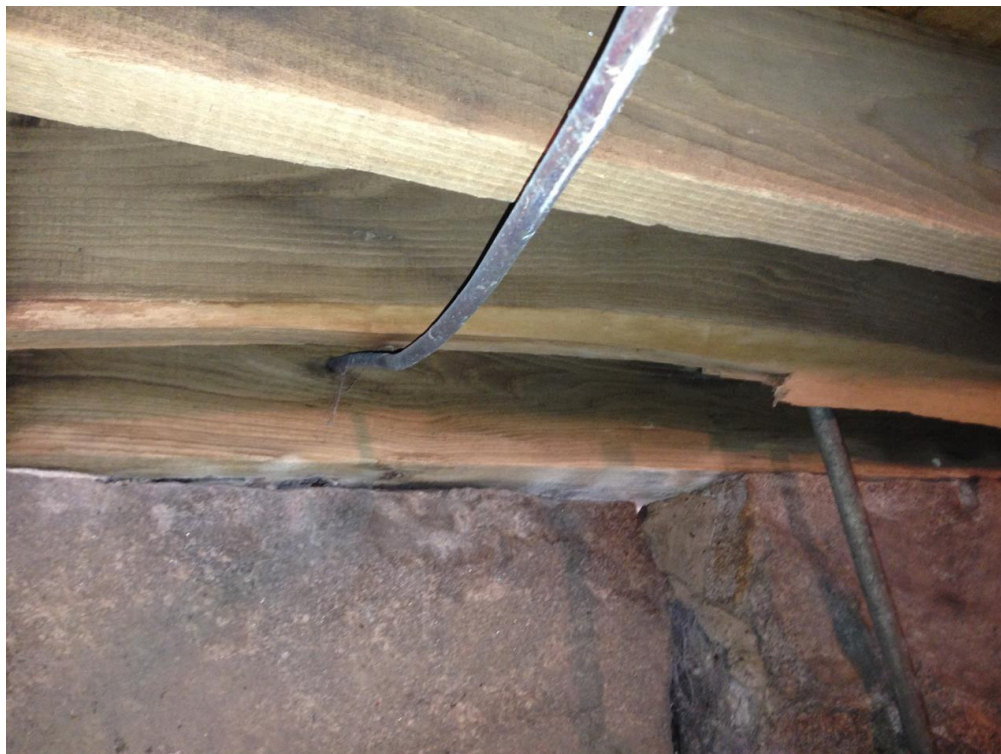
Figure 15: Warped, cut joists between Carrier Beam A and B - Front View

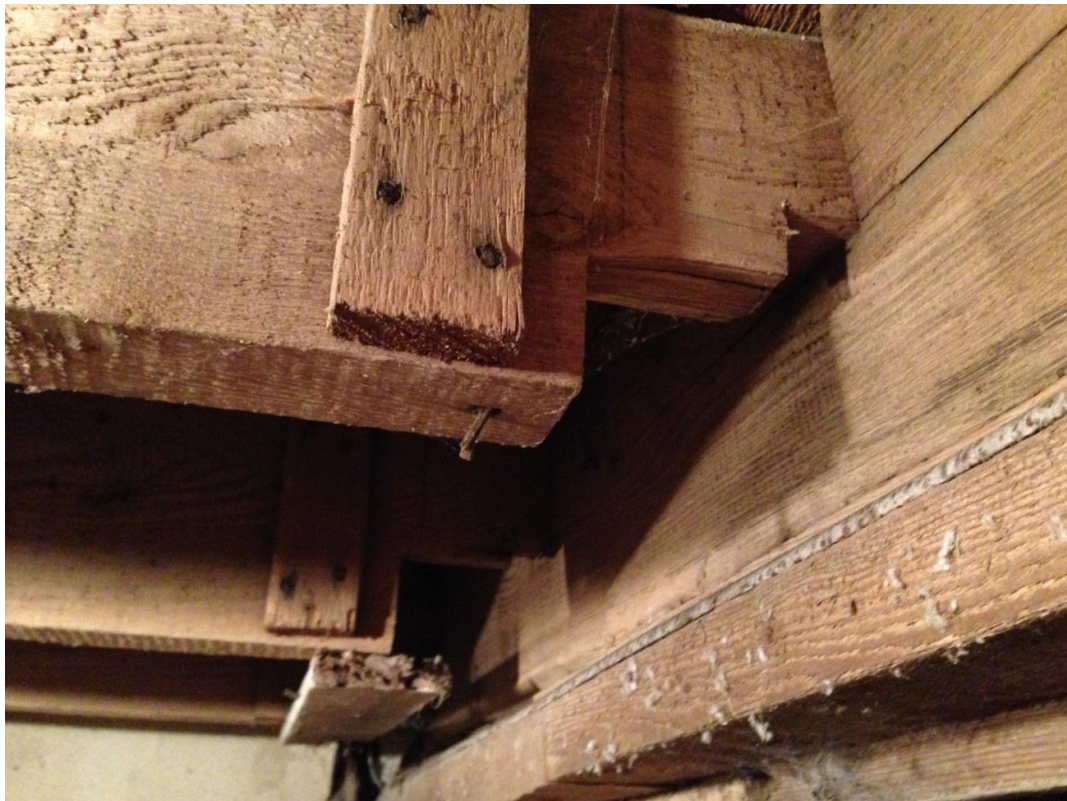
Every beam in the North bay between the North Carrier Beam to the addition has notches at the end of the span. As seen in Table 11, these beams fail the shear check due to the missing material. The notches in these beams also do not meet the standards specified in NDS Section 4.4.3. The standards specify that the notch may not be greater than  $\frac{1}{4}$  of the depth of the beam, whereas the notch in the beam is close to half the depth, as seen in Figure 16. The Middle Column is splitting down the middle, and all columns show signs of insect damage (Figure 17). The footings for the columns consist of rocks with no concrete or grout, as the floor of the basement is dirt (Figure 18).

Figure 16: Crossbeams notched at the end of the spawn at the back end of the Main Building.

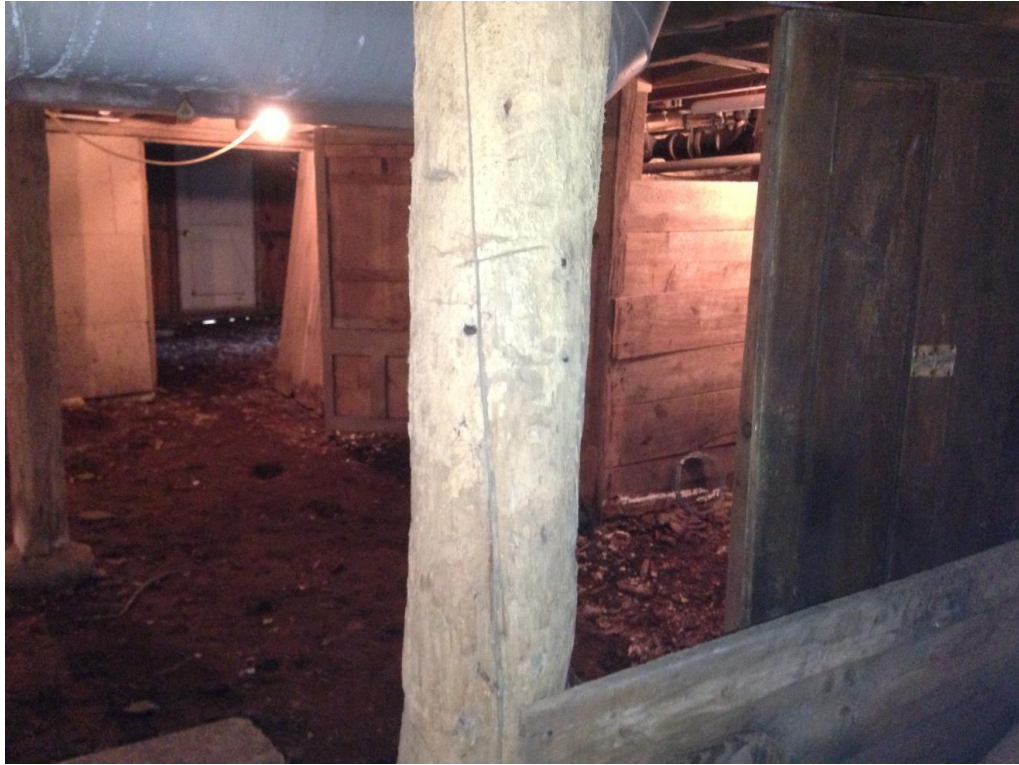
Figure 17: Basement support column splitting down the middle due to axial compression.

The replacement columns should be square Northern Red Oak beams with a 10" x 10" cross section. These columns will have a larger cross sectional area than the existing columns, which will allow them to support the required loads. At the same time, the dimensions are similar to the existing structural members, and will allow for easy installation. It is important to note that these given dimensions are exact measurements, not nominal. When ordering a 10x10 timber beam, the actual dimensions will be less than 10" x 10". Installing a nominal 11x11 may be necessary to provide the required cross sectional area. Figure 31 depicts the base of the new column as it meets the new footing.

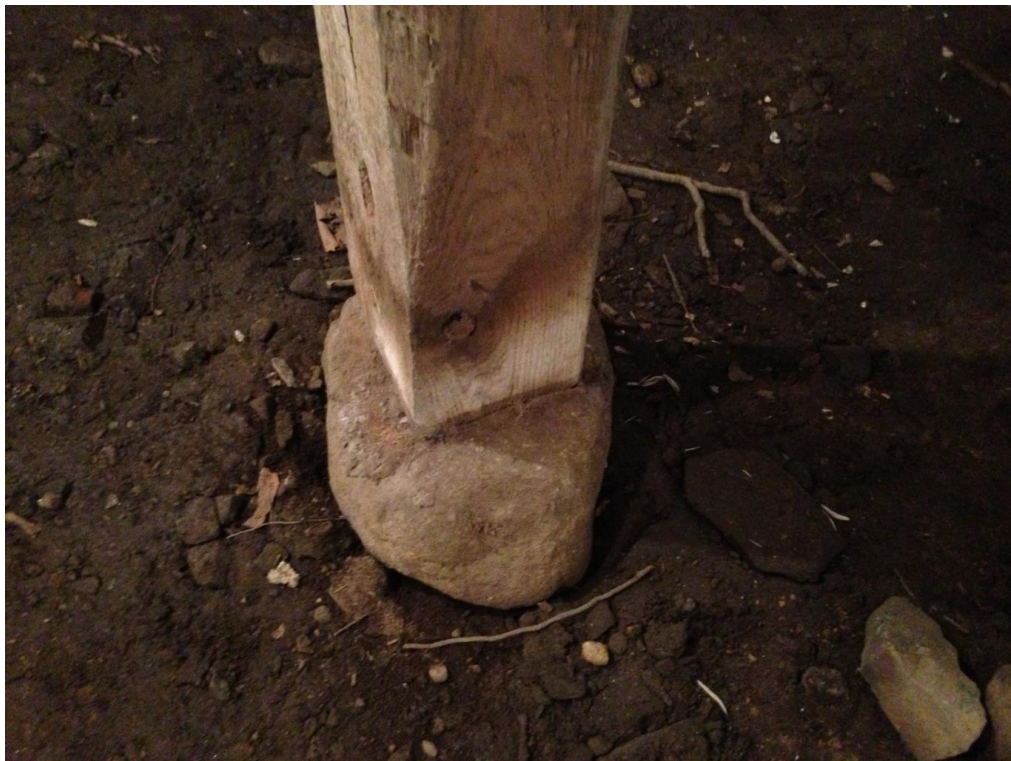
Figure 18: Rock footing for support column in the basement.

The new columns will require new footings to adequately disperse the load to the earth. The existing footings are insufficient for this purpose. The new columns should be made of reinforced concrete. In accordance with IBC 1809.4, the base of the footing must sit a minimum of 12 inches below the existing grade. For Mechanics Hall, this minimum will suffice. The footing should be a square 36" x 36" x 12" deep centered beneath the column. Due to the minimum required reinforcement needed, No. 7 rebar must be placed at a depth of 9" running in both directions to form a grid, as depicted above in Figure 31. The rebar should be spaced every 5" on center, with no rebar placed within 3" of any edge of the footing. This is shown below in Figure 32, with the red dotted lines indicated the placement of the reinforcing rebar. The supporting calculations for the column and the footings can be found in Appendix D and E respectively.

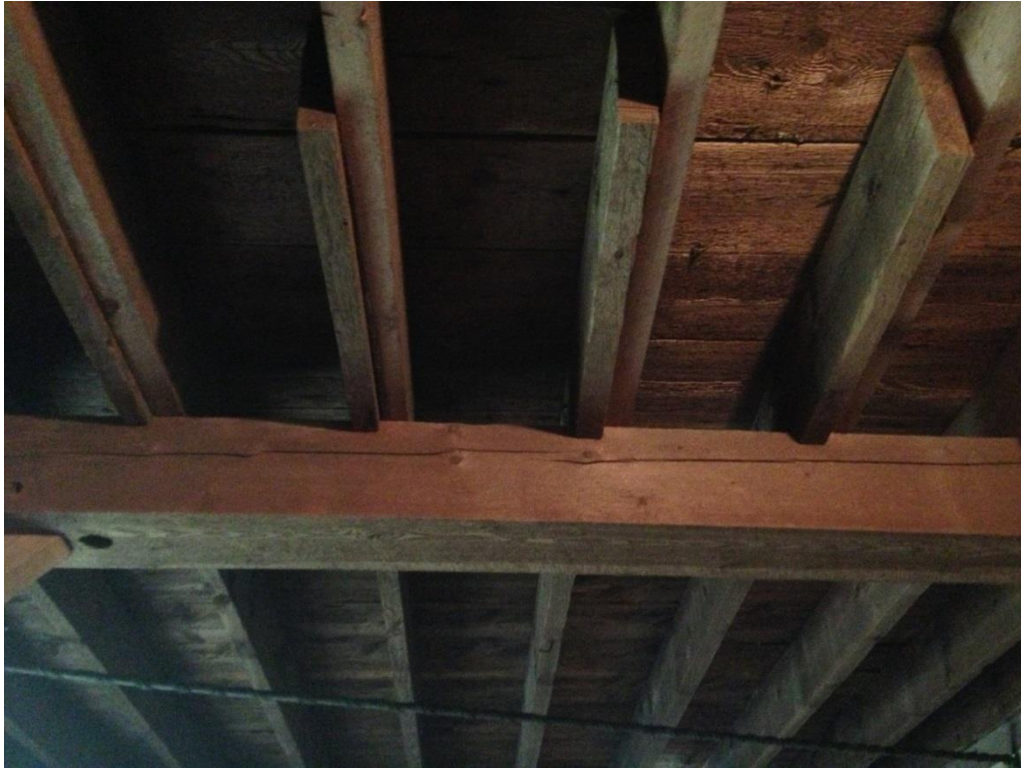
The structural members of the addition are generally less damaged than the members found in the original building. As seen in Figure 19, the main structural frame is free from mold and other visual signs of decay. Occasional cracks were found in structural members, as seen in Figure 19. The majority of the damage in the addition is found in the sideboards that make up the wall. These boards are exposed directly to the earth beneath the wall, resulting in rot and decay in the walls. Figure 20 depicts a hole that has rotted through on the side of Mechanics Hall. There is no foundation underneath the addition.

Figure 19: Framing as seen from the basement of the Addition

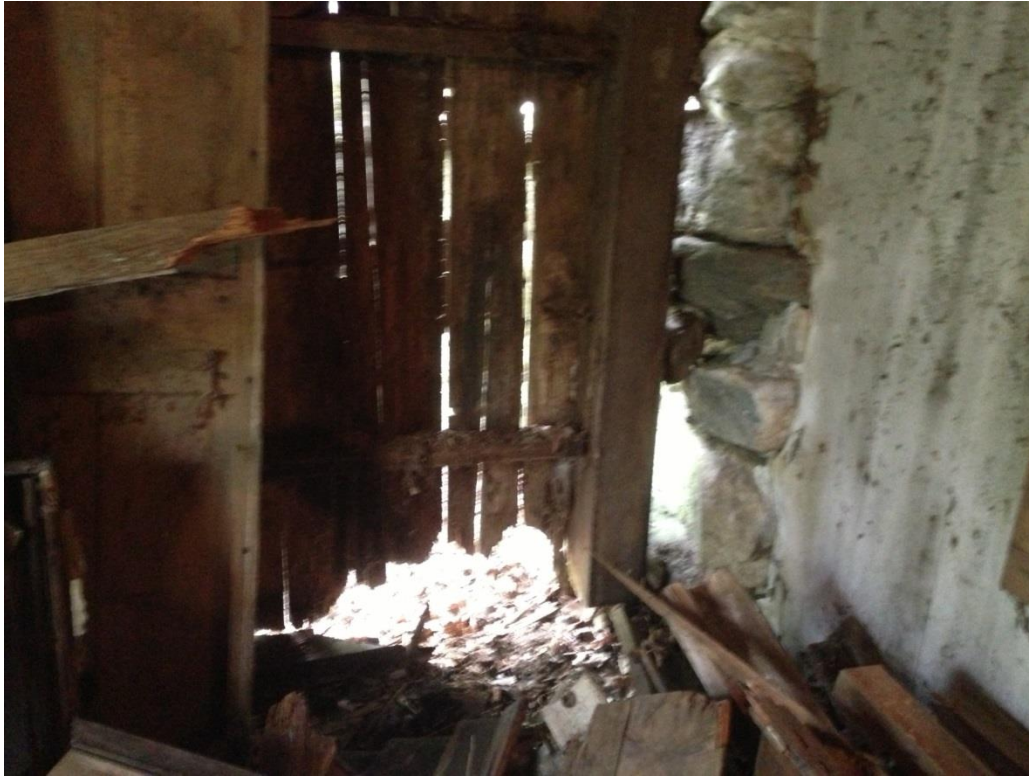
Figure 20: Hole in exterior wall as seen from the Addition Basement.

The addition has no foundation walls, as the land surrounding Mechanics Hall slopes downwards towards the back. The wooden exterior walls of the structure are in direct contact with the ground. This has led to significant rot and moisture damage in the exterior wall of the building, as depicted in Figure 20.

of 4 feet. Starting at 4 feet below the existing grade, a concrete footing measuring 16" wide by 1 foot thick should be placed. On top of the footing, an 11.5" thick by 3 feet tall concrete wall should be cast. All concrete should be rated at a compressive strength of 3000 psi. No steel reinforcement is required for this foundation. Design calculations can be found in Appendix F. A section view of the proposed wall and footing can be seen in Figure 34.

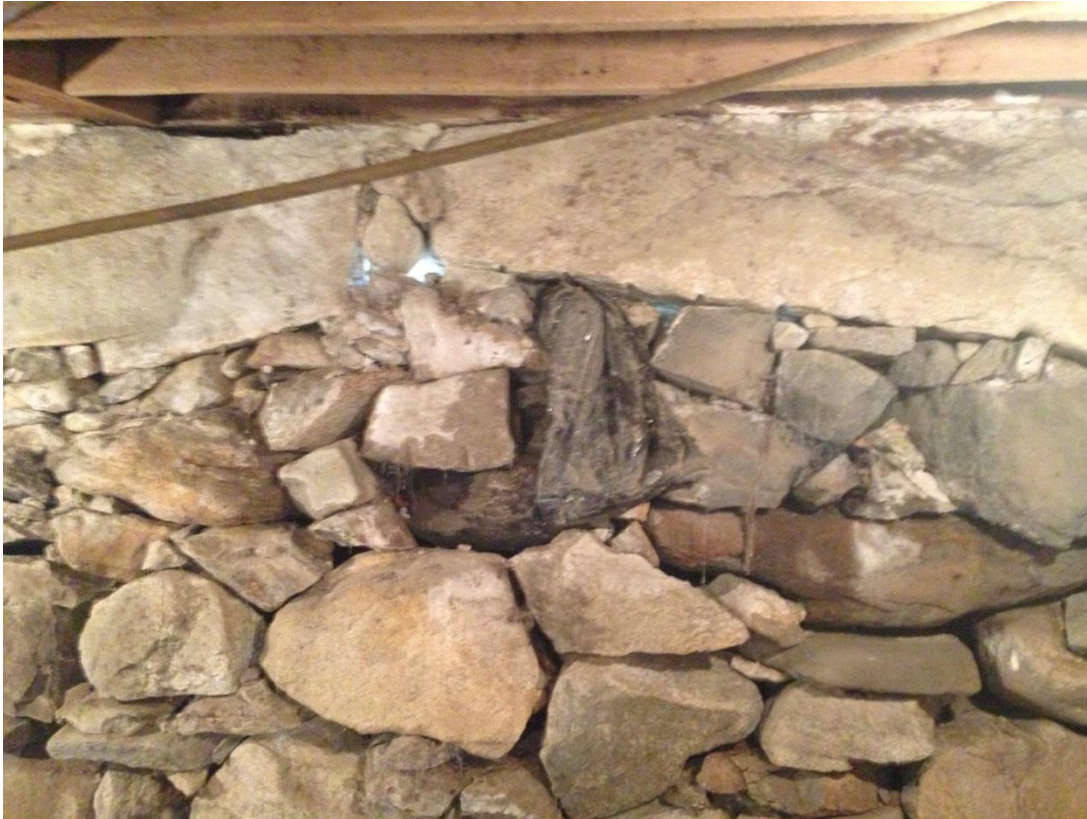
Mechanics Hall has a different foundation supporting the original building than supporting the addition. The original building has a fieldstone foundation on three of the four sides. Multiple holes have formed primarily on the western foundation wall, as seen in Figure 21. These gaps right along ground level in the foundation wall allow a significant amount of water into the basement, contributing to much of the damage to the structural frame. The thickness of the wall measured through one of the larger holes is 9 inches. The southern and eastern foundation walls are in better condition and have experienced minimal damage. There is no basement floor slab.

Figure 21: Hole in Western foundation wall with visible daylight.

To solve the drainage issue there are a few ways to approach the problem. The most conventional way to deal with leaking foundations is to excavate from the outside to install a perimeter drain, and install a drainage layer over waterproofing on the outside. This method tends to be expensive because of the amount of excavation that would need to be performed. Another solution that would be less expensive is to install an interior French drain. In Figure 35, shows a section view of an interior French drain system and its components.
