PRINCETON PUBLIC BUILDINGS FACILITIES ASSESSMENT

Princeton, Massachusetts

FINAL REPORT

April 2015

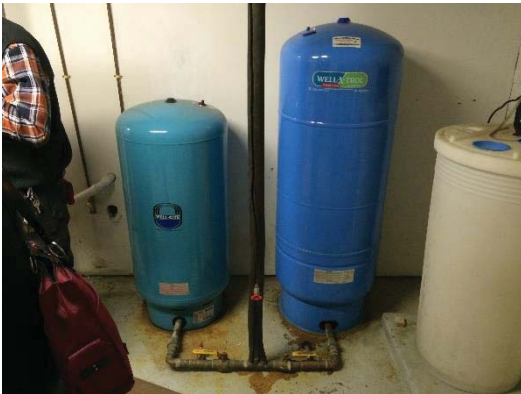
Photo 1: Well Pump Tanks

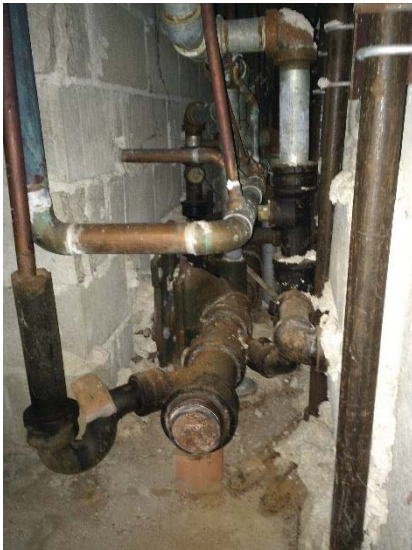
GENERAL COMMENTS: The sanitary waste piping is in very poor condition. In one location pipe and fittings were cracked and split open.

Photo 3: Deteriorating Sanitary Piping

Survey existing sanitary piping and replace failed piping as required

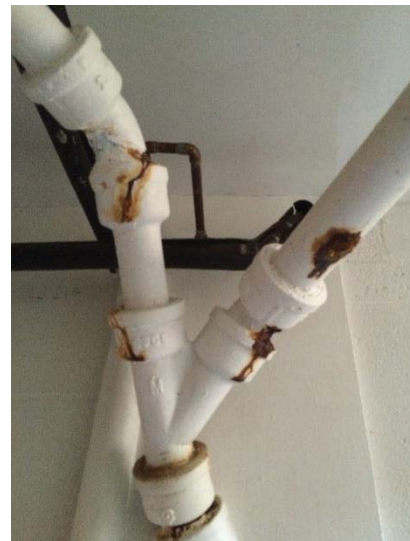
Photo 4: Deteriorating Sanitary Piping

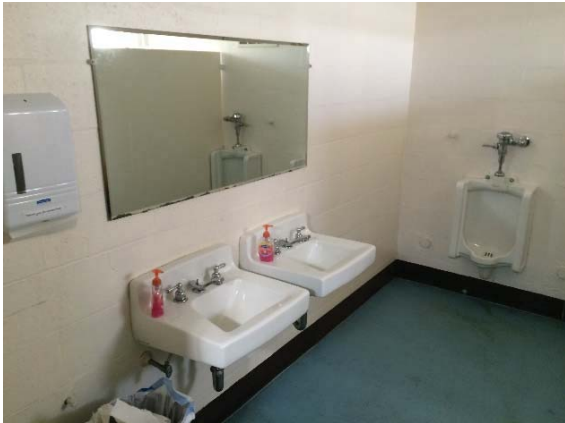
Photo 5: Fixtures

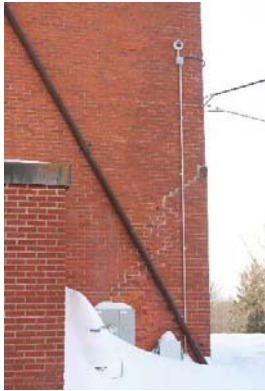
Photo No. 1

Wall Condition: Fair to good. Settlement at northwest corner will require repairs. Otherwise, some repointing will be required. (Photo No. 1) There is efflorescence and spalling of the bricks and sandstone on the east façade above the present accessible entrance. The interior wall has been found to be wet/damp at times. It is thought that this is most likely caused by the metal gutter and cornice flashing, but it must be confirmed upon closer inspection. This should be addressed as an emergency repair as soon as possible inasmuch it can be a safety issue if the spalled masonry should fall on someone who is entering the building at this location. The building inspector has commented that he will require some form of protection if this is not addressed very soon.

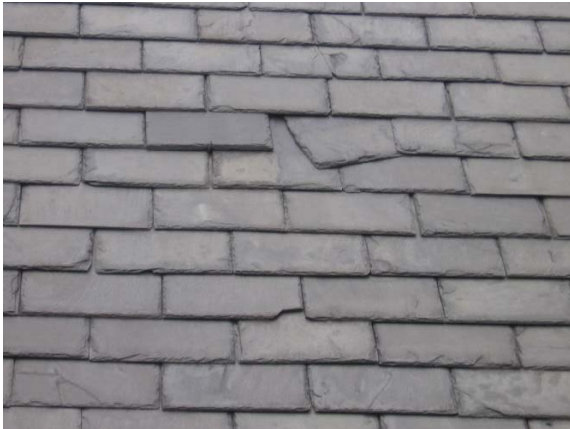
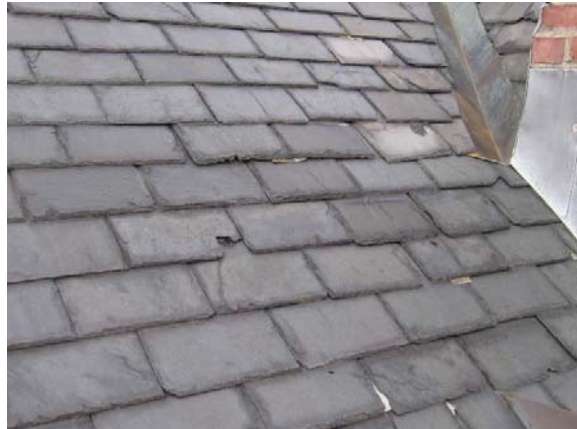
General loose and broken slates:

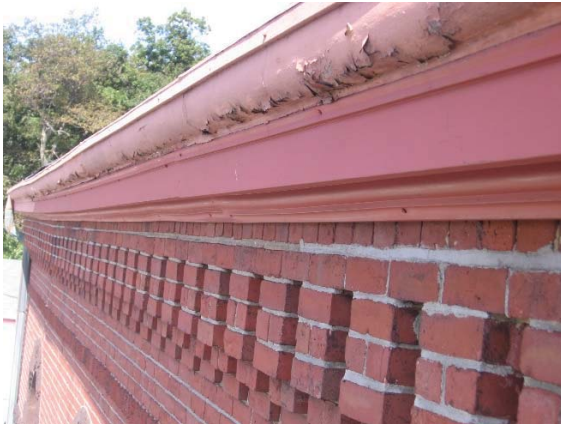
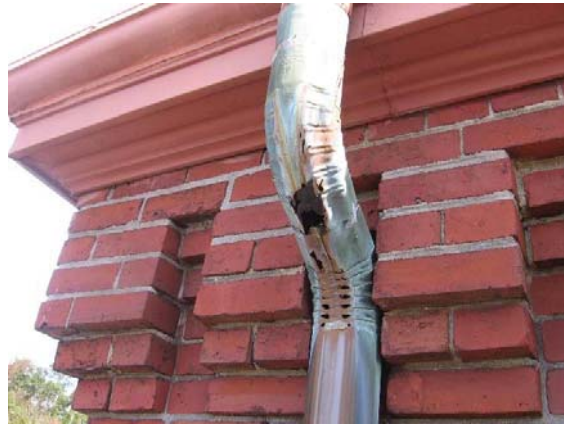
Deteriorated gutters and leaders:

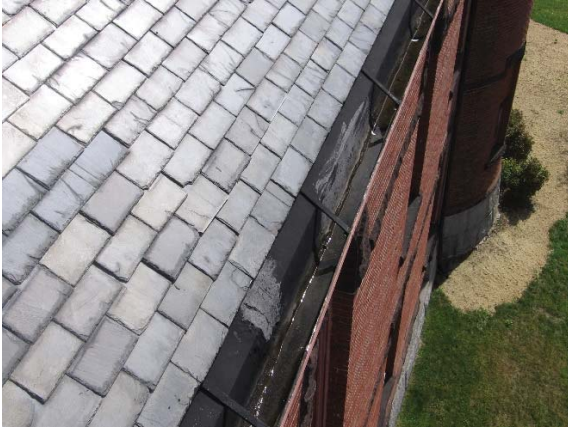
Deteriorated wood gutter lining:

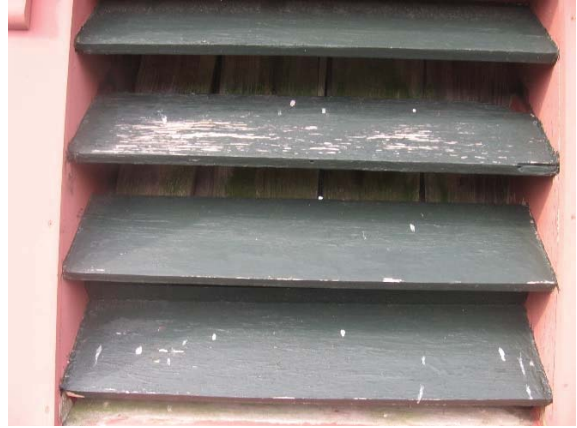
Non-weatherproofed louver at cupola:

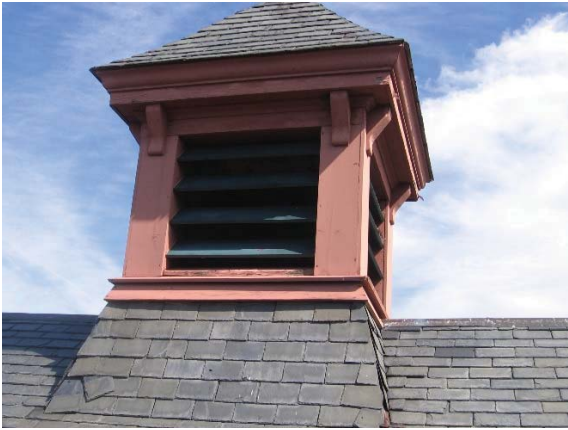
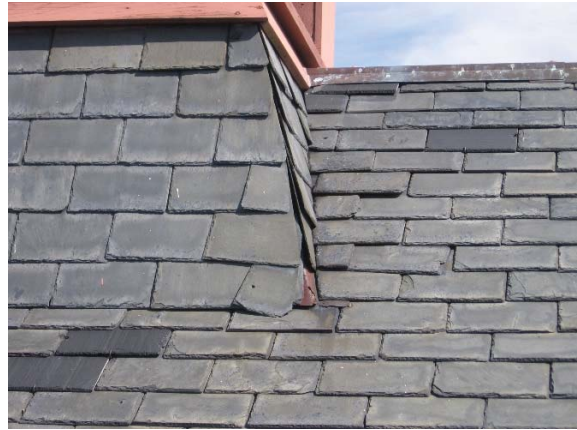
General repairs needed on cupola:

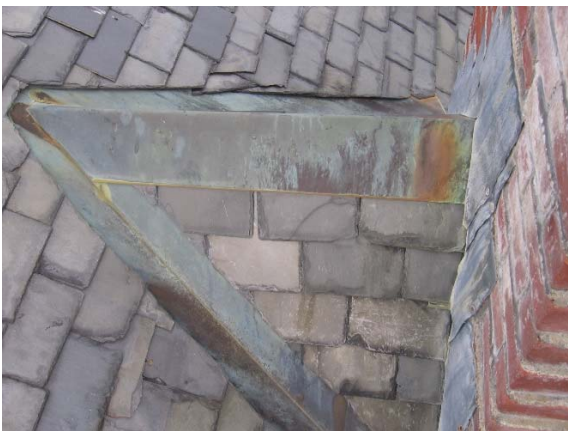
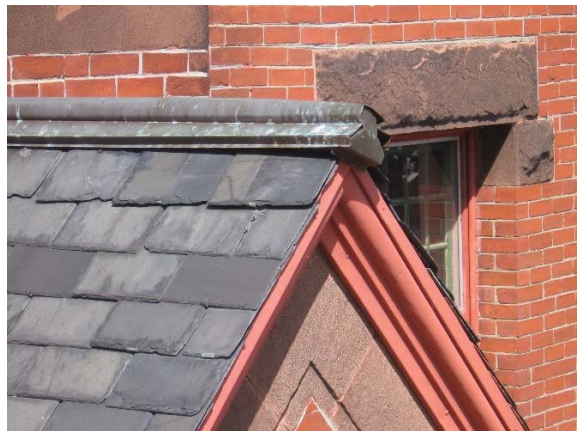
Flashings are in poor condition:
