TOWN OF PRINCETON

Needs Assessment & Four Buildings Master Plan

Public
Information
Meeting

February 3, 2018

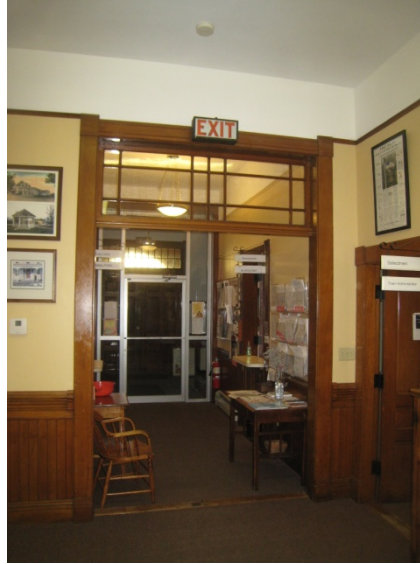
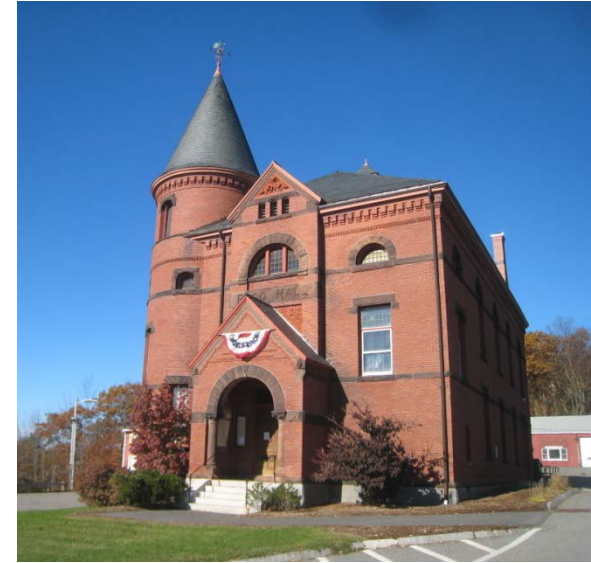
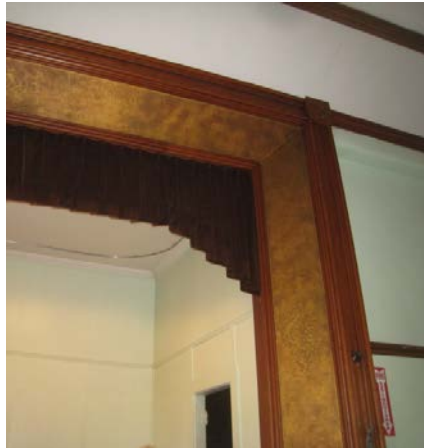
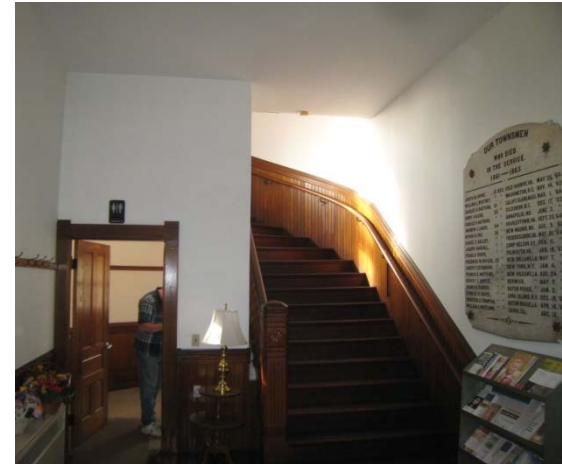
- Significant historic building with prominent location
- Well built and sturdy
- Beautiful detailing throughout
- Most historic features have been preserved to date
- Potential community / meeting space on second floor already exists
- Has endured quite well for 134 years with very little maintenance

Despite deficiencies Baggs Hall supports government functions

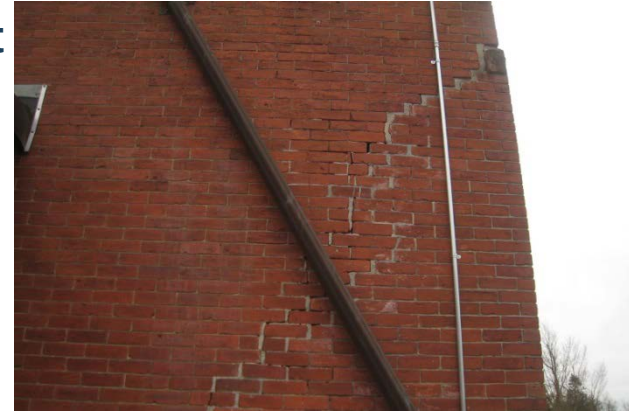
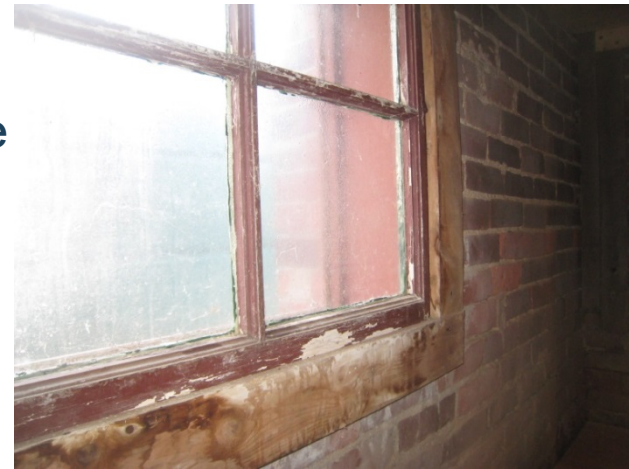
BAGG HALL: CONS

- The exterior envelope needs repair—east and west walls are undermined due to water running down the hill through the basement
- Heating system doesn't provide enough heat given lack of insulation & high air infiltration throughout
- Windows are in poor shape; many openings are out of square; some are covered in plywood
- Cracking in walls and deflections in the floors due to settlement of the floor framing on 2nd floor
- Plaster not firmly anchored to lathe on 2nd floor
- Window air conditioning is inefficient, unsightly and doesn't allow for fresh air
- Lack of access for mobility impaired citizens is a liability

Bagg Hall is a half-used treasure

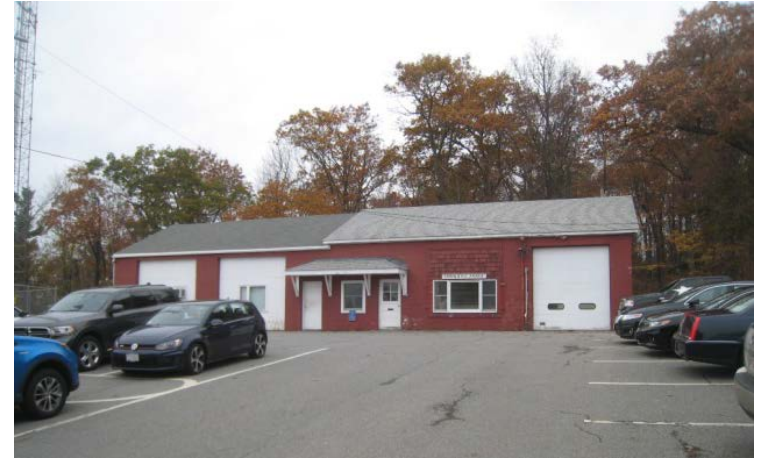
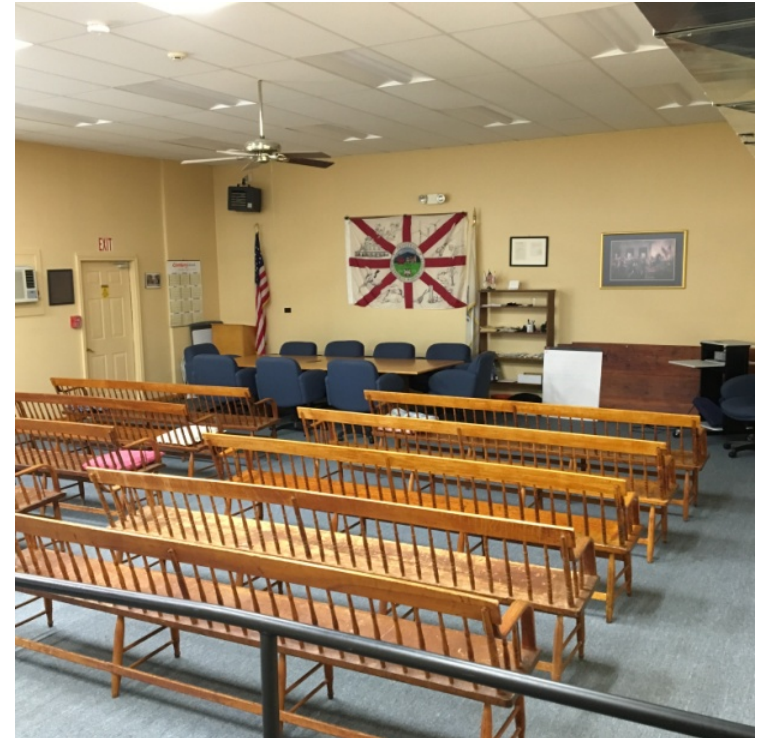
- Provides crucial meeting space
- Close proximity to Town Hall and Library
- At grade level, which makes it the most accessible of municipal structures

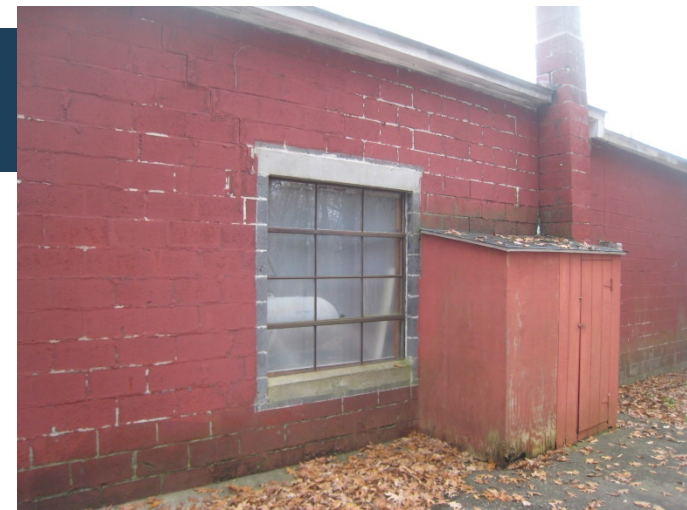
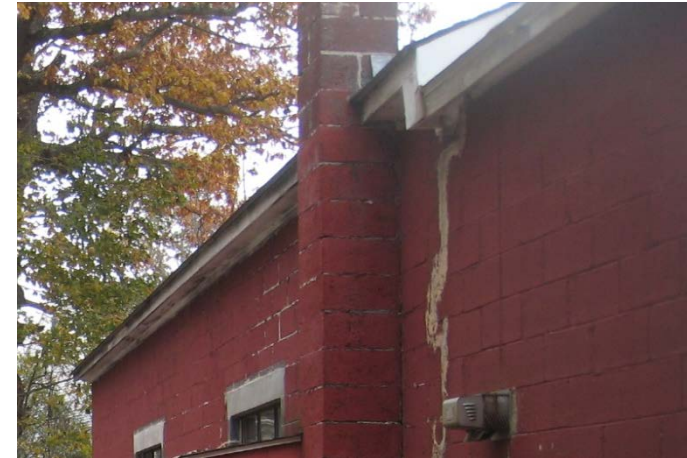
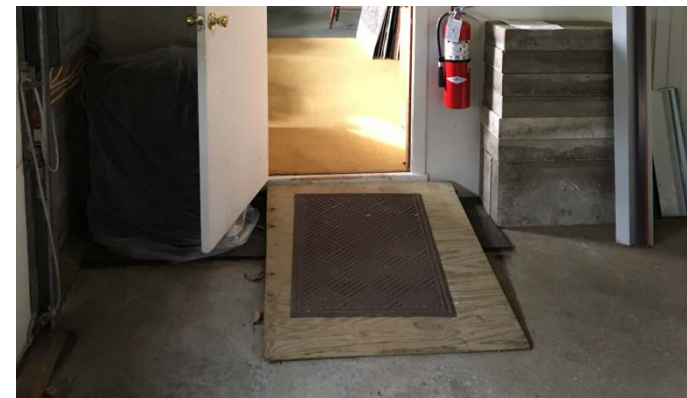
TOWN HALL ANNEX: CONS

- Former garage used for meetings, offices, & storage
- Poor condition: cracks in concrete block walls, rotted wooden fascias
- Poor air quality & ventilation = discomfort
- Thermostatic control of heat needs attention & inadequate insulation
- North portion of roof needs replacement
- Apparent water leakage through front wall at windows
- Cracked precast window lintel at right wall
- Inadequate parking for major events
- Meeting spaces in separate building from town offices and library is not ideal
- Not secure

Spaces are uncomfortable in every way

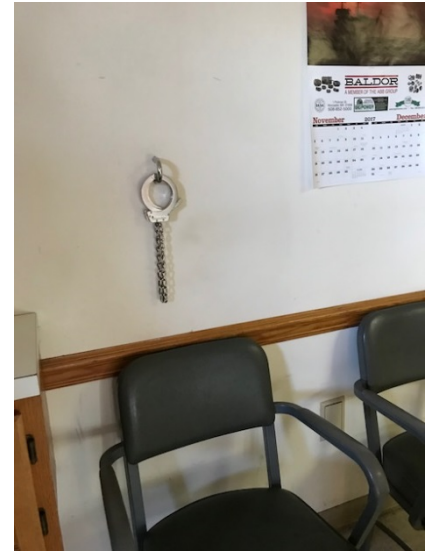
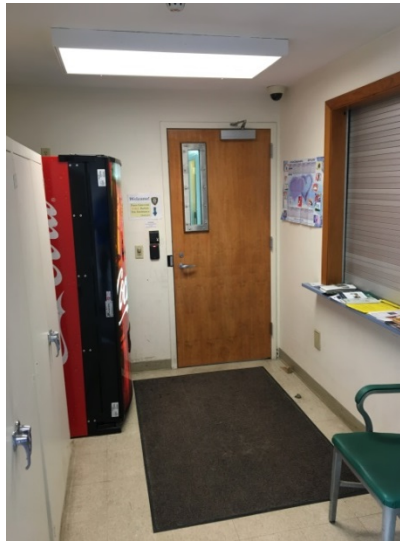
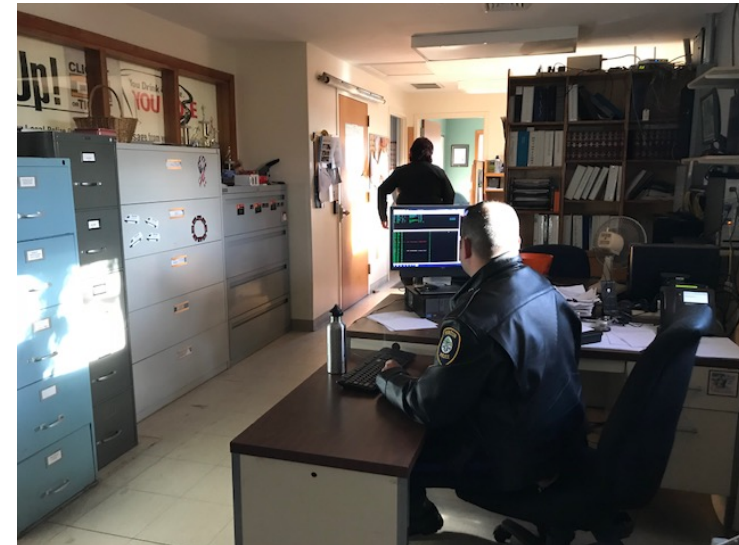
PUBLIC SAFETY – POLICE: CONS

- Lock-up occurs in open office space – no holding cell - dangerous and inhibits policing efforts
- No interview space - no privacy for confidential matters
- Unwelcoming public entry
- Evidence and file storage is inadequate
- Inadequate separation of genders – shared bathrooms and locker rooms for staff

Lack of critical spaces for safe operation is a major concern

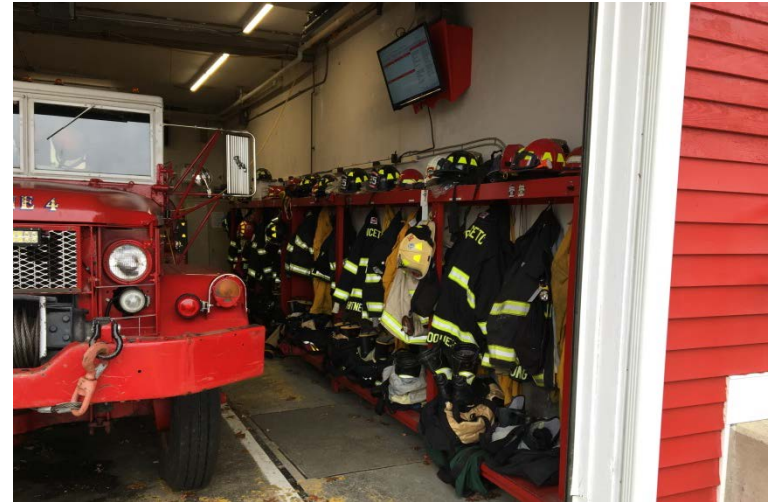
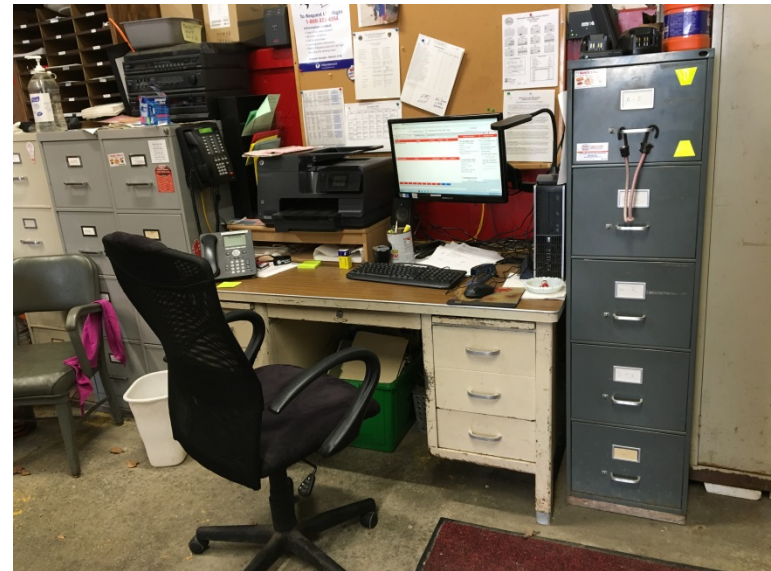
PUBLIC SAFETY – FIRE: CONS

- Critical spaces are lacking:
 - clean-up spaces (showers, laundry)
 - turnout gear room
 - secure narcotics space
 - secure storage for HIPAA information
 - sleeping quarters for extended emergencies
 - locker rooms
 - office space
 - EMS supply space
 - breakroom & storage
- No real public entry
- No exhaust evacuation system
- Insufficient parking & potential vehicular conflicts

Safe operation is a major concern

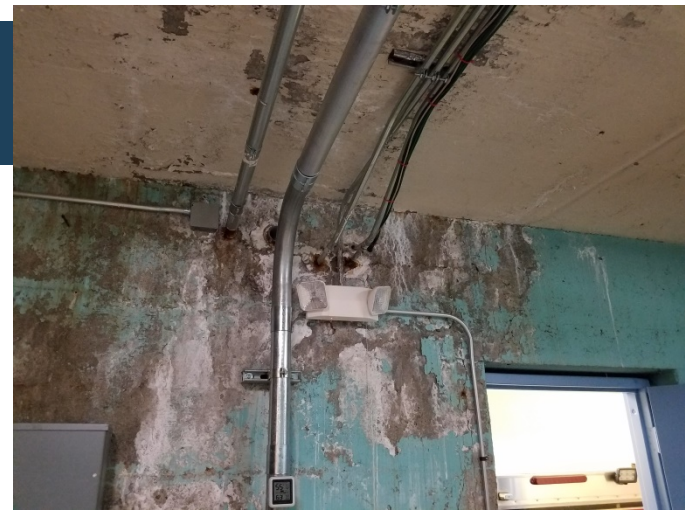
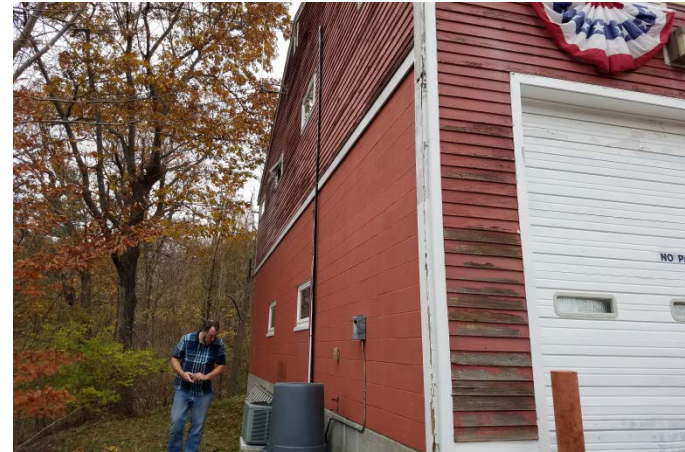
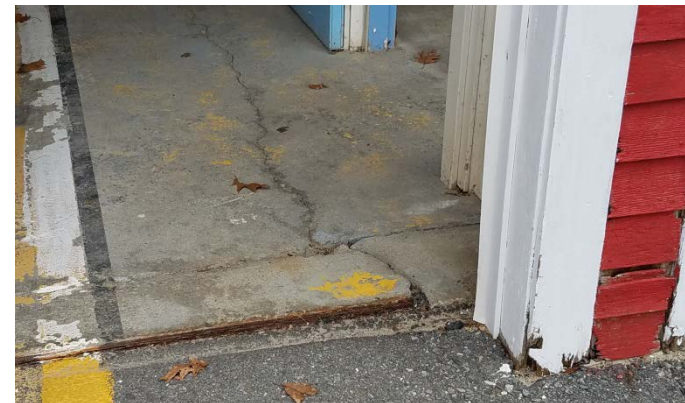
PUBLIC SAFETY BLDG: CONS

- Roof sags over garages due to truss overstress (URGENT)
- Severe chloride related damage within concrete vault space below police garage bay – threatens valuable radio equipment
- Asphalt roof is in poor shape (< 5 years)
- Ingress of water at rear
- All Mechanical/Electrical/Plumbing systems are at end of useful life
- Wood clapboards, soffits and fascia in poor shape
- Fire equipment barely fits (by inches) – damaging vehicles, the building, and restricts future vehicle sizes

Building is not worth saving

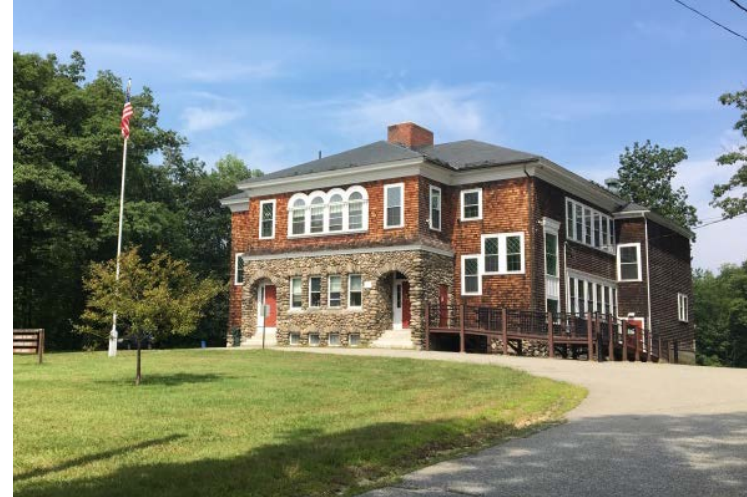
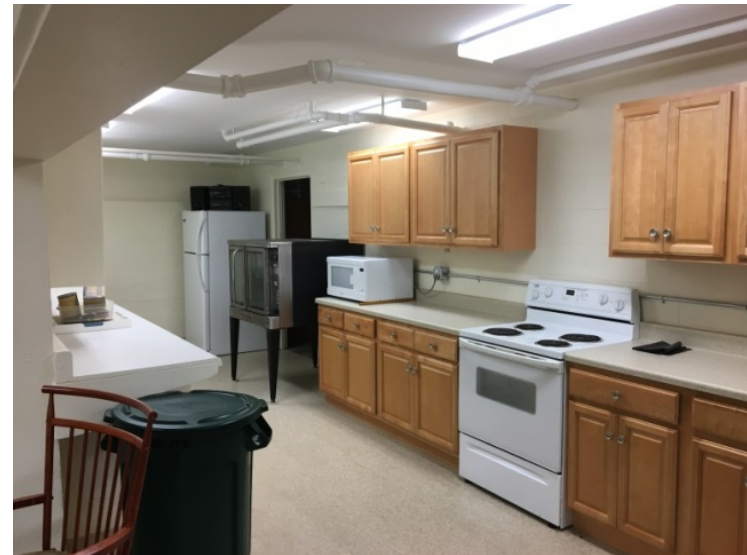
- Historic school building
- Site has great potential
- 4 Room Classroom portion is in good structural condition
- Served town well for many years, and its closure has been problematic for many community user groups

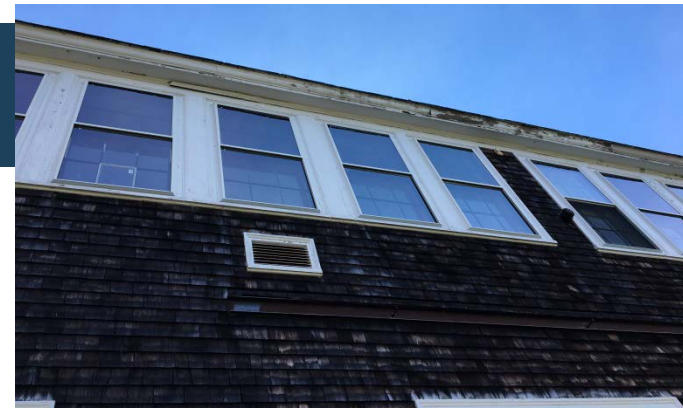
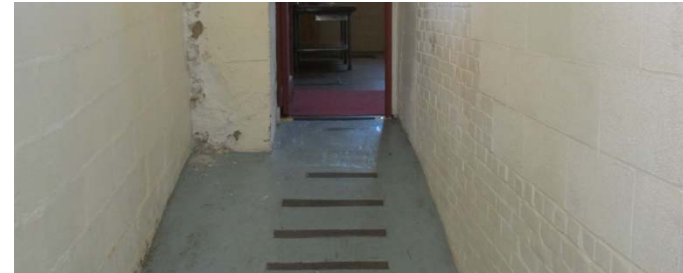
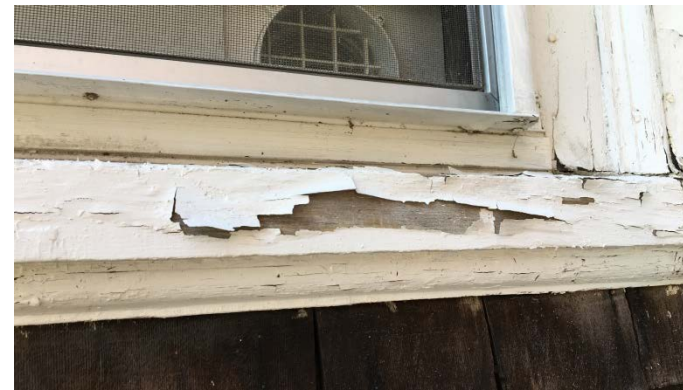
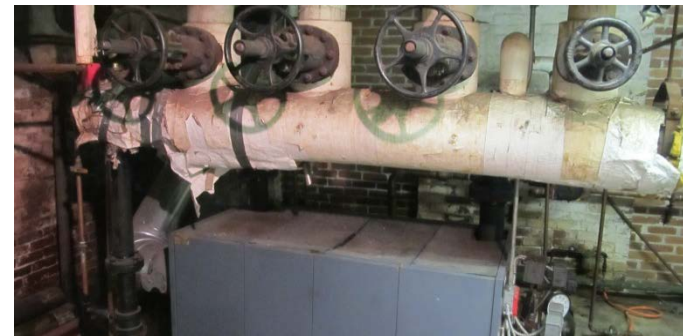
PRINCETON CENTER: CONS

- Building closed due to safety violations
- Difficult to make accessible – there are at least seven different levels
- Not very flexible
- Roofs of rear addition and west wing and side roof eaves sagging
- Loose stones at corners of front foundation
- Lightly framed & unbraced roof at addition
- Significant rot damage at some window sills, eaves, & fascia
- Significant leaks in condensate piping - adding water to the system can cause corrosion and other issues

Requires significant work to be useable again

- Original 4-room school may be saved and incorporated into a new public safety complex; recommend demolishing later addition

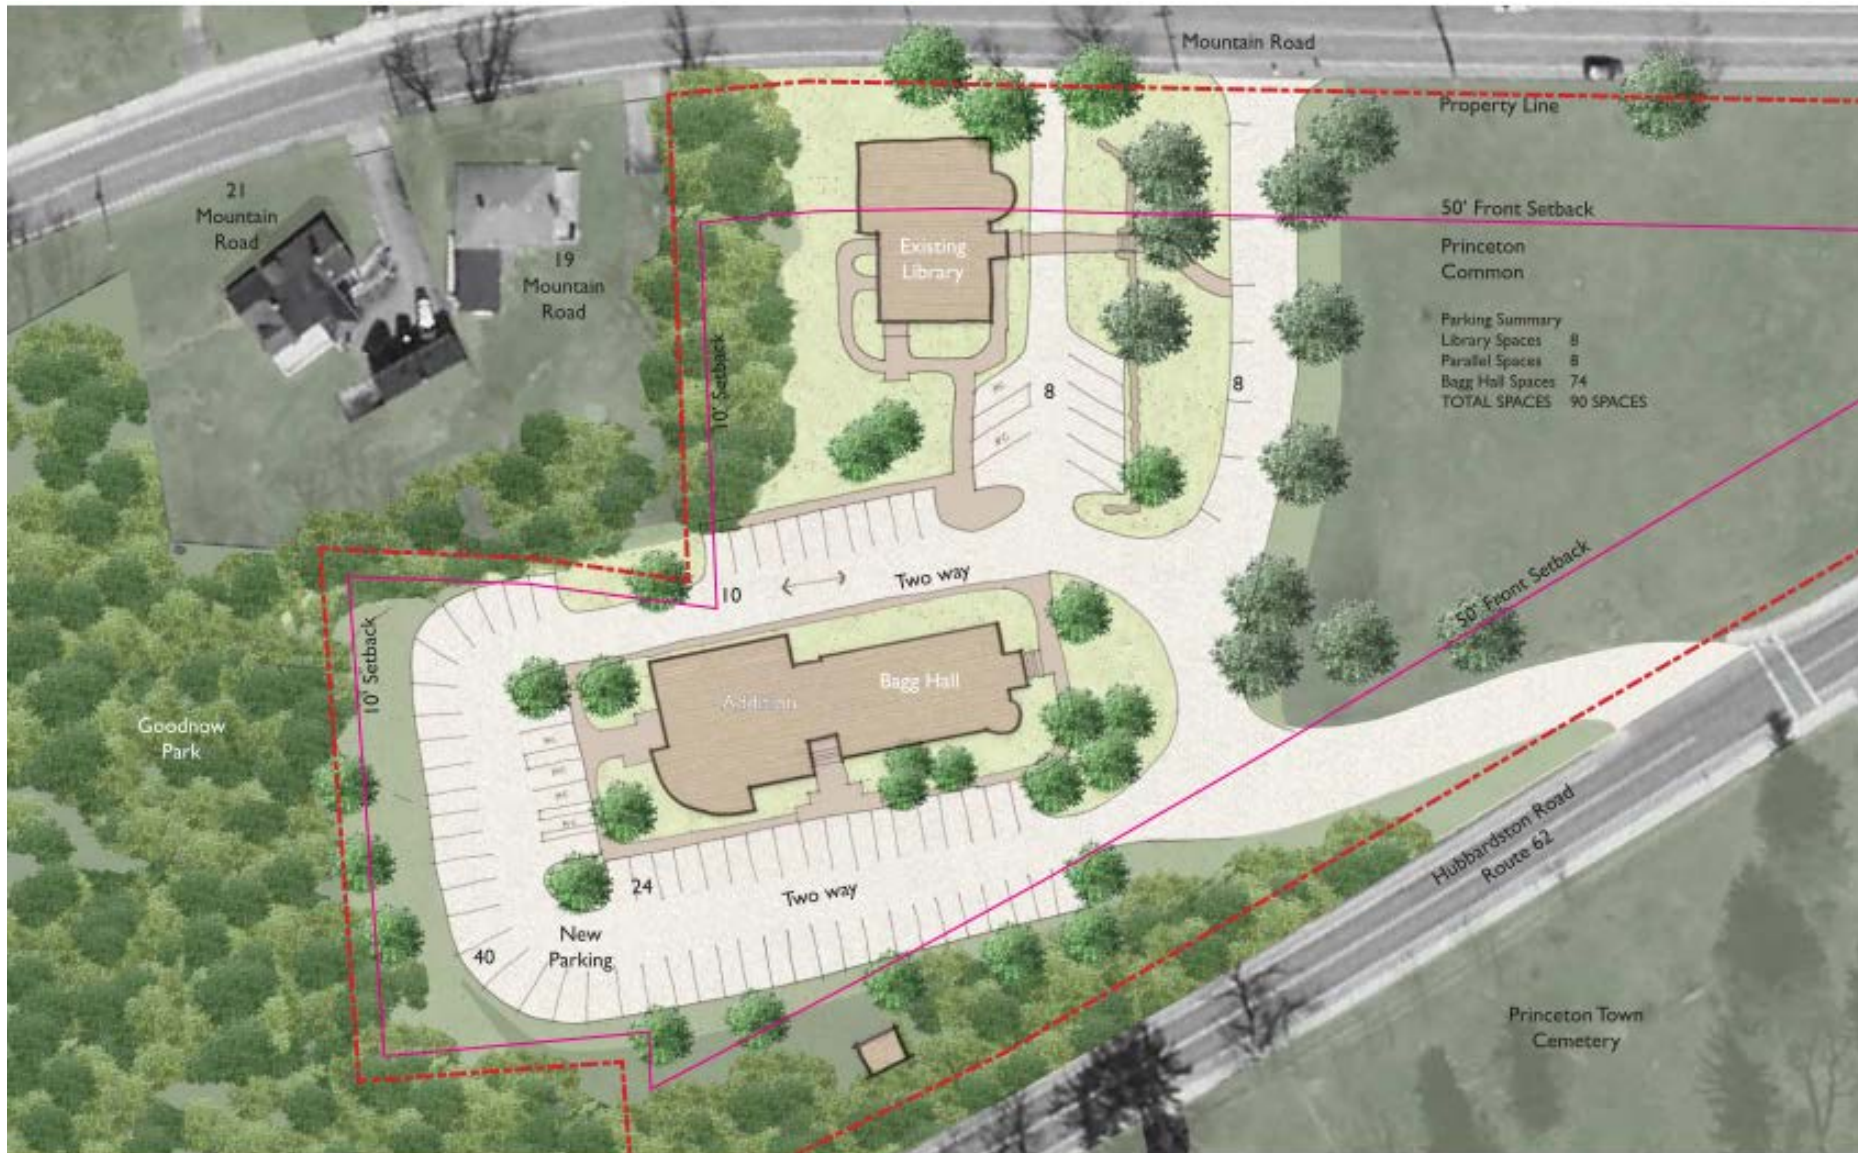
OPT A & B - TOWN HALL / COMMUNITY USES

OPTION 1C- LARGER ADDITION WITH SENIOR CENTER, REPLACE TOWN ANNEX AND PUBLIC SAFETY WITH PARKING

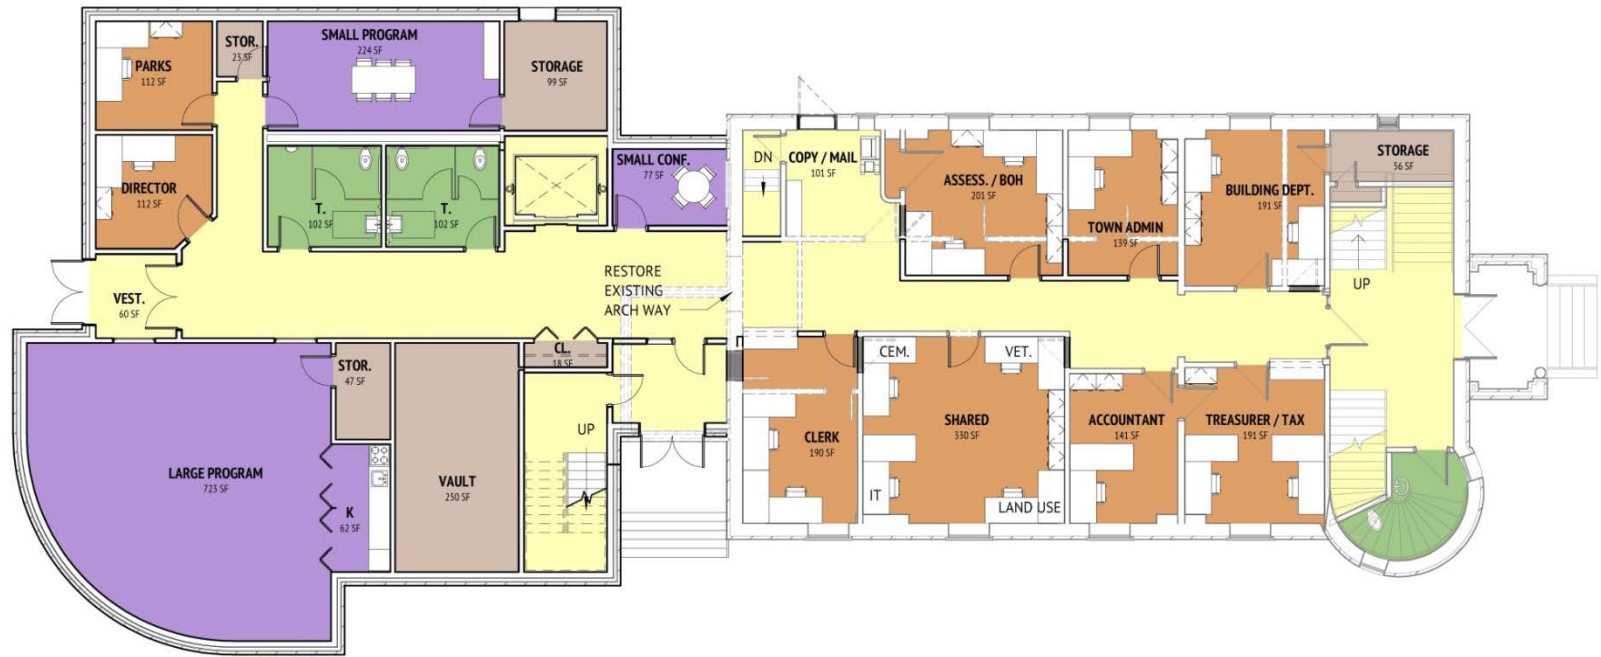
OPT A & B - TOWN HALL, COA & COMMUNITY

Current Annex Meeting Space:
1,320 sq ft

Proposed Meeting Space:
3,100 sq ft

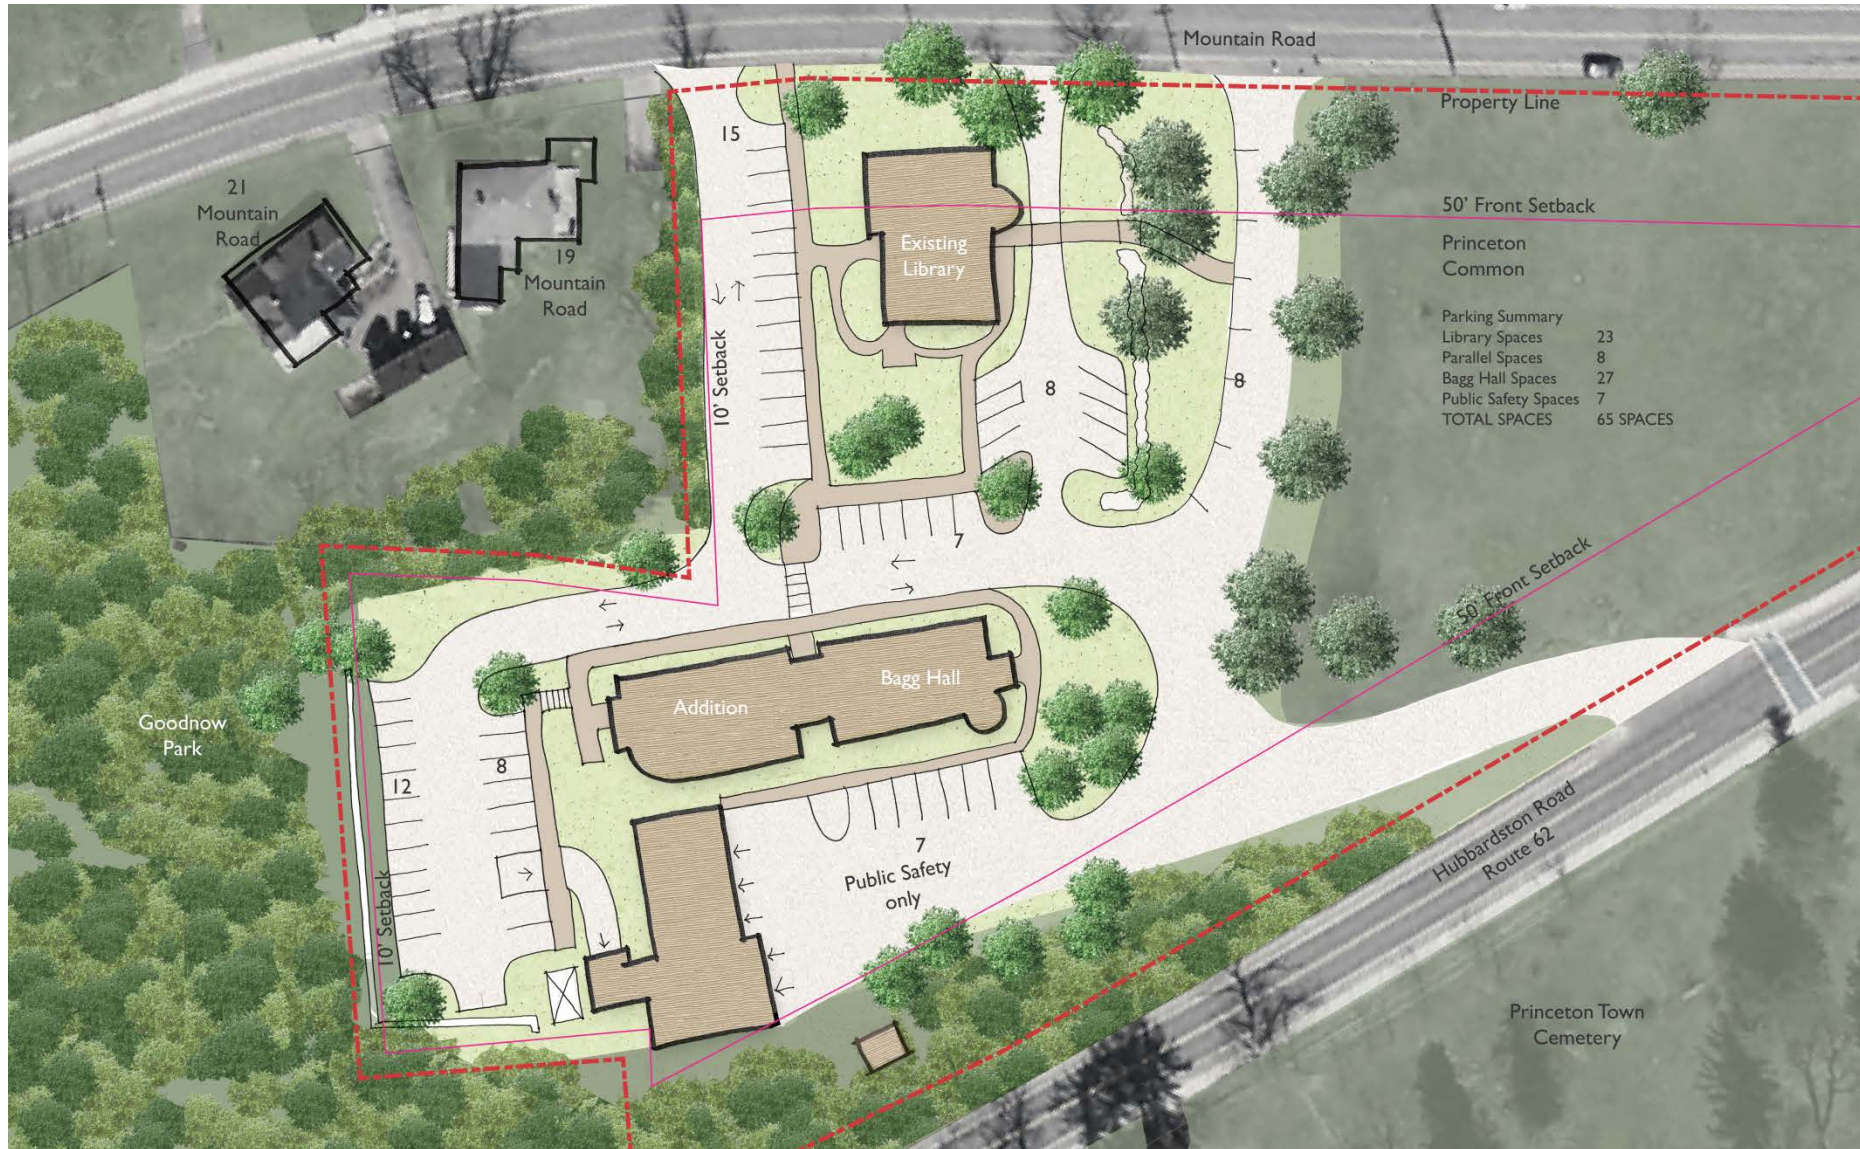
OPT C – BAGG HALL FIRST

OPTION 3E ADDITION TO BAGG/ KEEP PUBLIC SAFETY/ REMOVE ANNEX

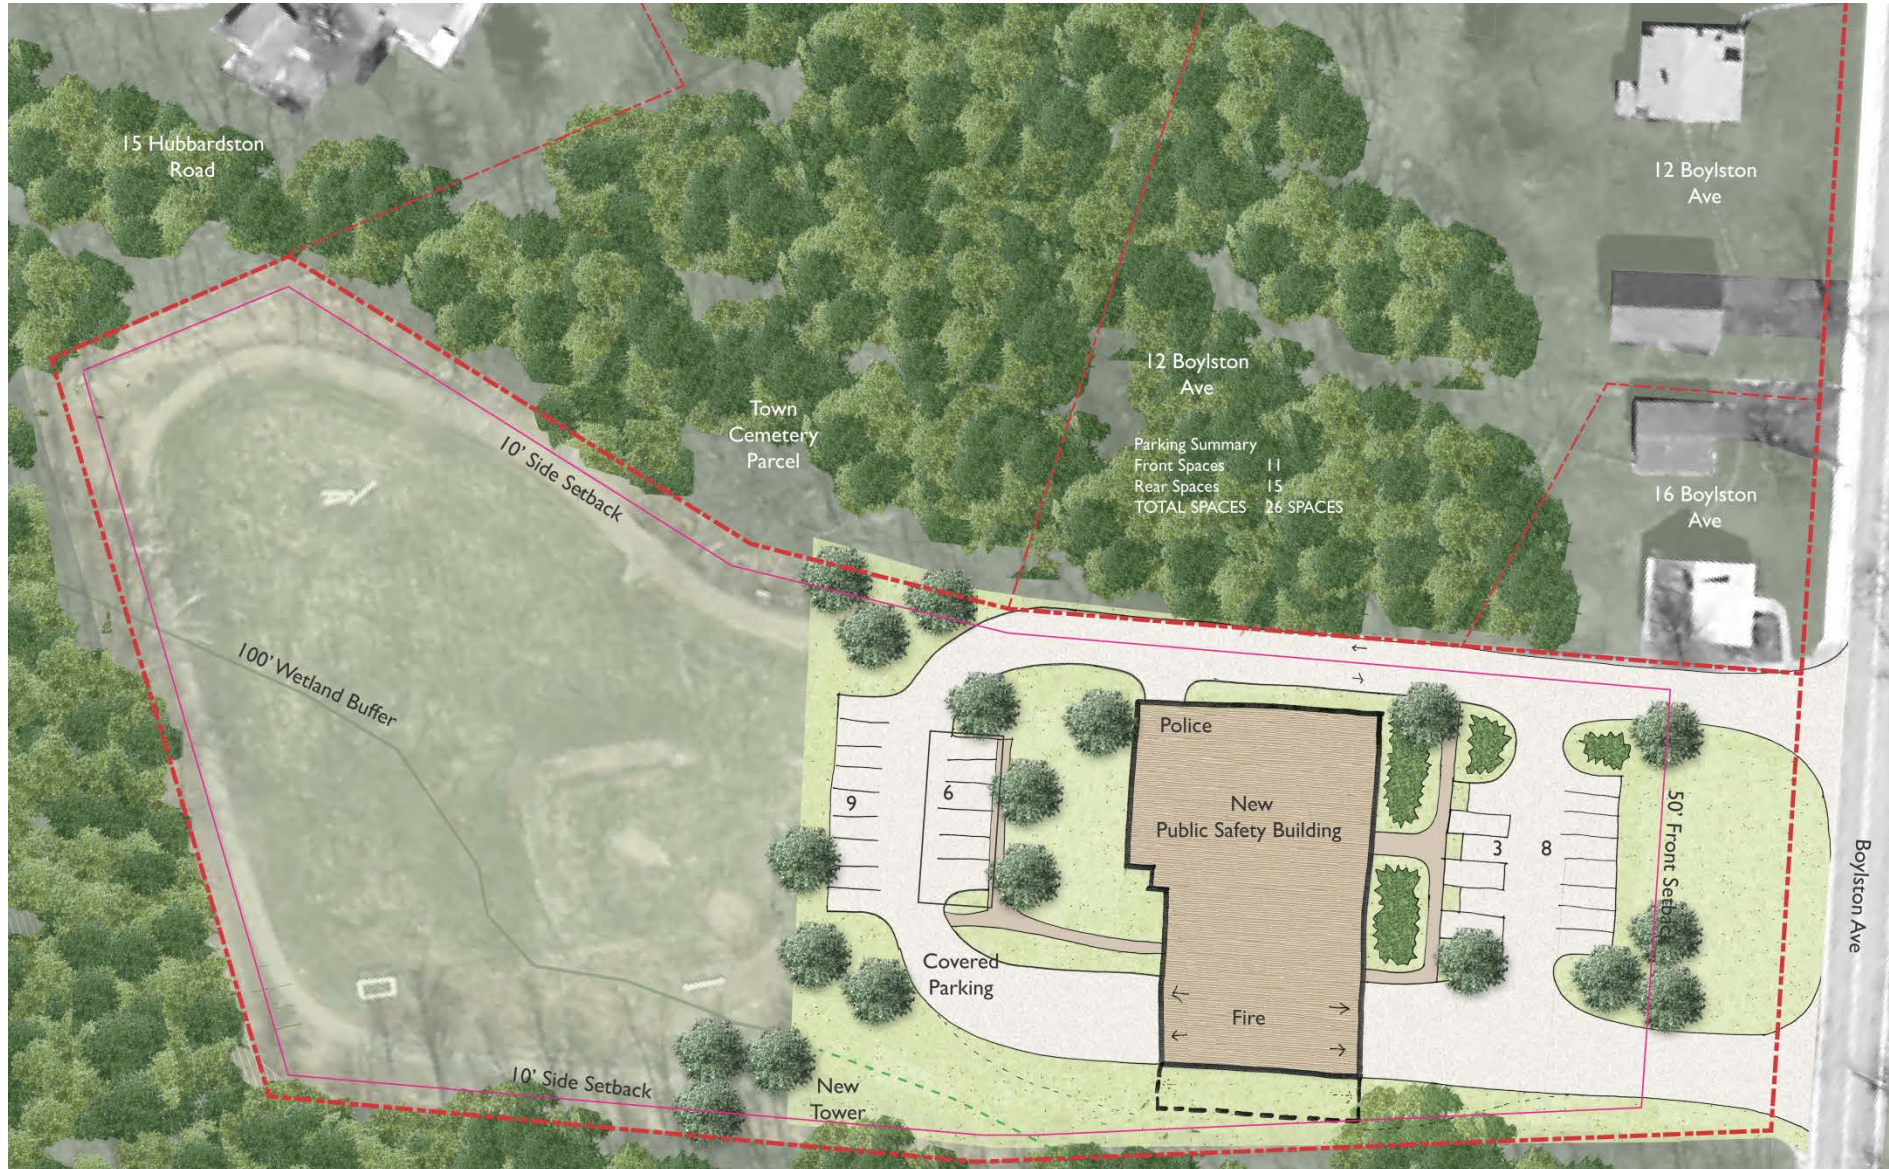
PUBLIC SAFETY – ALL NEW OR ADD/RENO

TOTAL AREA:
11,700 SQUARE FEET
