**Town of Princeton
Self-Evaluation and Transition Plan
June 2021**

**TOWN OF PRINCETON – SELF-EVALUATION AND TRANSITION PLAN
TABLE OF CONTENTS**

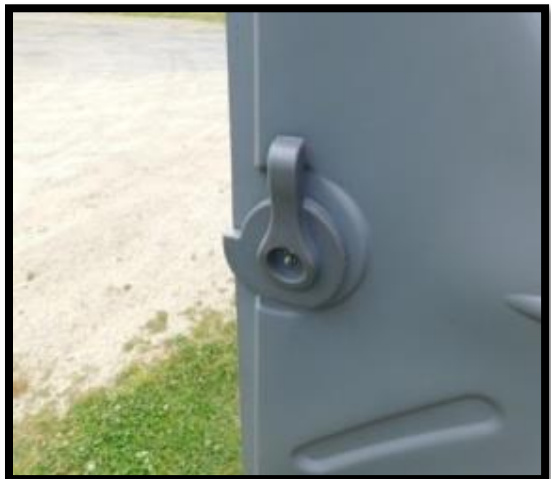
Representative Examples of an ADA Compliant Portable Toilet

If the town provides portable toilets for short-term events or for seasonal use, then they must be “ADA Compliant”. An important distinction to note is that “ADA Compliant” is not synonymous with “Wheelchair Accessible.” Wheelchair Accessible usually indicates a ramped or ground level entrance with a wide enough door for a wheelchair to gain entry. Clearances; setbacks; and dispenser, grab bar, and water closet heights do not necessarily meet ADA or 521 CMR Standards. “ADA Compliant”, however, generally means reinforced construction; ramped or ground level and wheelchair accessible entrance; spring loaded magnetic door that closes automatically; reinforced grab bars; dispensers, grab bars, and the water closet at the proper height and near, far and front setbacks; compliant door hardware; and enough interior space for a wheelchair to make a 360 degree turn that all fully comply with the 2010 ADA Standards and/or 521 CMR, whichever is more stringent. Illustrative examples of an “ADA Compliant” portable toilet are shown below.

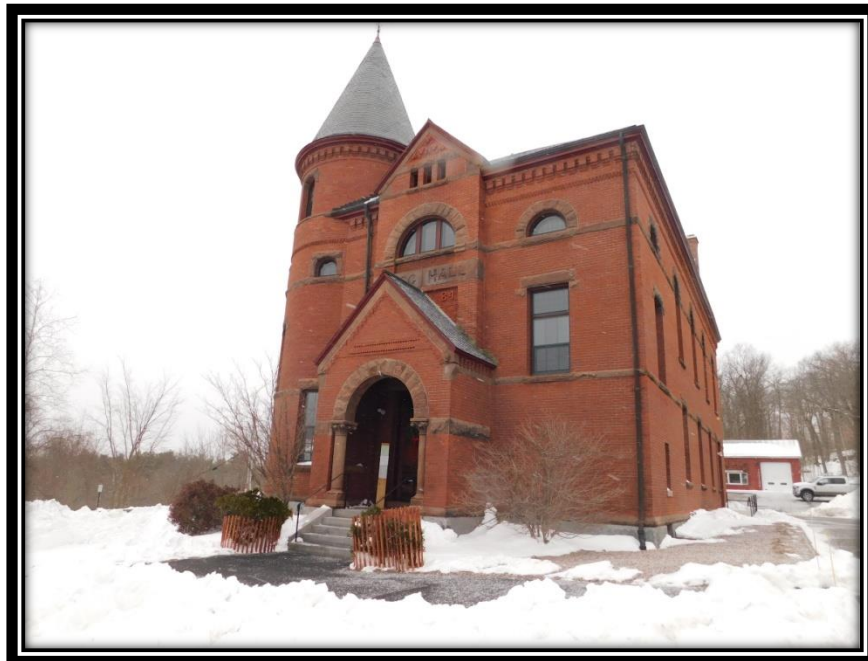
BAGG HALL (Princeton Town Hall)

Description of Facility and Programs: Bagg Hall is a 2+ level masonry building with a basement which was constructed in 1885. The building has remained generally unchanged to the present except for interior partition work, electrical, heating, plumbing and some first floor accessibility modifications in 1998. The building is currently undergoing additional first floor primarily cosmetic office renovations. Bagg Hall is listed on the National Register of Historic Places, as part of the Princeton Town Center Common Historic District and also has a recorded preservation restriction (2002) with the Massachusetts Historical Commission. The first floor of the building houses local government offices and services including Board of Assessors, Board of Health, Board of Registrars, Building Department, Cemetery Department, Recreation, Tax Collector, Town Administrator, Town Clerk, Town Treasurer, and Veteran's Services. The second floor is not accessible and consists of a large meeting hall, stage, and balcony. This area of the building is not open to the public and used solely for storage. There is also an upper clock tower and a basement, both of which are also closed to the public.

General Description or Obstacle Which Limits Mobility or Access: Neither of the accessible parking spaces are designated as van accessible. The parking spaces and shared access aisle have excessive running slopes and the signage for the accessible parking is mounted too low. The main entrance lacks directional signage for the side/rear accessible entrance. The ramped approach to the accessible entrance only has a railing on side but because the running slope is under 5.0%, no further action is required. The stair railings at the front entrance do not fully extend at the bottom of the stairs. The drop box located at the top of the stairs to the front entrance is not on an accessible route of travel. Interior and exterior doors with closers have excessive operating forces and close too fast. Interior doors have non-compliant knob-style hardware and also lack tactile designation signage. Wall mounted room signage, although not installed due to renovations, appear that once installed, will serve as protruding objects. Office counters at doorways are too high. In addition, hallway coat hooks and a number of light switches are not within

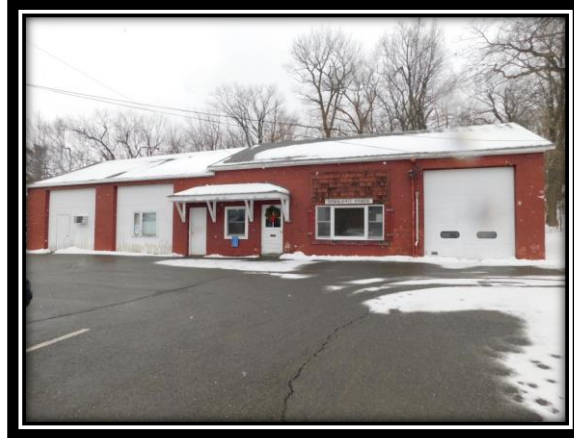
TOWN HALL ANNEX

Description of Facility and Programs: The Town Hall Annex is a single-story masonry building which was constructed in the 1950's. The building contains a large meeting room with a unisex "accessible" bathroom, a smaller meeting room with office and file space, and a garage/storage area. The garage/storage area is closed to the public.

General Description or Obstacle Which Limits Mobility or Access: The accessible parking space lacks striping for both the space and access aisle. The signage for the accessible parking is too low. The landing at the accessible entrance is not fully level. There is no directional signage noting which of the 2 doors to the annex serves as the accessible entrance. The support bracing for the overhang at the entrances serve as protruding objects. The landing at the front accessible entrance is not fully level. The front exterior doors close too fast. Interior doors have non-compliant knob-style hardware and also lack tactile designation signage. The large meeting room light switch is too high. The ramp from the large meeting room to the smaller meeting room/offices is wholly non-compliant as the running slope is too steep, the ramp is too narrow, the ramp lacks railings and a level landing at the top, among other things. Similarly, the ramp to the accessible bathroom is also non-compliant as there is only one ramp railing which lacks extensions and has a lower railing that is too low. The ramp is too narrow and the top landing lacks the minimum required maneuverability. The designated accessible bathroom has a number of areas of non-compliance including the lack of tactile designation signage, a towel dispenser that is too high, grab bars that are mounted too high, a rear grab bar that is too short, a water closet flush control located on the wrong side, and a toilet paper dispenser that is mounted too far from the front of the water closet.

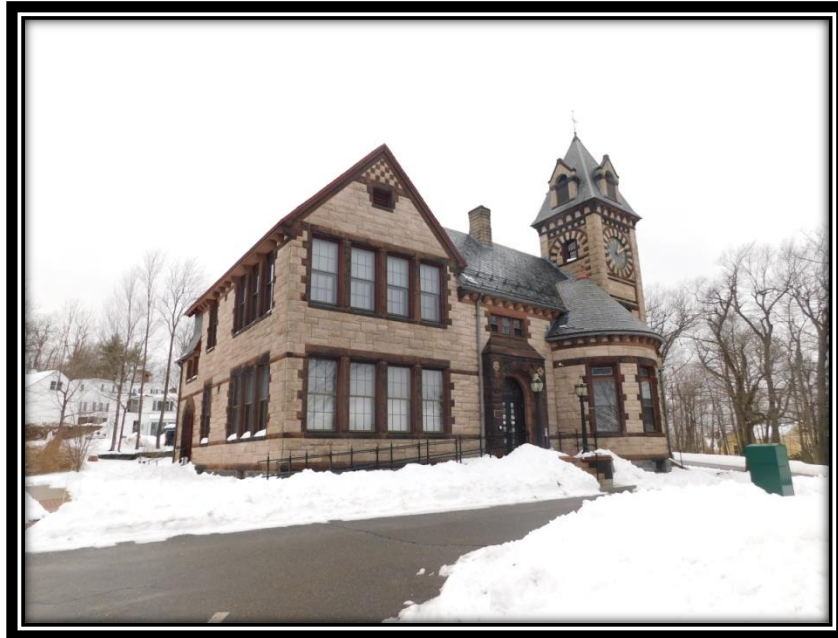
GOODNOW MEMORIAL LIBRARY

Function and Description of Facility and Programs: The Goodnow Memorial Library is a 2-story masonry building with a clock tower and a finished basement. The clock tower is closed to the public. A 2001 renovation included improvements to the basement converting the space into a story hour room, kitchen area, small meeting room, and a room for the Historical Society. Bathrooms are located on the basement and main levels with the Director's Office located on the 2nd level. The library is listed on the National Register of Historic Places.

General Description or Obstacle Which Limits Mobility or Access: None of the “accessible” parking spaces are designated as van accessible. The cross slopes for both designated accessible spaces and the shared access aisle vary from 3.4% to 4.0%. Signage for both spaces is 13½” to 16” too low. There is no level landing at the top of the curb ramp from the parking. There are abrupt changes in level surface at the transition from asphalt to brick walkway, at the transition from the walkway to the concrete ramp, and along the walkway itself to the ramp due to deterioration and heaving. The ramp railings do not extend at the ramp base, and for the majority of the ramp, have an upper railing that is ½” too low. The front, side, and rear exterior stairs have railings that do not fully extend at the top and/or bottom. The front stairs have only one middle railing. Interior doors, including the chair lift, either lack tactile designation signage, have signage that is too low, or is mounted in the wrong location. The chair lift doors have excessive operating forces and too fast closing speeds. Coat hooks for children and adults are not within reach range. A number of tables do not provide adequate knee clearance. The main level “high” drinking fountain serves as a protruding object. The front check-out counter is too high. The stacks on Level 2 do not provide the minimum required clear width. Floor grates in the main level reading room exceed the maximum opening of ½”. The Level 2 library director's office is not on an accessible route and

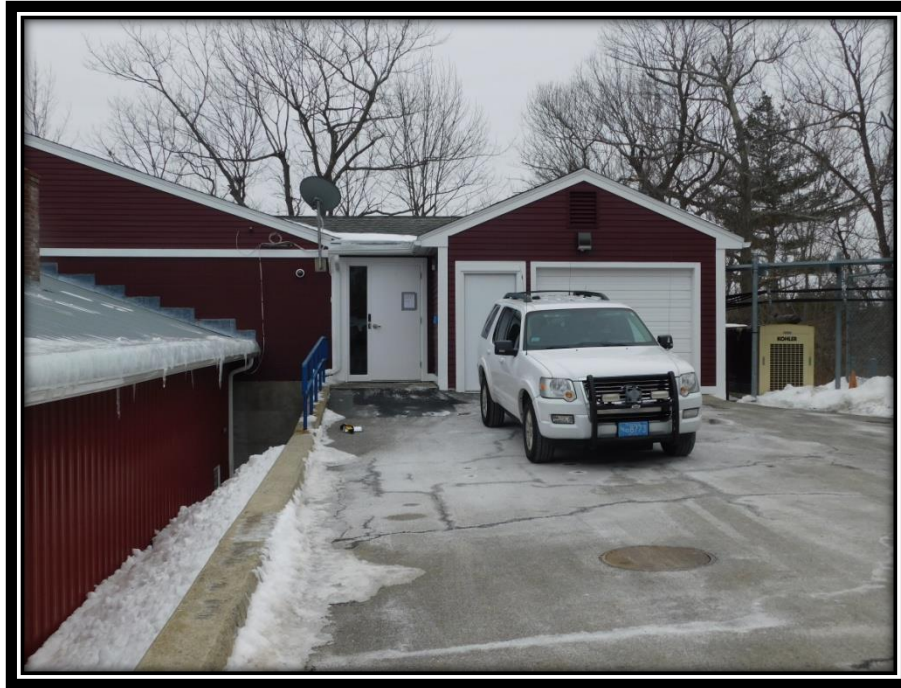
PRINCETON POLICE DEPARTMENT

Description of Facility and Programs: The Princeton Police Department consists of a Chief, 2 Sergeants, an Administrative Assistant, and a number of patrol officers. Dispatch is handled externally by the Holden Regional Dispatch Center. The Police Station consists of offices, a booking area, locker room, storage rooms and areas, a staff kitchenette, and bathrooms (2 non-accessible, 1 accessible).

General Description or Obstacle Which Limits Mobility or Access: There is no designated accessible parking. The accessible route of travel to the entrance has a running slope that exceeds the maximum allowed. There is only one railing on the ramped approach. There is no directional signage for the accessible entrance. The front door does not meet the minimum closing speed. Interior doors with closers have excessive operating forces and too fast closing speeds. Interior doors lack tactile designation signage on the latch side of the door and most doors have non-compliant knob-style hardware. Some doors lack adequate maneuvering or pull clearance. Two doors with counters are too high with one serving as a protruding object. The accessible bathroom has a number of areas of non-compliance including coat hooks that are too high, a mirror that is too high, sink piping that is not wrapped, a grab bar that is mounted too low, a toilet paper dispenser that is too close to the water closet, a water closet that is too high, and water closet front clear width that is restricted due to a chair.

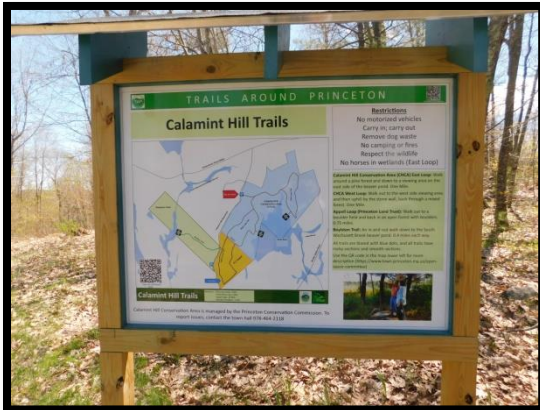
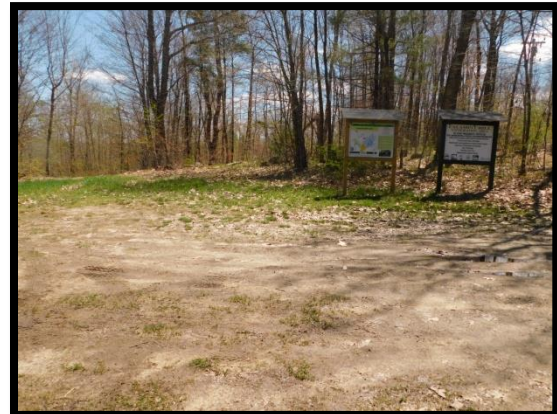
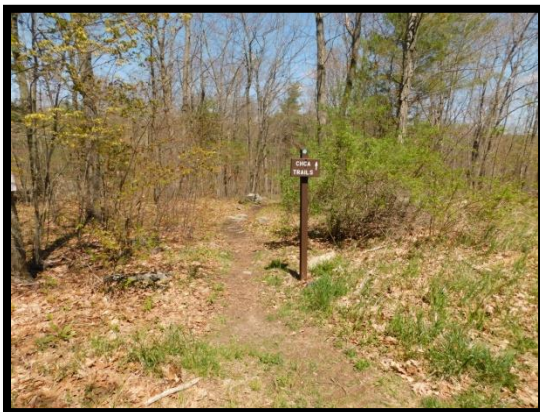
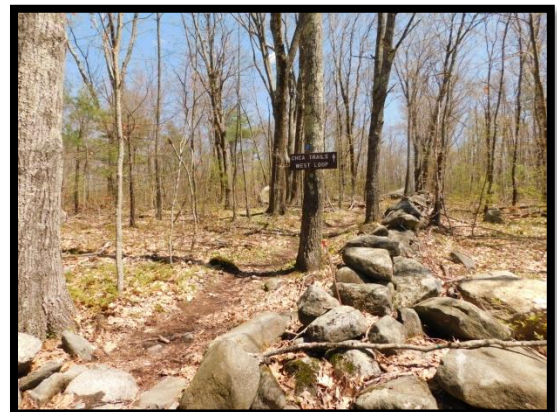
General Description or Obstacle Which Limits Mobility or Access: There are 4 trails on the site, but none are formally maintained to a standard that would be considered to be an accessible route of travel. The parking for the facility is an unimproved and unstable gravel surface and therefore non-compliant. No signage or striping is provided.

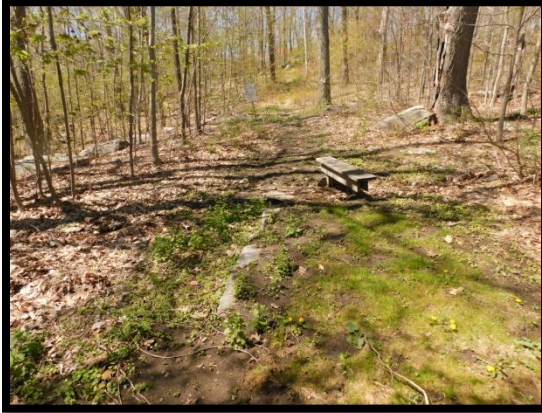
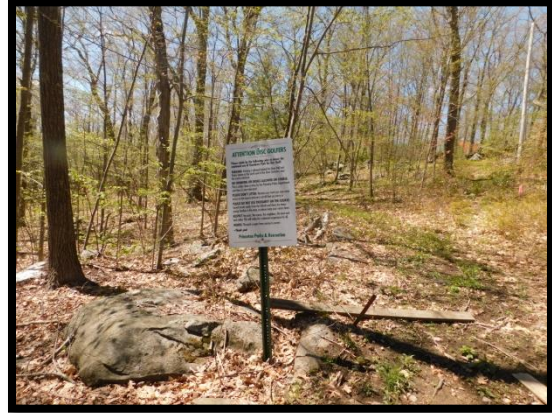
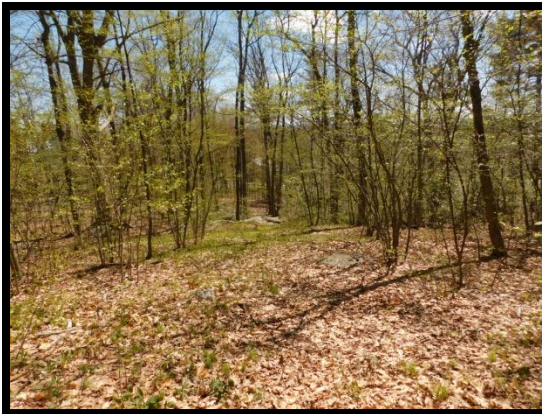
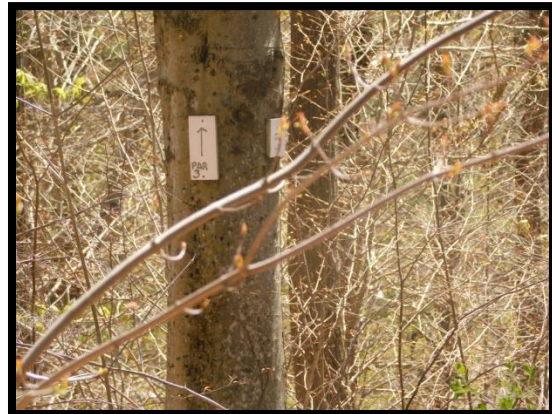
General Description or Obstacle Which Limits Mobility or Access: There are trails on the site, but none are formally maintained to a standard that would be considered to be an accessible route of travel. Most of the trails, which appear to be part of the Disc Golf Course are overgrown and barely usable. There is no formal parking for the facility but the Town Hall Annex and adjacent Bagg Hall has designated accessible parking.

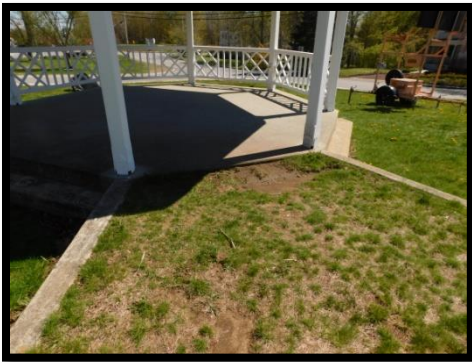
Photo Town Common 1

General Description or Obstacle Which Limits Mobility or Access: The gazebo is not accessible to those with mobility limiting disabilities. There is no accessible route of travel to the gazebo and the gazebo itself can only be accessed by stairs with 2 steps. The gazebo stairs lack railings. There are no accessible routes to the bench and monuments.

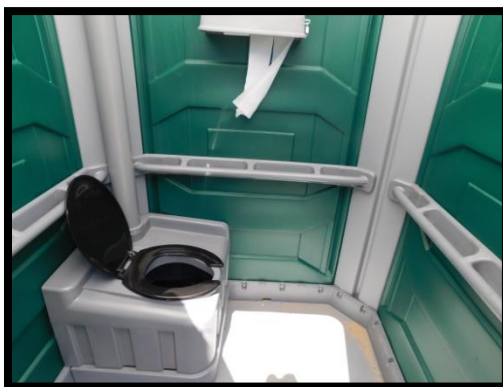
Photo Krashes 1

General Description or Obstacle Which Limits Mobility or Access: There is no designated accessible parking. The portable toilet is not on an accessible route of travel and is not fully “ADA compliant”. The field house stairs lack railings and the accessible route to the snack bar and bathroom facilities has a 1” abrupt change in level surface at the transition from the asphalt to the brick walkway. The snack bar counter is too high. The field house bathroom facilities have a number of areas of non-compliance related to maneuverability, clearances, heights, and operability. There are no accessible routes of travel to and around the fields, playground, horseshoe pit, and other amenities. The paved access to the upper field is locked which restricts usability. The running slope of the route of travel to the upper field varies up to 10.2%, which exceeds the maximum allowed. None of the picnic tables are accessible. Non-compliant wood chips are the primary surface throughout the playground and none of the play components are accessible.

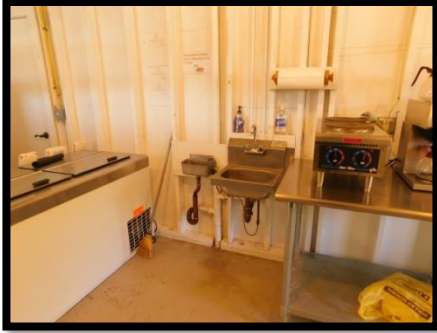
Photo Krashes 3

Kitchen/Snack Bar. The door to the kitchen/snack bar area has a glass pane which exceeds the maximum height allowed. The sinks are not accessible due to inadequate knee clearance, unwrapped or unguarded sink piping, and hardware that requires pinching and twisting of the wrist.

<p>None of the wash sinks (3) provide knee clearance and all have piping that is not wrapped or insulated. One of the sinks has non-compliant hardware that requires pinching and twisting of the wrist.</p> <p>See Photos Krashes 2 and 3.</p>	804.3.2 306.3 309	32.2 32.5 32.6 32.7	Replace one sink so that it meets the minimum required 27" knee clearance; has piping that is wrapped, insulated, or guarded; and has hardware that is operable with a closed fist.	4	3	N	Up to \$750
<p>Picnic Tables None of the picnic tables (4 at field house, one at side soccer field/playground) have sufficient knee depth clearance.</p>	226.1 902	19	At least 5% or at least one table must be accessible at each separate location. Purchase 2 accessible picnic tables and locate on an accessible route of travel. The table surface s/b 28" to 34" a.f.f. to the top surface with at least 27" knee clearance, 30" clear width, and 19" depth.	2	2	N	\$1,500

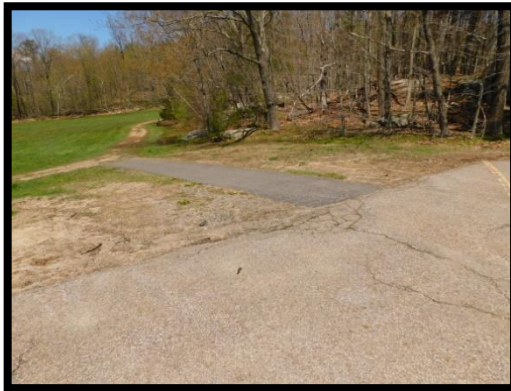
Photo Center 1

General Description or Obstacle Which Limits Mobility or Access: There is no designated accessible parking near the recreation area. There is accessible parking for the building but it is too far from the Center School Recreation Area entrance, lacks an access aisle, has excessive running and cross slopes, and has non-compliant signage. There are no accessible routes of travel to the recreation area from the asphalt parking and to the playground equipment, horseshoe pit, benches, picnic table, and baseball field. A stone dust walking trail surrounds the Center School Recreation Area. There are areas along the entirety of the stone dust accessible route of travel within the park that are getting overgrown with grass and weeds and becoming slightly deteriorated and uneven. The accessible route of travel around the recreation area perimeter needs to be routinely maintained including weeding, adding of additional stone dust, and compacting to ensure full compliance with the standard of “*firm, stable, and slip resistant*”. The picnic table is not accessible. There are no level areas for wheelchairs adjacent to the benches. The playground has non-compliant surfaces below play equipment and there are no accessible play components.

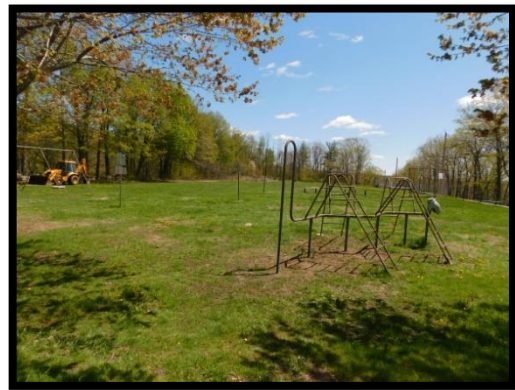
Photo Sawyer 2

General Description or Obstacle Which Limits Mobility or Access: There is no designated accessible parking. There is no accessible route of travel to the park or to the play equipment, picnic table, and baseball field. The picnic table is not accessible. The slides and climbing structure have non-compliant surfaces below play equipment and there are no accessible play components.

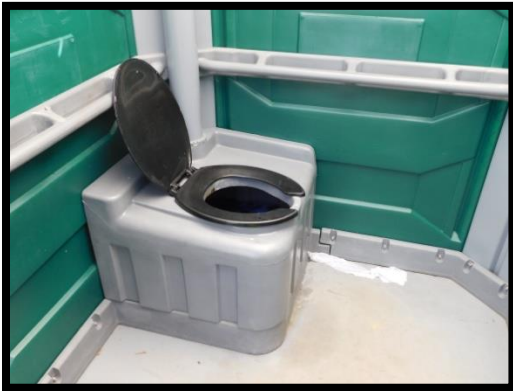
Photo TPS 1

General Description or Obstacle Which Limits Mobility or Access: The portable toilet is not on an accessible route of travel and is not fully “ADA compliant”. The concession stand has abrupt changes in level surface to one of the counters and to the inside of the building. The concession counters (3) are too high. There are no accessible routes of travel to and around the fields, playgrounds, picnic tables, baseball dugouts, bleacher seating, and other amenities. The picnic tables at the track and field area are not accessible. Non-compliant wood chips are the primary surface throughout the playgrounds and none of the play components are accessible.

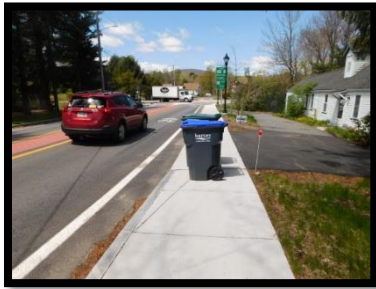
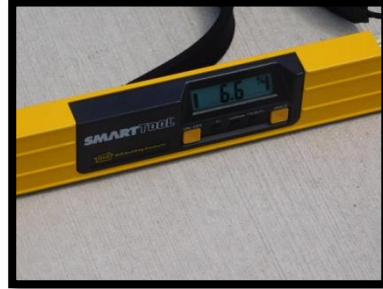
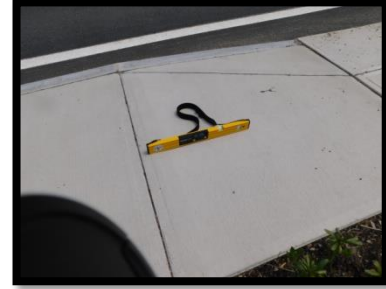
Although the sidewalks are in very good to excellent condition, the running slopes of the sidewalks at the transition to the 2 driveways (6.2% to 6.6%) at “Captain Bob’s” and at Wachusett Drain Service (5.3% to 6.3%) exceed the maximum allowed as the natural topography does not exceed 5.0%. The curb ramp and crosswalk at Mechanics Hall ends in a driveway on the opposite side and another crossing on Route 140 ends at granite curbing on the opposite side. Trash receptacles placed on the sidewalk on Route 140 block the accessible route and restricts the clear width of the sidewalk. Residents should be reminded on trash pick-up day not to put their trash receptacles on the sidewalks to ensure that people of all abilities have use of the walkways. Although there are mailboxes on Route 140 that are mounted in the sidewalk in

various locations, there remains sufficient 36" clear width within the sidewalk and the mailboxes and posts do not serve as protruding objects.

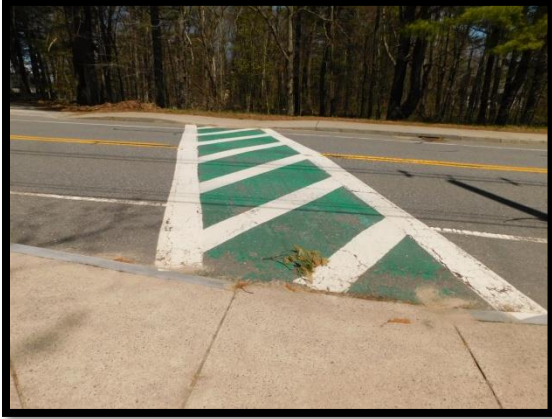
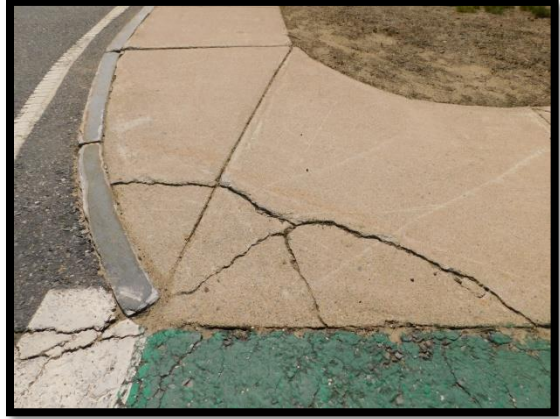
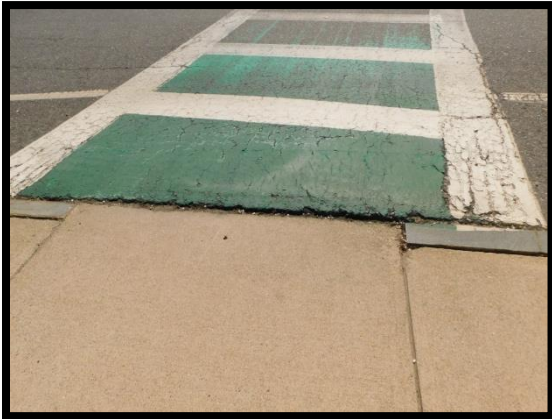
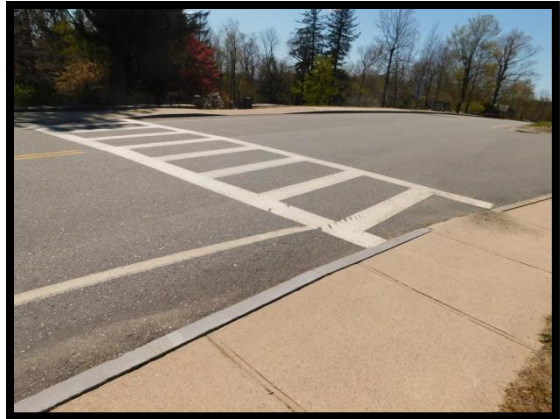
The crosswalk and curb ramp across Gregory Hill Road lacks a level landing on the Church side with an up to 4.8% running slope. The Common side has a 3.6% cross slope at the landing with an up to 1" abrupt change in level surface at the transition from the road to the curb ramp.
