Town of Princeton
Needs Assessment & Four
Buildings Master Plan
Summary Report
March 2018

3.1 Existing Conditions Report: Bagg Hall

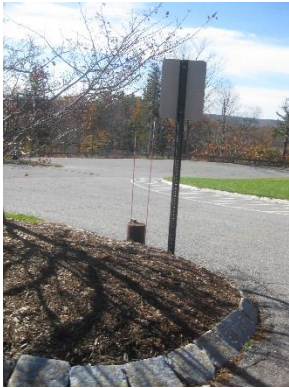
- A ■ Quality of water and longevity of well unknown. If improvements proposed, may be required to meet DEP requirements for public water supply.
- B ■ Existing well has the capacity of 20 GPM, with no water treatment. Well pump is located 272 ft below grade. The static water level is approximately 25 ft below grade. Well is an 8" Artesian well. Installation Date Unknown.

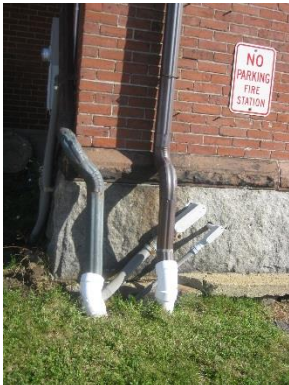
Drainage

- A ■ Existing drainage appears to be in place. We heard anecdotally that the basement of Bagg has water issues. This drainage system is occasionally overwhelmed during heaving rainstorms and there is no subsurface drainage around the building other than parking area catch basins. Any improvements to Bagg will need to consider addressing these concerns.

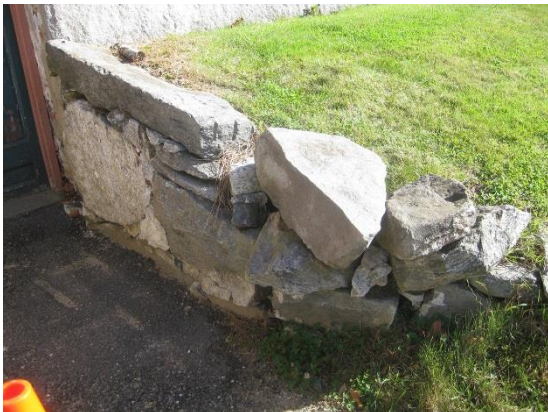
- A ■ Existing Retaining Walls with access to basement are loosely placed. Site improvements may consider improving these walls

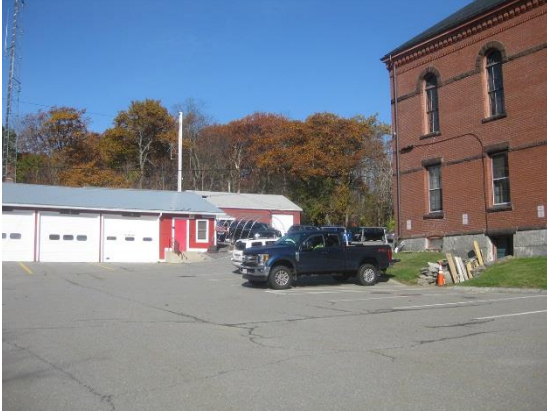
- A ■ Paving has many cracks and patches in the parking areas surrounding Bagg Hall.

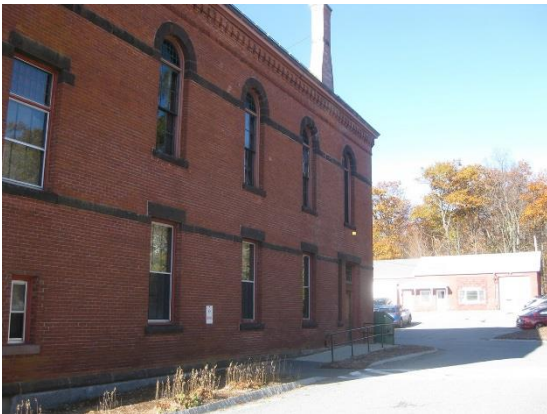
ADA Access

- B ■ Existing Ramp may not meet current ADA codes. Improvements may require updates to existing ADA ramp, as well as additional points of access into the building.

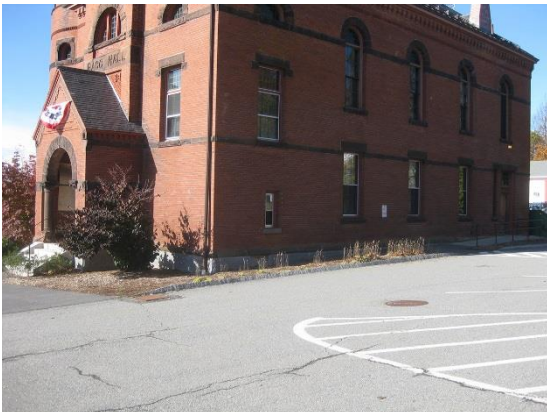
- A ■ Existing Planting sparse. Large mulch beds. Team may review with Town maintenance to evaluate alternatives and maintenance expectations for softscape areas around Town buildings.

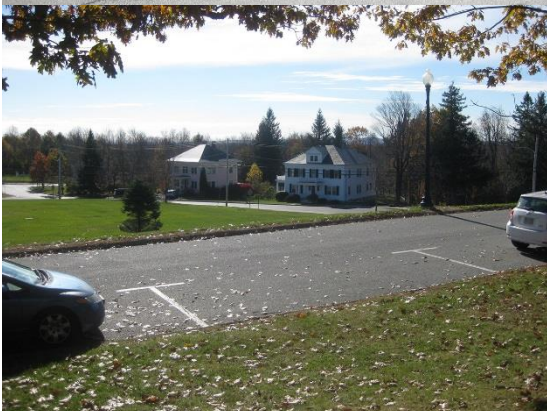
- B ■ Existing Septic System is shared by multiple buildings on site. The system has been pumped regularly. Unknown as to the system's longevity or if an alternative site can be located if this system needs replacement. Depending on the number of full time staff and users on site, the system may require review by DEP

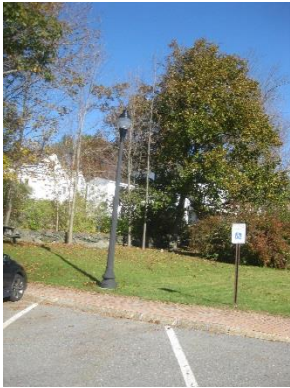
Pedestrian Pavements

- A ■ Pedestrian concrete pavers are in need of replacement between Bagg Hall and the Library.

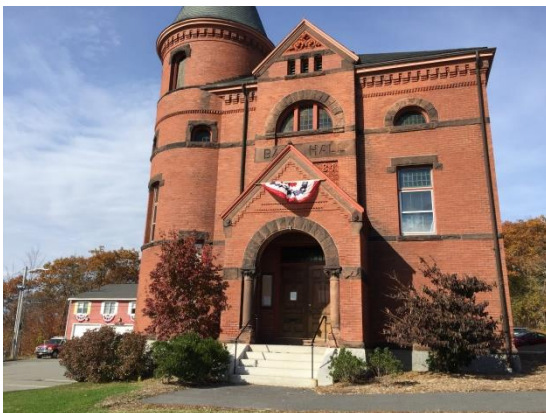
Sprinkler System:

- B ■ If more than 50% of an individual floor is reconfigured, sprinkler protection is required within the reconfigured area only, unless it can be demonstrated that the available water supply is not sufficient for the design of a sprinkler system without a fire pump (IEBC 804.2.2).
- C ■ Sprinkler protection is required throughout the building, unless it can be demonstrated that the water supply is not sufficient (MGL C. 148 Sec. 26G)

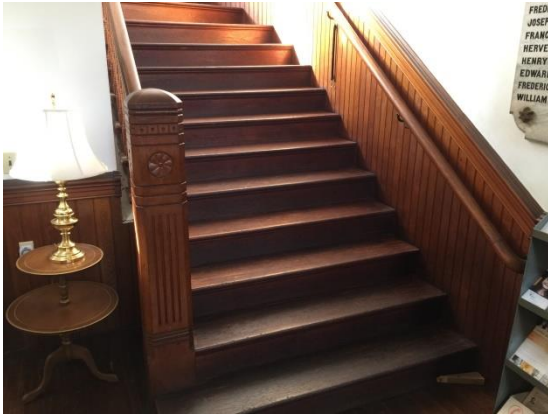
Stairs:

Although the existing stairs do not comply with all of the dimensional requirements for new construction, regardless of the level of renovation they do not have to be brought into full compliance (other than potentially handrails and nosings as discussed below).

- B ■ For a Level 2 renovation stairs within the work area must be enclosed in 1 hour rated construction (IEBC 803.2). Although if the building is fully sprinklered a rated enclosure for the stairs is not required (IEBC 803.2 Exception 5).
- C ■ A Level 3 renovation requires full enclosure of all stairs in 1 hour rated construction at all levels, unless the building is full sprinklered (IEBC 903.1). All stair handrails and nosings must be altered or replaced to comply with 521 CMR (521 CMR 27).

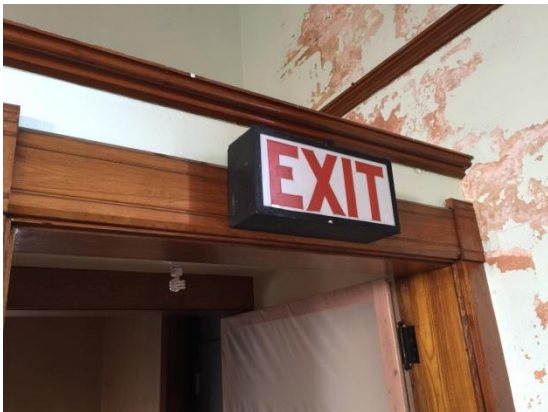
Exit Signs & Emergency Lighting

- B ■ The building includes existing exit signs that appear to have the ability to be illuminated, although they were not illuminated at the time of the site visit. Signs must be repaired or replaced to comply with the requirements for new construction in any renovated areas (780 CMR 102.6.4).

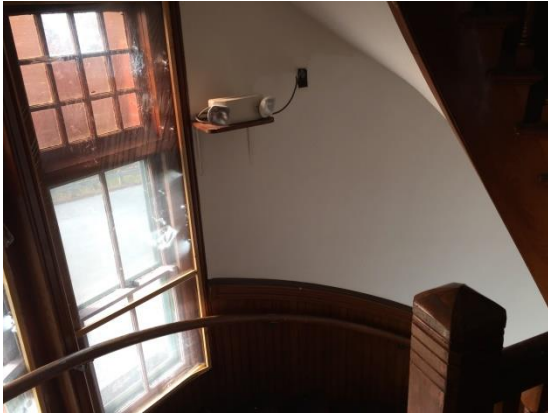
- B ■ Existing emergency lighting fixtures were not tested or evaluated for adequate coverage but may need to be replaced or supplemented in any renovated areas to comply with current code requirements (780 CMR 102.6.4).

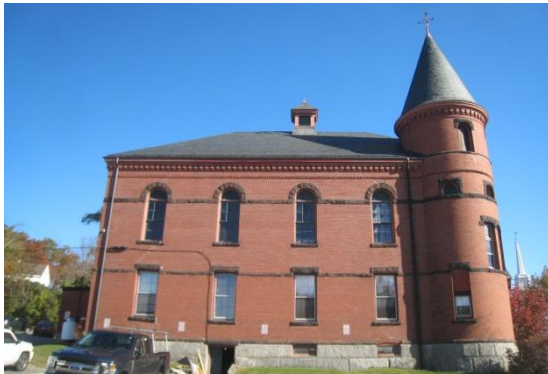
Roof:

- B ■ Conical roof is missing slate
- B ■ Roof and flashings are in need of repair - daylight can be seen through the roof in the attic at the interface of exterior brickwork and cornice at the soffit which was not included in previous repairs made at roof.

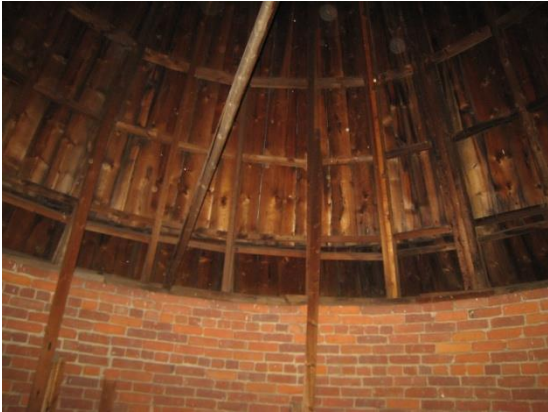
Insulation:

- B ■ No exterior insulation in first floor, walls and attic.
- First floor ceiling: to be determined.

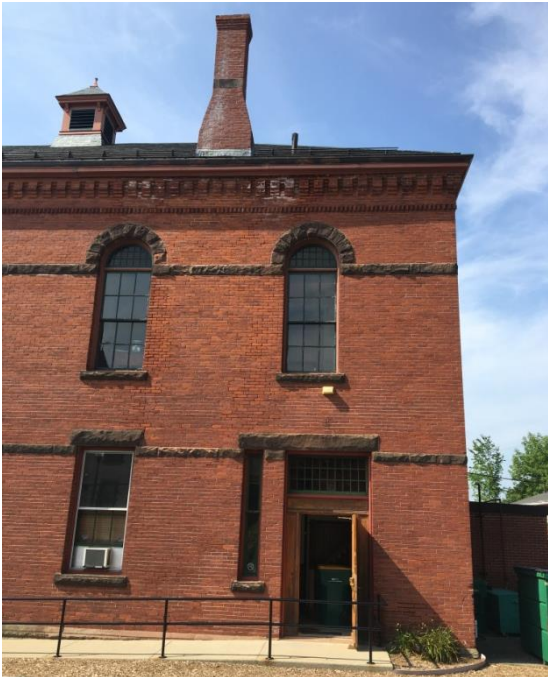
Exterior Doors:

- B ■ Original entry doors are in fair to good condition
- A ■ Accessible entry door has been replaced, some repairs are needed

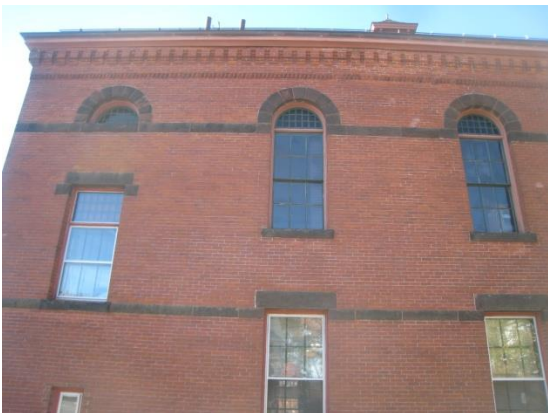
Windows:

- A ■ Fair to poor condition overall
- A ■ First floor windows are drafty - pockets for sash weights allow air penetration.
- B ■ Windows are difficult to operate
- A ■ Second floor windows are in poor shape
[P. Connors notes that 6 sets of wood sash have been removed due to decay/deterioration]

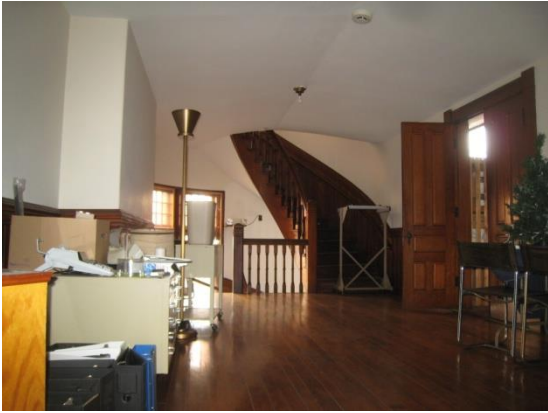
Floors:

- C ■ Wood flooring is in fair to good shape where exposed
- B ■ Carpet appearance is fair/worn condition

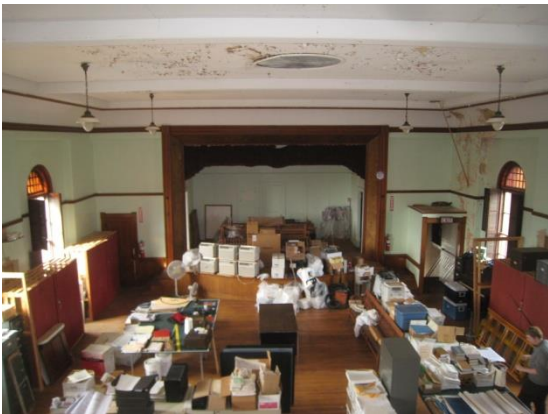
Walls:

- C ■ 1st floor - condition of walls is good
- B ■ 2nd floor - plaster is water stained and paint is peeling. Historic stenciling has been painted over. Walls need to be patched; wainscoting and window stools need repair.
- B ■ Evidence of moisture has been found on interior walls - possibly caused by metal gutter and cornice flashing. [P. Connors reports that observed moisture is old and is believed to have been corrected with recent roofing project.]

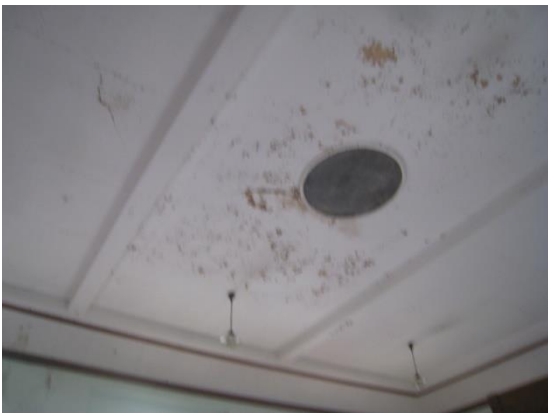
Ceilings:

- C ■ 1st floor - ceiling is in good condition, except for 1 small crack in the clerk's office.
- B ■ 2nd floor - poor condition, water damage is apparent and paint is peeling.

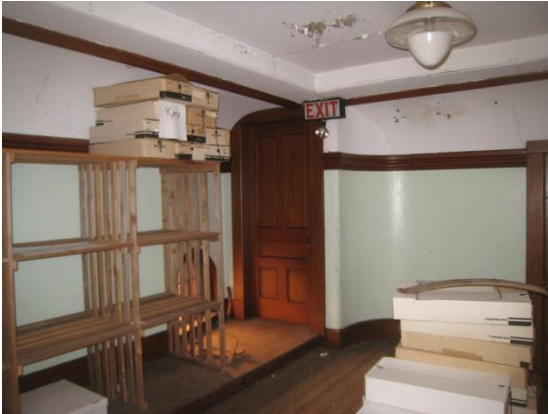
Interior Doors:

- Many original doors remain.
- A ■ 1st floor - Fair condition, but hardware is non ADA compliant. There are some replacement doors which do not match, historically.
- B ■ Aluminum door at entry is not historically compatible

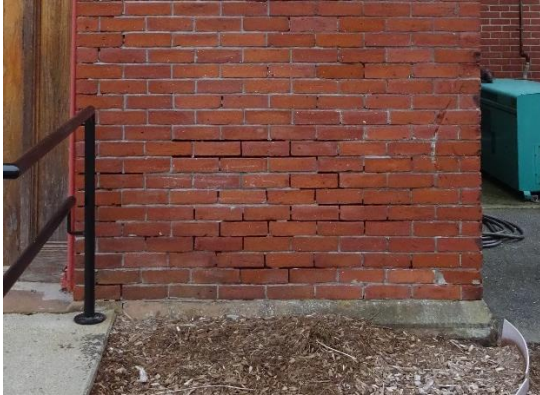
C ■ Eroded Mortar Joints

There are eroded mortar joints around the exterior of the building. The larger areas of eroded joints are located below the watertable and at the northwest corner on both elevations. The eroded mortar joints should be cut and pointed with a compatible mortar.

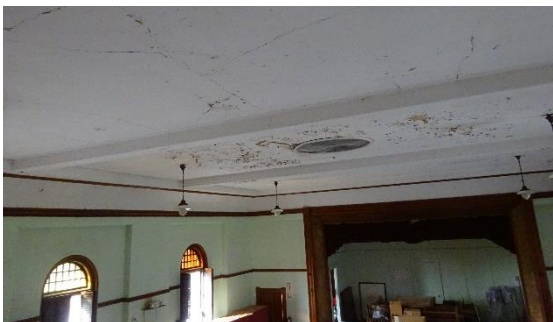
C ■ Water Damage

There is water damage visible in the second floor ceilings, which has caused the plaster to deteriorate. By reviewing the areas from the attic space, the water infiltration appears to have been eliminated. The damaged plaster should be repaired.

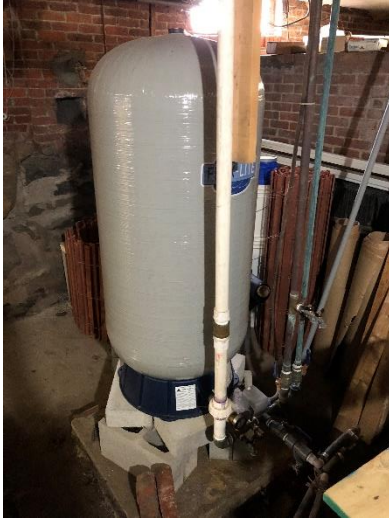
Water Systems:

The building is supplied from one well which serves all four buildings on the Town campus; Library, Bagg Hall, Public Safety Building, and the Annex building. The pressure tank is located in the basement of Bagg Hall. The water is supplied from Bagg Hall to the Public Safety Building, then to the Annex building. The well pressure tank has a 90 gallon volume.

A Recommend installing thermostatic mixing valve and hot water circulator on water heater.

A Insulate all domestic water piping.

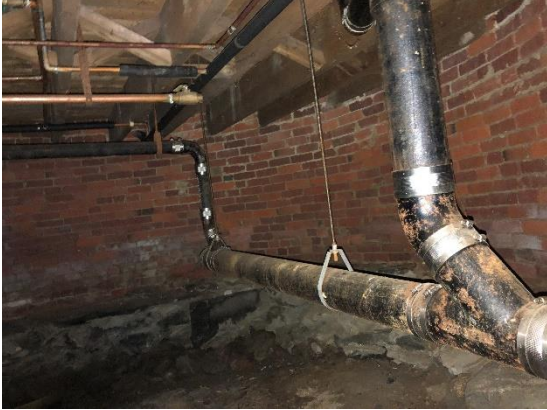
Drainage Systems:

Cast iron is used for sanitary drainage. Smaller pipe sizes are copper tubing. Where visible in Basement cast iron appears to be in fair to good condition.

- A Recommend video inspection to confirm integrity and pitch of existing below grade piping.

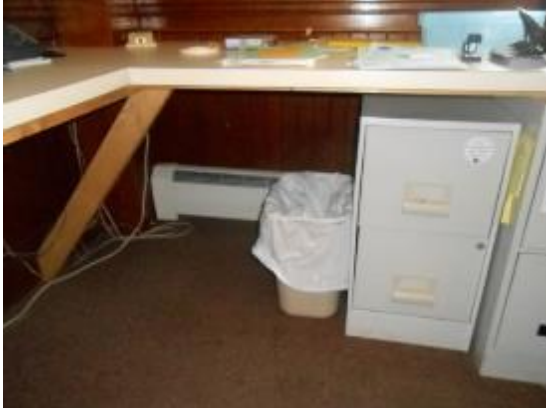
Partially Blocked Hot Water Baseboard Heat

The furniture blocking the convective flow through the baseboard heaters also exacerbates the overall lack of installed baseboard capacity. The second heating zone is the foyer/handicapped bathroom. Ventilation is via operable windows. The bathrooms have no ventilation other than operable windows. The offices are cooled by window air conditioners, which prevent the windows from being used for ventilation during the summer.

- B ■ Add self- contained valves to any baseboard that tends to overheat room.
- C ■ Add ventilation system.
- C ■ Add ductless mini-split air conditioners, as they are quieter than through the wall air conditioners, plus are more efficient.
- C ■ Install air separator near boiler.

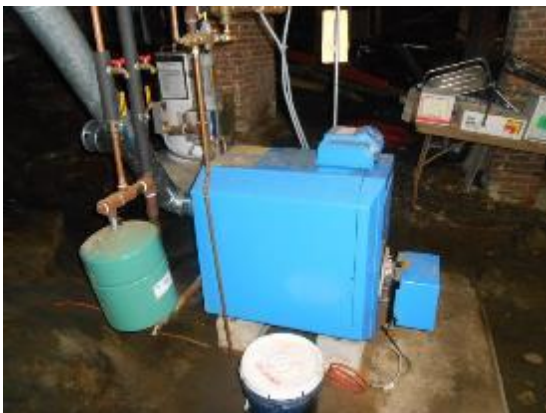
Oil Fired Hot Water Boiler

There is one oil-fired cast iron hot water boiler manufactured by Buderus, Model Logano G115/5WS with a gross output capacity of 136 MBH and a net IBR output of 119 MBH (Action Priority C). The boiler fires 1.1 GPH of #2 fuel oil via a Riello Model 40 power burner. The boiler is provided with a dual low water cut-off and all operating and safety controls. Fuel oil is stored in a 330 gallon basement oil tank. The boiler is vented to a masonry chimney via a 6" single wall galvanized vertical riser which immediately transitions to a 6" double wall insulated horizontal breeching. Combustion air migrates into the boiler room due to the large volume of the open basement area. Hot water expansion is handled by a Flexco Model HTX60 expansion tank. There is no air scoop or air separator on the hot water heating system. Hot water is circulated to the building via two (2) Grundfos Model UPS 15 58 FRC 3 speed pumps, with each pump dedicated to a heating zone (Action Priority C). Heating hot water is supplied to cabinet unit heaters, horizontal unit heaters and baseboard radiation via copper piping insulated with closed cell foam insulation. The existing boiler was installed around 2007, and the existing piping distribution and baseboard radiators were installed in the early 1990s.

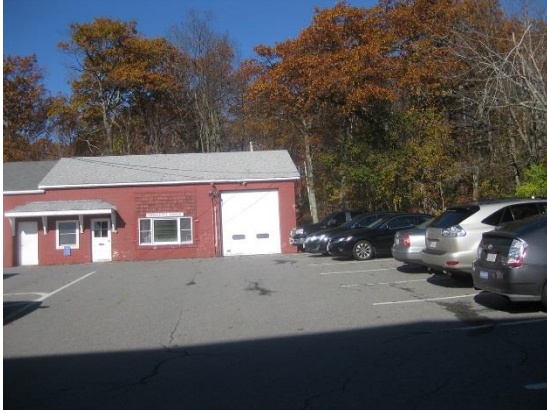
- B ■ Asphalt Paving has been patched and is cracking in places.
- Front Entry is fully accessible at grade

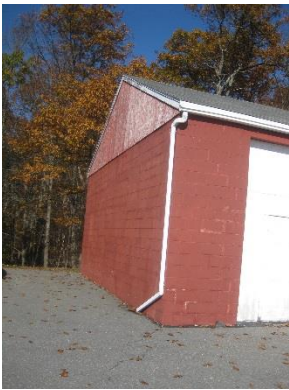
Downspouts

- B ■ Drainage at building may need to be addressed with any site improvements.

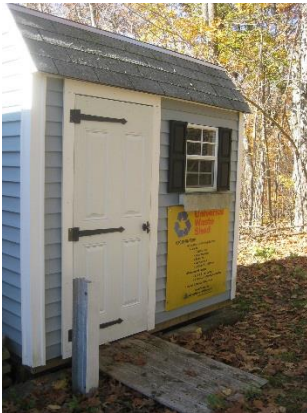
Hazardous Materials Shed

- C ■ Shed appears to be in good condition from the outside

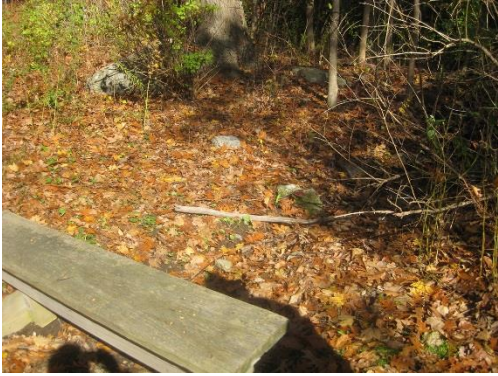
Park Access

- B ■ Access and entrance to Park undefined.

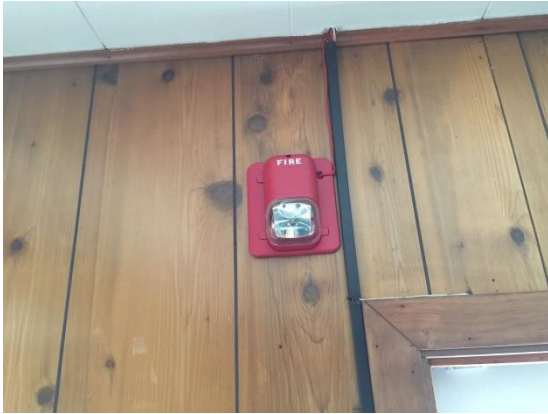
Fire Alarm System:

- A ■ The building has an existing fire alarm system that is currently disconnected and not functioning. Given the current assembly uses of more than 49 occupants the fire alarm system must be restored.

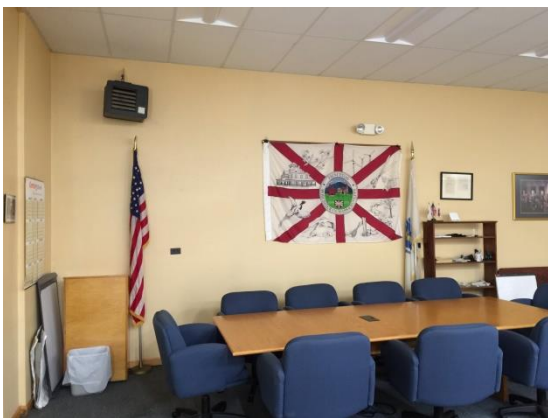
Exit Signs & Emergency Lighting

- B ■ The building includes non-illuminated exit signs. Illuminated exit signs with battery back-up must be provided as required for new construction in any renovated areas if the building will be used for assembly purposes by more than 49 occupants (780 CMR 102.6.4).
- B ■ Existing emergency lighting fixtures were not tested but appeared sufficient for the space. They should be tested to confirm they will operate properly and have sufficient battery back-up power if the space will be used for assembly purposes by more than 49 occupants (780 CMR 102.6.4).

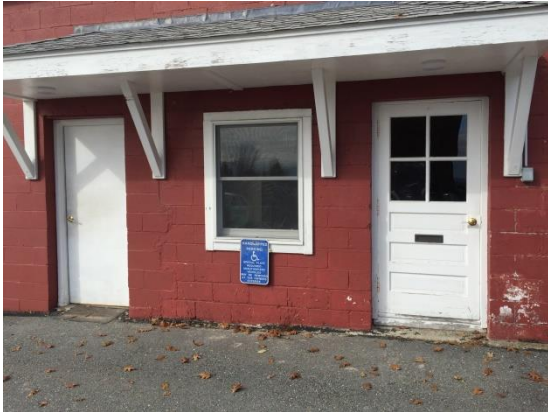
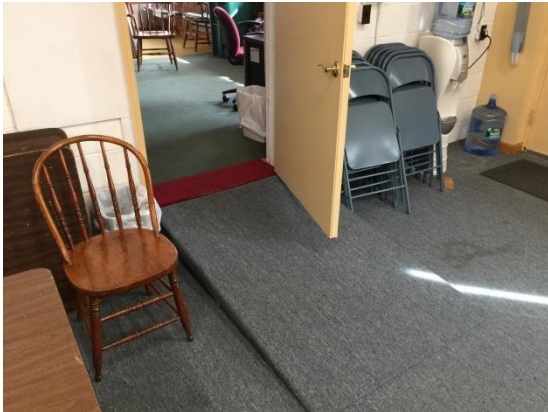
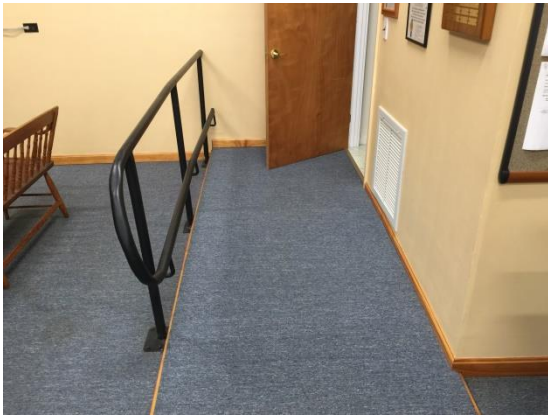
Accessibility

The existing building includes an entrance door at grade and an accessible toilet room. Only the meeting room area is at grade elevation, the other portion of the building is one step higher and currently accessed via a non-compliant ramp.

- B ■ The existing entrance door at grade provides functional access, however there is a small slope at the door threshold, it is not level as required (521 CMR 26.6.1). The toilet room has sufficient floor space, however the rear grab bar is also only 36" long, less than the 42" minimum required (521 CMR 30.8). In addition, the ramp leading to the toilet room does not include the required handrails on both sides and if a second handrail is installed the clear width will be less than the 48" minimum required (521 CMR 24.3). The top of the ramp is also approximately 47" wide and does not provide the required 60" x 60" turning space necessary at the landing and in front of the door (521 CMR 24.4).

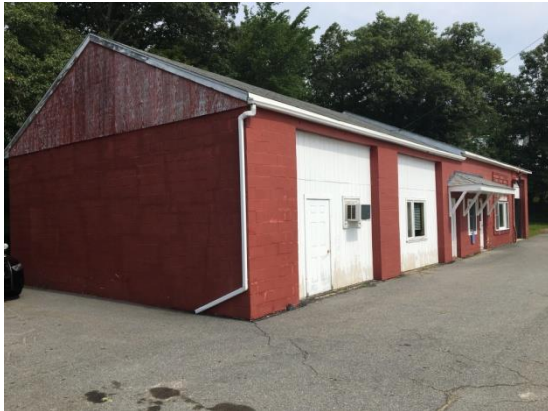
Roof:

- C ■ South side of roof was replaced within the last 15 years
- A ■ North side is in poor condition
- B ■ Soffit is in poor condition, and the east side of the roof does not have gutters
- B ■ Extent of roof insulation is unknown

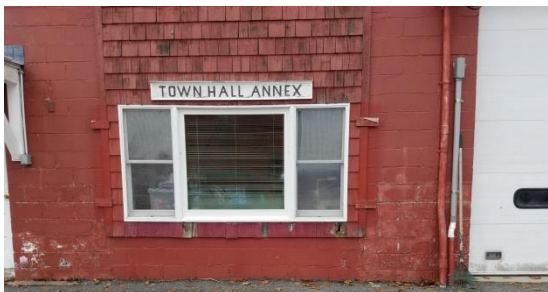
Walls:

- B ■ CMU is in overall good condition, except for a settlement crack on the west side
- A ■ Plywood has weathered and in poor condition

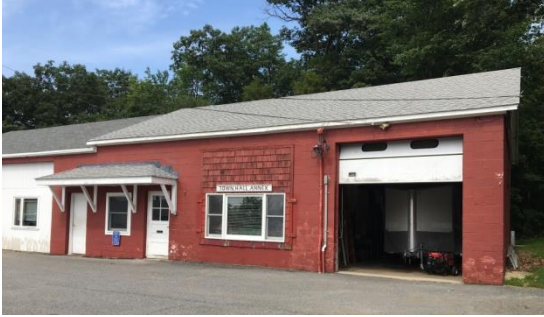
Doors:

- B ■ Good to fair condition

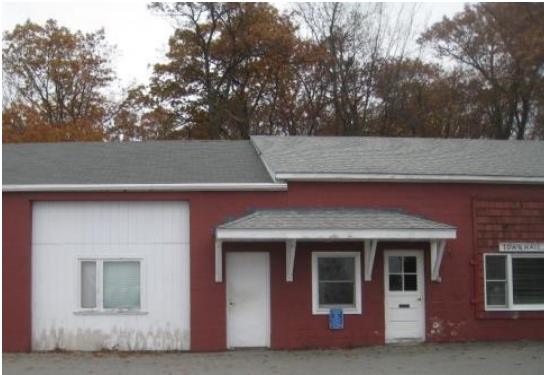
Windows:

- B ■ Good to fair, include thermal glazing

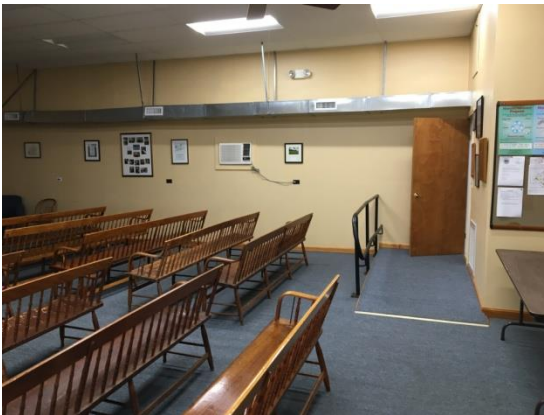
Floors:

- B ■ Carpeted areas are in fair to good condition
- B ■ Floors are slab on grade, with no perimeter insulation
- A ■ Water damage evident – particularly in south-west corner. Carpet should be removed and inspected for mold.

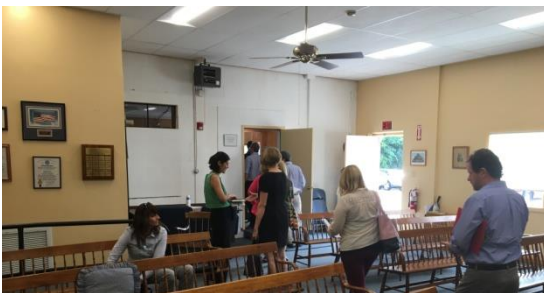
Walls:

- C ■ Overall wall condition is good

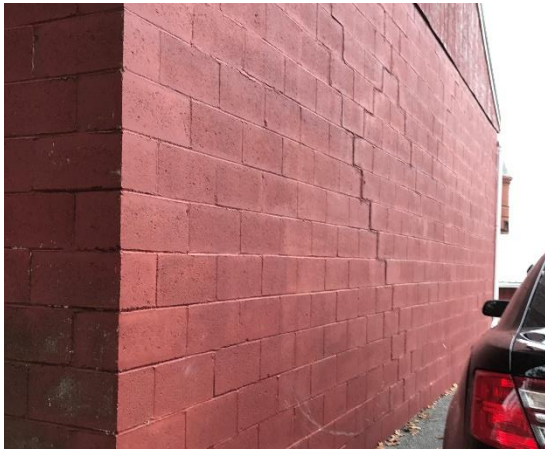
A ■ Diagonal step cracks

There are numerous and opposing diagonal cracks in CMU wall at left side of structure. These may be from foundation settlement, from corroding metal embedments, or even just from expanding and lifting of badly deteriorating mortar joints. There are also step cracks running upward from the ends of window lintels at the rear wall.

The cracks significantly weaken the wall as they eliminate the wall's shear and bending strength. Unlike eroded mortar joints, the cracks likely run through the full thickness of the wall construction and need to be repaired from both sides.

This can be done in several ways:

- By removing interior finishes to expose the inner face of the wall and deeply cutting and pointing from the interior and exterior using backer-rods.
 - By removing and re-setting the concrete blocks along one or both sides of the cracks from the exterior.
- or
- By incrementally cutting through the entire thickness of the wall and installing grout filled lozenge type sock anchors from the outside of the wall and then pointing outer surface (this is a proprietary system that this office has developed).

Any rusting metal embedments should be removed.

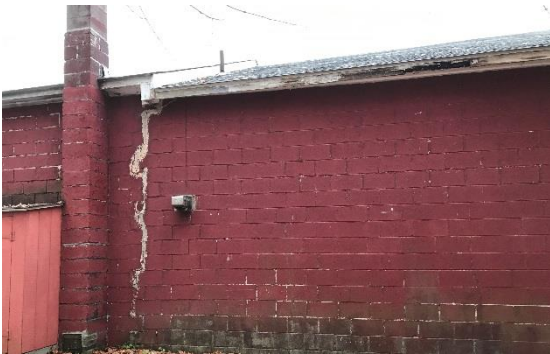
B ■ Chimney damage

The lower portion of the rear chimney is in very poor condition and the entire chimney needs to be rebuilt.

B ■ Rotted wooden fascias

There are rotted holes in the fascia boards at several locations. The rotted boards should be removed and the supporting blocking and rafter ends should be inspected, treated and repaired as needed, and the fascias should be replaced.

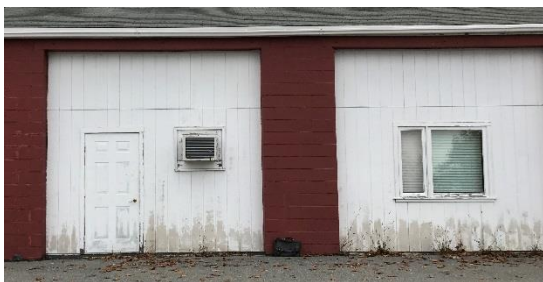
B ■ Leakage through at infilled doorways

Water apparently leaks into the interior where wall where doorways have been infilled in the front wall. The infilled openings should be inspected from both sides and properly sealed. The roof edge flashing should also be checked to confirm it is not also a source of damage.

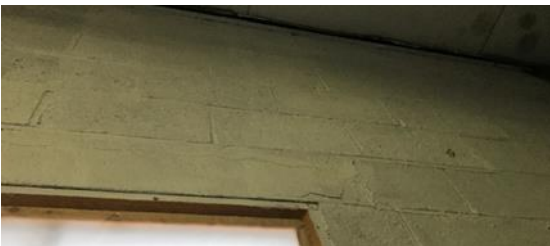
B ■ Cracked window lintel

There is a cracked precast concrete lintel spanning over a window on the east wall. The crack runs horizontally and is likely due to expansive rust in the reinforcing steel. The lintel should ultimately be replaced.

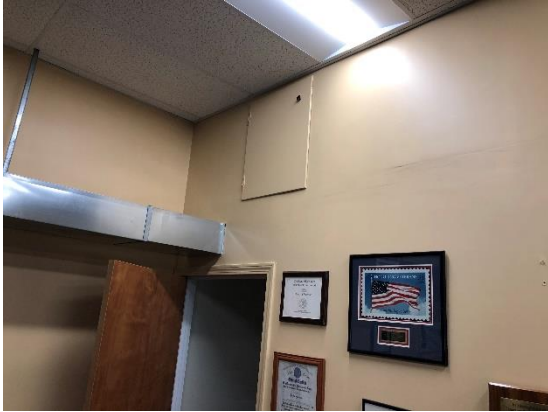
Domestic hot water is generated through an electric tank type water heater. Water heater is located above the ceiling of the bathroom, which is accessible through a wall panel. The system is not equipped with a mixing valve or expansion tank. The hot water system is not recirculated.

- A Recommend installing thermostatic mixing valve on water heater.

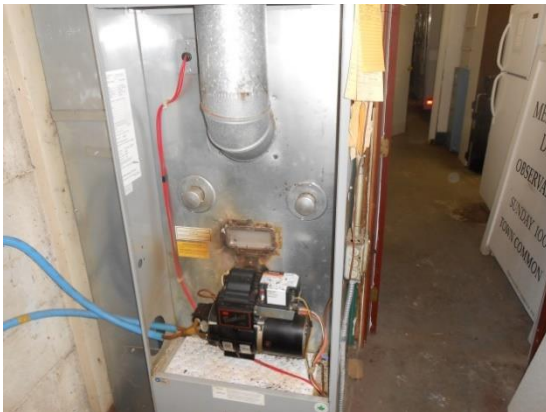
Meeting Room Oil Fired Hot Air Furnace

The meeting room is heated by an oil fired York Model P-H-MX 14F 10001 warm air furnace which supplies warm air to an exposed uninsulated galvanized steel ductwork run down one side of the room (Action Priority B). Air is supplied via sidewall grilles and returns to the furnace via a low wall grille. The furnace can burn 0.75 to 1.0 GPH of kerosene via a Becket burner with an output range of 87 to 116 MBH. The furnace is vented through galvanized sheet metal ducting into the masonry chimney via natural convection. There is also a wall mounted power venter mounted on the wall, however this equipment has not been used in years. The power venter is locked out. The 225 gallon kerosene tank is located outdoors in an enclosure attached to the building. The furnace supplies minimal heat to the police storage bay via an open ended flexible duct. The meeting room bathroom is ventilated by a wall mounted exhaust fan that exhausts to the attic. The meeting room is cooled by two (2) through the wall air conditioners and two (2) ceiling paddle fans. The meeting room is ventilated by operable windows, as the furnace has no source of fresh air.

- C ■ Add wi-fi programmable thermostat to meeting room.
- C ■ Add ventilation system.
- C ■ Add ductless mini-split air conditioners, as they are quieter for meetings than through the wall air conditioners, and are more efficient.

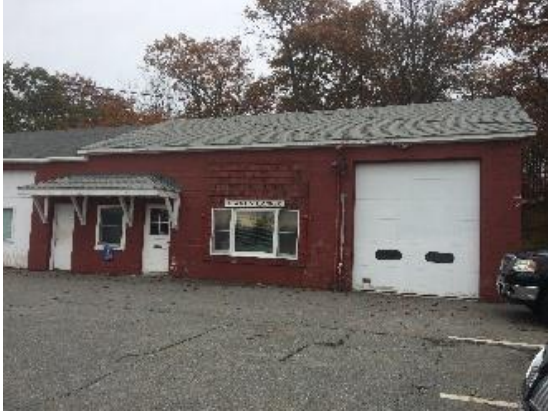
Exterior Lighting:

- B ■ Minimal use of exterior building mounted lighting.

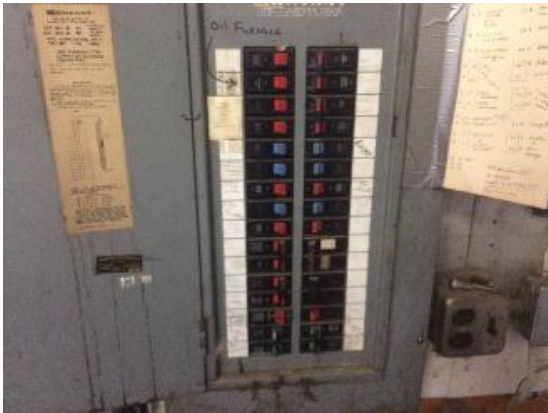
Load Center End of Life:

- A ■ Main distribution panel showing signs of corrosion and all circuits assigned.

- A ■ Antiquated Load center recommended for replacement.

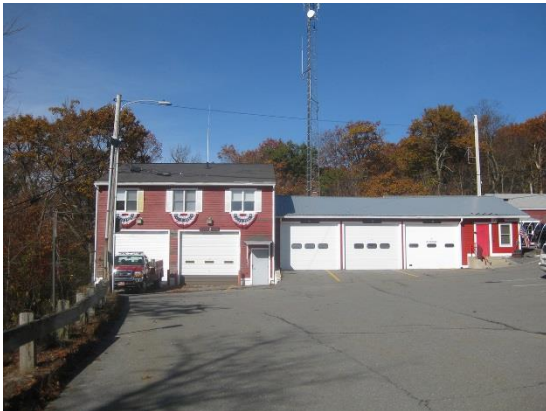
- B ■ Asphalt Paving has been patched and is cracking in places.

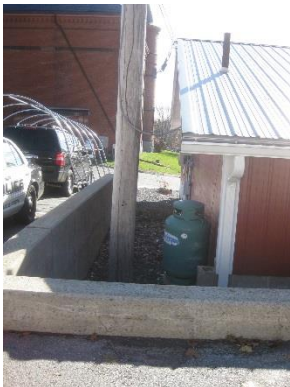
Coordination with Site Constraints

- A ■ Any improvements may require accessible entrances and modifications to entrances and access per MA Code. Modifications may be challenging accommodating associated utilities and grades.

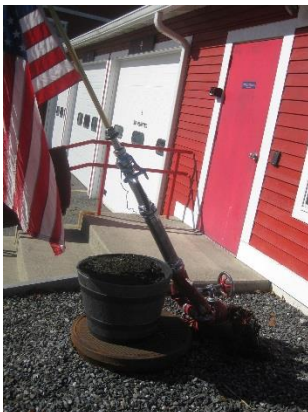
Accessible Entrances

- A ■ Any improvements may require accessible entrances and modifications to entrances and access per MA Code.

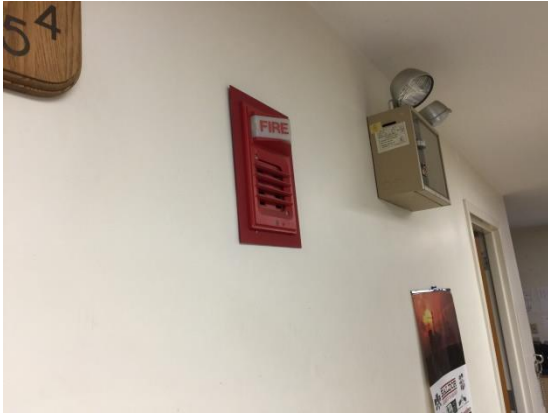
Fire Alarm System:

- C
- The existing fire alarm system lacks notifier (IEBC 804.4.1 Exception), however, improvements are only required if the building is open to the public and the renovation cost exceeds the 30% cost threshold in 521 CMR.

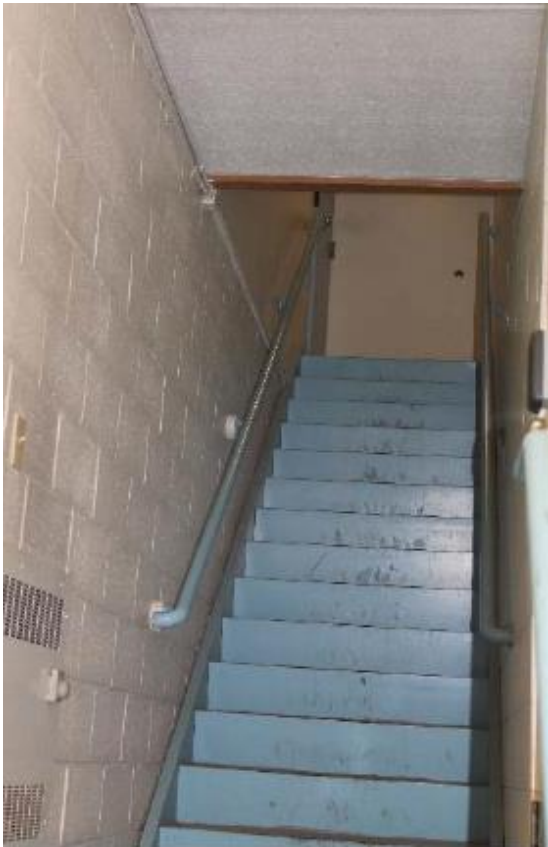
Stairs:

Both levels of the building are provided with two means of egress that are sufficient for the building's current use.

- B
- For a Level 2 renovation stairs within the work area must be enclosed in 1 hour rated construction (IEBC 803.2). Based on the masonry construction used for the stair enclosure it likely meets this requirement.
- C
- Stair handrails must be altered or replaced with handrails providing the required extensions at the top and bottom of the stair to comply with 521 CMR (521 CMR 27).

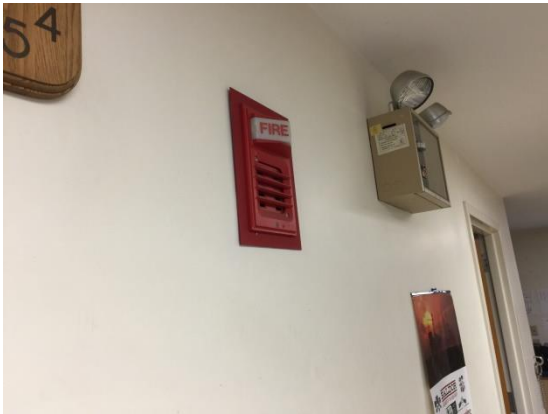
- B ■ The building exit signs that appear capable of illumination but were not illuminated during the site visit. Existing signs must be repaired or replaced with signs having adequate battery back-up as required for new construction in any renovated areas.

- B ■ Existing emergency lighting fixtures were not tested or evaluated for adequate coverage but may need to be replaced or supplemented in any renovated areas to comply with current code requirements (780 CMR 102.6.4).

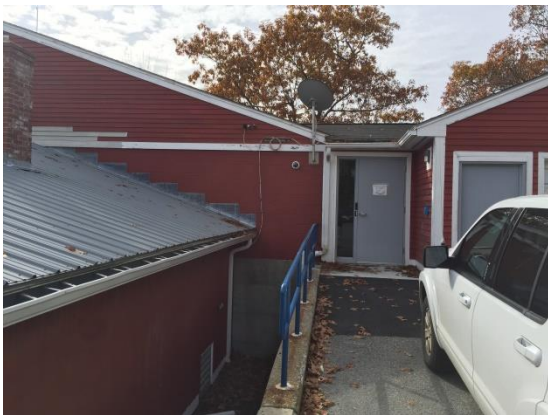
Accessibility

The existing building does provide public access on the Police side via a monitored vestibule that can be used as a safe haven for a member of the public should they arrive at the police station in distress, however, that vestibule is not at grade. Accessible access is available through the back door of the building. Additionally, the fire department office may receive members of the public.

- B ■ The existing rear entrance door is at grade and wheelchair accessible. However there is grade leading to the door and no accessible route from an accessible parking location to the door. If renovation costs exceed \$100,000 and this door remains a public entrance an accessible route from the door to an accessible parking location must be created.

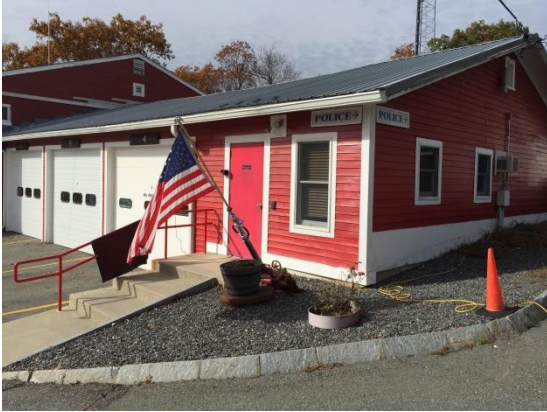
- If full compliance is required (due to cost of alterations exceeding 30% of the assessed value) alterations would be required to all areas open to the public, which may only include the rear entrance vestibule and fire department offices. The fire department entrance exterior steps are not accessible; a ramp would be required.

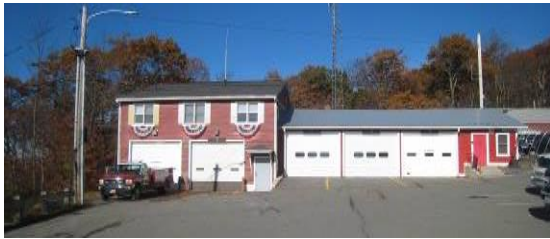
Roof:

- A ■ Asphalt shingles on police station. There is batt insulation at the bottom cords of the roof trusses. The asphalt roof is over 25 years old. It needs to be replaced.
- C ■ Metal roof on fire station with aluminum gutters and leaders. The metal roof is in very good condition.
- A ■ There are severe ice dams on the north side of the fire station as reported by HKT.

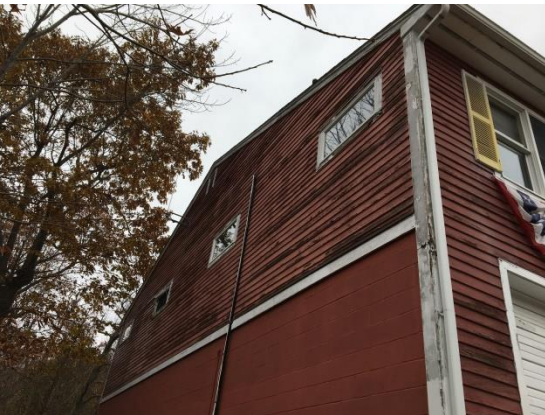
Walls:

- A ■ Painted Wood Clapboard. Fair to poor condition. Wood clapboards are splitting and peeling.
- B ■ Painted CMU. Fair condition. Paint peeling in some locations
- C ■ Metal Siding. Excellent condition
- B ■ Exposed concrete. Fair condition
- A ■ Trim. Poor condition

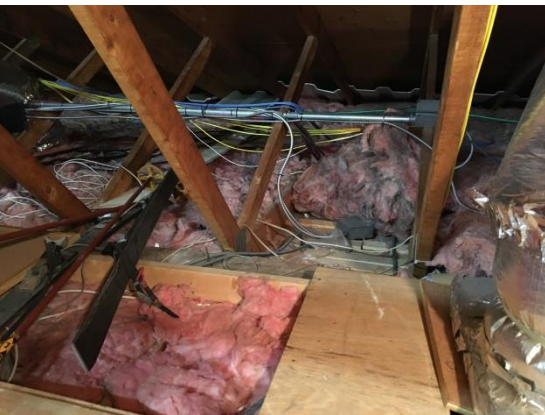
Insulation:

- B ■ Batt insulation in addition only. Not evenly applied
- C ■ New rigid insulation added under new metal siding at fire station.

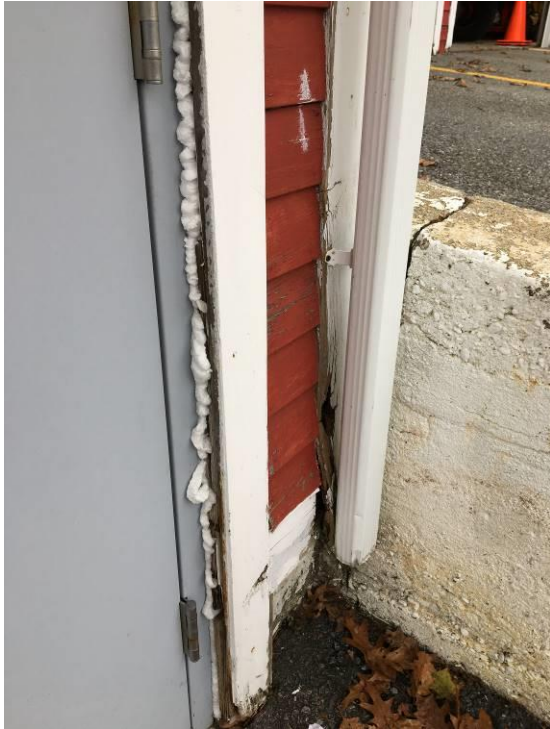
Doors:

- B ▪ Overhead doors in apparatus bays. The overhead doors have a gap at the floor and are rusting at the sills.
- B ▪ Insulated hollow metal doors in pressed metal frames. The egress door interior stairway does not close properly. There is daylight between the metal frame and the wall.

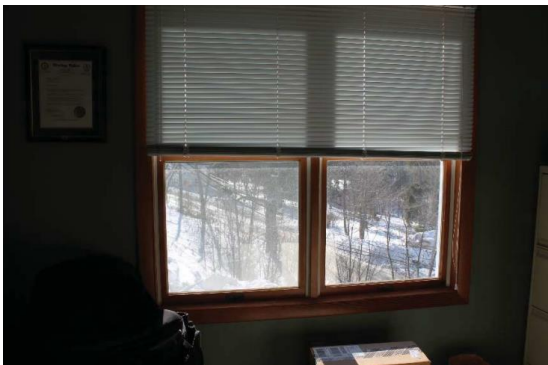
Windows:

- C ▪ Double hung and awning. Good condition given their age.

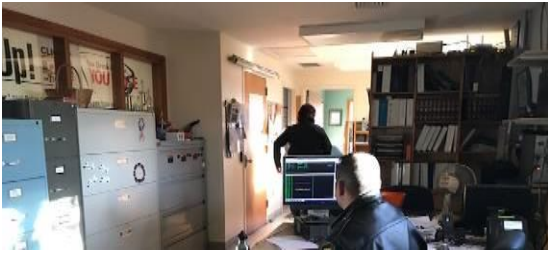
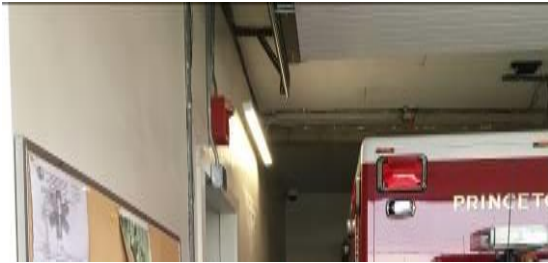
Ceilings:

- C ■ Plaster skim coat in Police. Good condition.
- A ■ GWB in the vehicle bays on the first floor. Some water damage. Also sagging in places. See Structural Report

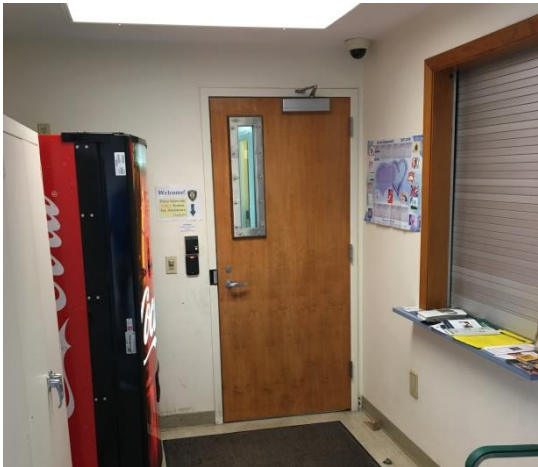
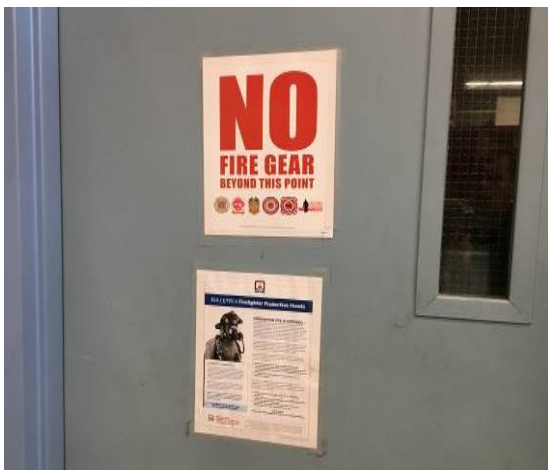
Doors:

- C ■ Flush wood doors in metal frames. Good condition. Several doors are not ADA compliant – due to hardware and/or door clearances.
- C ■ Flush metal doors in metal frames. Good condition.

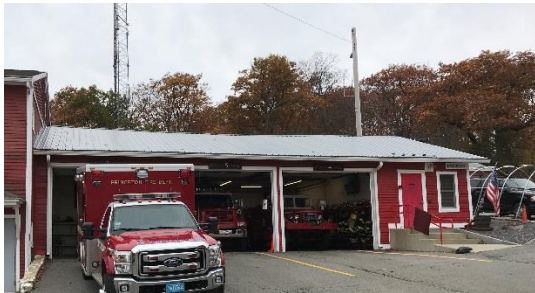
- A
- Roof sags over garages due to truss overstress
- The roof of the garage 3-bay section of the police station sags noticeably at the ridgeline due to the overstress and deflection of the supporting truss (please see “Interior”/ below).

The entire truss must be significantly reinforced, or even sistered or replaced. This could be most efficiently achieved bolted steel members that are assembled and connected in place. The roof ridge should be jacked upward during the installation and the ceiling removed and the eaves pulled in.

Because of the importance of the spaces below, the extreme deformation that has occurred and the potential severity of winter snow, this should be considered an URGENT condition.

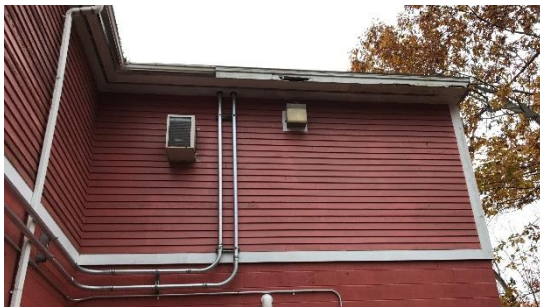
- B
- Rotted wooden fascias
- There are rotted holes in the fascia boards at several locations. The rotted boards should be removed and the supporting blocking and rafter ends should be inspected, treated and repaired as needed, and the fascias should be replaced.

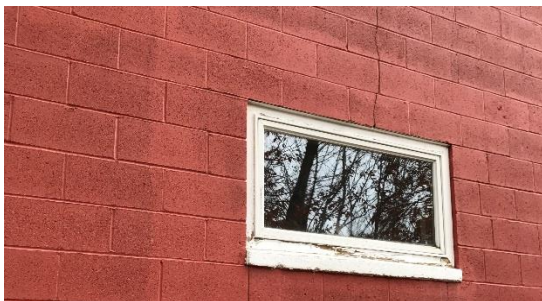
- B
- Settlement crack
- There is a vertical crack running through the concrete block portion of the left wall, crossing a window. This is probably due to some minor settlement and has presumably stabilized by now. The crack should be spanned with flexible sealant and monitored for further movement

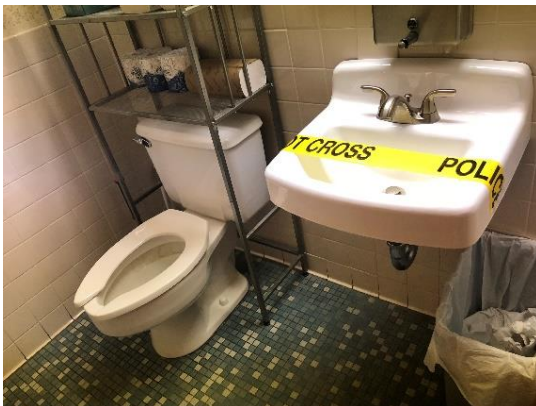
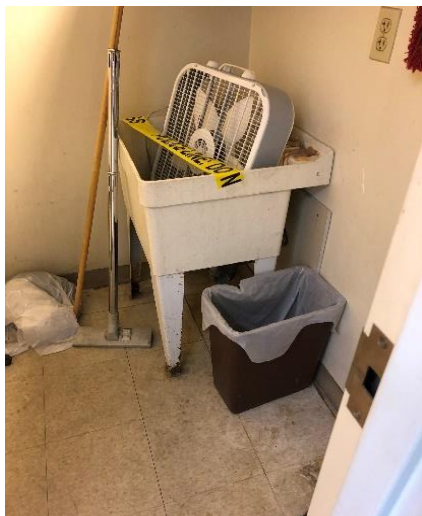
At time of visit, the majority of lavatories were out of order due to poor drainage. Owner has performed work on existing drainage system to correct issue.

Service sink is a molded stone laundry tub with deck mounted faucet. At time of visit, the sink was out of order due to poor drainage.

- A Recommend all fixtures be replaced. Provide accessible public and staff facilities.
- A Provide mixing valves at lavatories to limit hot water temperature to 110 deg. F.
- A Provide new service sink and drinking fountain.

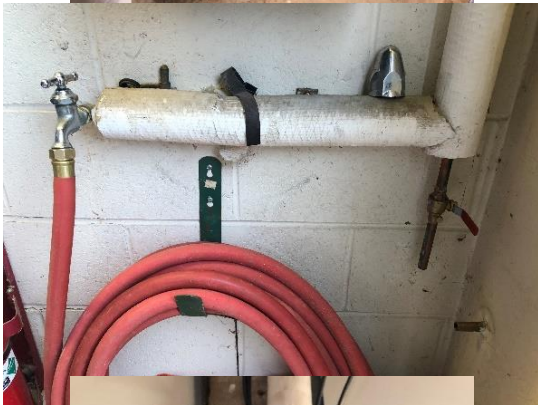
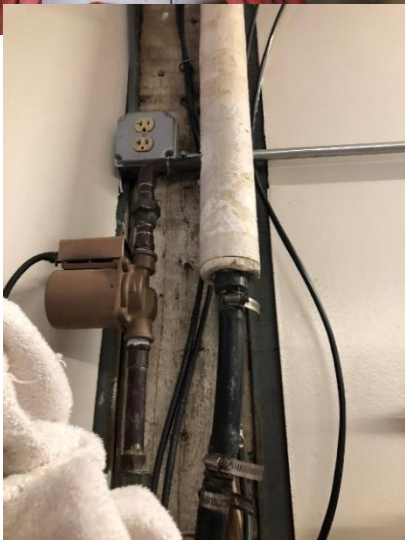
There are two pendant sprinkler heads located in the Mechanical Room which are supplied from the domestic water system. There does not appear to be a backflow preventer on the supply.

- A Recommend installing thermostatic mixing valve and hot water circulator on water heater.
- A Provide backflow preventer on supply to sprinkler heads.
- A Provide backflow preventer on supply to hose valves in Apparatus Bays.

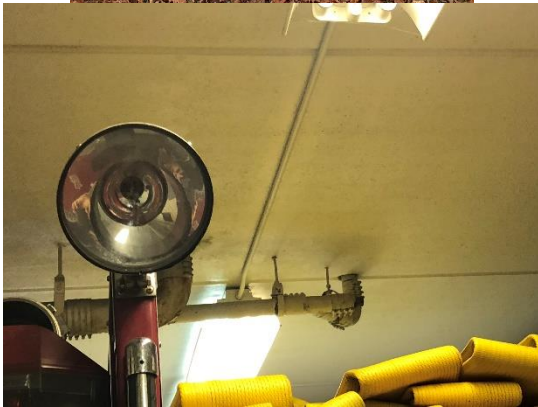
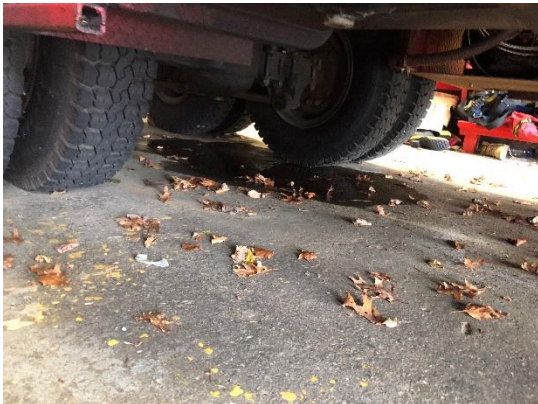
Drainage Systems:

Cast iron is used for sanitary drainage. Smaller pipe sizes are copper tubing. Where visible piping appears to be in good condition.

Garage/Apparatus areas do not have floor drains or drains have been plugged.

It was reported by the staff that there are drainage issues with the below grade piping.

- A Recommend video inspection to confirm integrity and pitch of existing piping. Replace all poor draining sanitary piping.
- A Provide floor drains in garage areas. Drains to discharge to an exterior industrial waste holding tank.

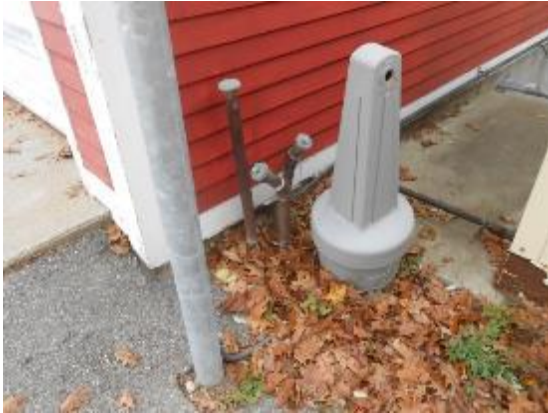
Oil Fill & Vent to be Extended

- A ■ Raise oil tank vent.
- A ■ Add a motorized damper on the combustion air duct to save energy.
- A ■ In the police station, replace the utility closet ceiling exhaust fan and other inoperable ceiling exhaust fans.
- A ■ Add an exhaust fan to the fire station bathroom.
- B ■ Add fresh air duct to police station air handler.
- C ■ Add ductless mini-split air conditioner to fire station office.
- C ■ Add central ventilation system to the police station with the energy recovery unit located in the attic with ductwork run in attic. Add high-efficiency air conditioning system to replace window AC units that are seasonally installed.
- A ■ Existing Boiler and furnace combustion exhaust piping require repairs, including sealing the pipes and securing their connection to masonry opening.
