Town of Princeton
Needs Assessment & Four
Buildings Master Plan
Summary Report
March 2018

3.1 Existing Conditions Report: Bagg Hall

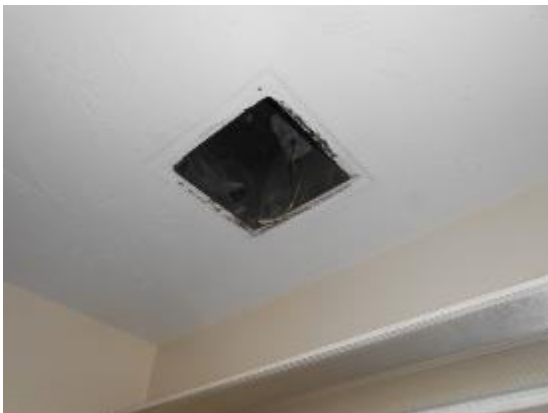
Police Station Utility Room Missing Ceiling Exhaust Fan

- A ■ Raise oil tank vent.
- A ■ Add a motorized damper on the combustion air duct to save energy.
- A ■ In the police station, replace the utility closet ceiling exhaust fan and other inoperable ceiling exhaust fans.
- A ■ Add an exhaust fan to the fire station bathroom.
- B ■ Add fresh air duct to police station air handler.
- C ■ Add ductless mini-split air conditioner to fire station office.
- C ■ Add central ventilation system to the police station with the energy recovery unit located in the attic with ductwork run in attic. Add high-efficiency air conditioning system to replace window AC units that are seasonally installed.
- A ■ Existing Boiler and furnace combustion exhaust piping require repairs, including sealing the pipes and securing their connection to masonry opening.

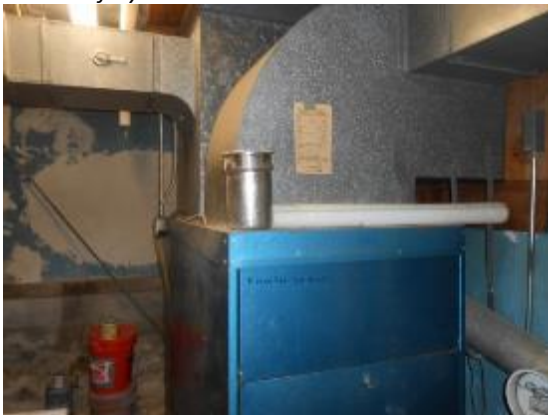
The warm air furnace is a Metromatic Model 200 LB firing 1.65 GPH of #2 fuel oil through a Beckett power burner providing 200 MBH of heating output (Action Priority B). The furnace is vented to a masonry chimney via single wall galvanized stove pipe. Warm air is supplied to the engine bays via short runs of uninsulated galvanized ductwork tied into wall grilles. Wall openings in the engine and ambulance bays provide a path for the return air to get back to the boiler room, as the boiler room functions as a plenum for the open return on the furnace. Combustion air is supplied to the boiler room via a wall louver tied into a 30"x10" open ended combustion air duct that terminates 18" AFF. The combustion air duct has only a manual damper. There is no motorized damper installed that closes when combustion air is not required.

Fire Station Oil Fired Furnace w/ Distribution Ductwork

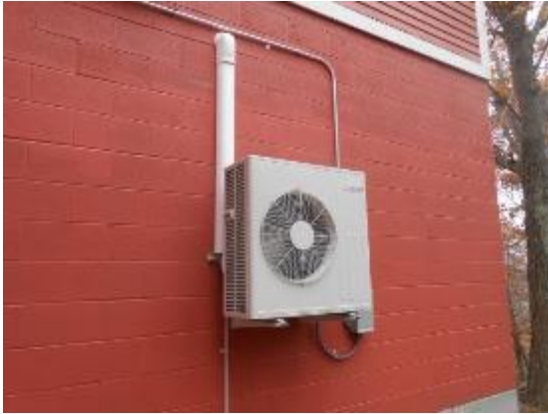
Fitness Room Condensing Unit

installed in Fall 2017. There is no ventilation in the fitness center other than minimal operable windows. The emergency communications/oil tank room is heated and cooled by a Mitsubishi Model MSZ-GL18NA 1.5 ton wall mounted heat pump with a Mitsubishi Model MUZ-GL18NA R-410A condensing unit mounted on the communications room exterior wall (Action Priority C).

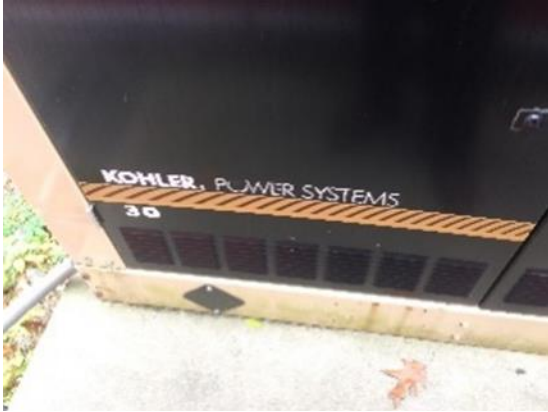
Stand-by Generator:

- A
 - Standby Generator is scheduled for replacement. Phil Connors reports that propane storage tank and generator output are undersized for this building to continue emergency/first responder coverage during periods of lost or interrupted power.

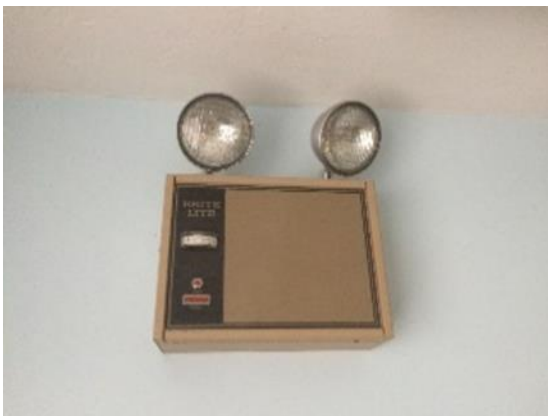
Egress Lighting and Fire Alarms:

- A
 - Replace Fire Alarm System, means of egress lighting and signage and add initiating devices: smoke, heat, CO and pull stations per code. Batteries in this unit were unresponsive to testing.

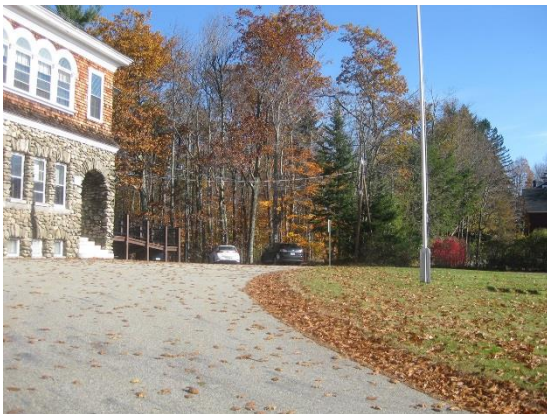
Paving – Front of Building

- B ■ Existing Paving may need replacement in 3-6 years.

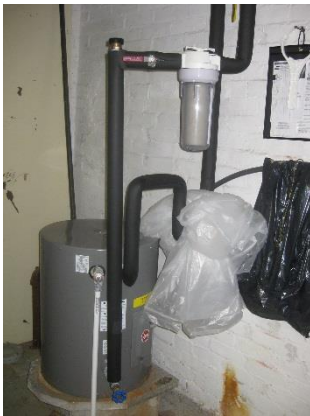
Water Sources

- B
- Water Sources: 15 year old well; 200-225 ft. Artesian 6" well under the gymnasium, believe less than 2-5 GPM. Water Treatment: pH adjustment with soda ash. Water has not been tested for water quality.

- A
- If additions/ renovations well may require meeting DEP standards, such as a new well with a Zone 1 outside of pavements or building footprints.

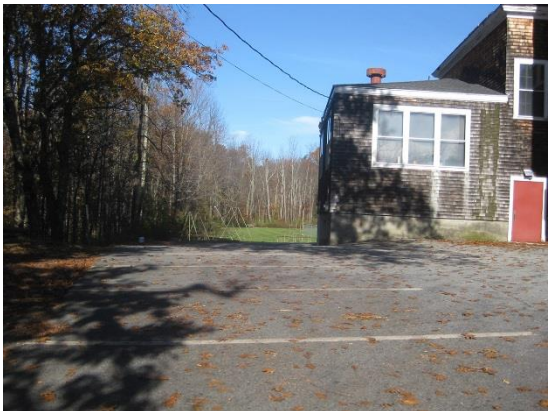
- A
- ADA Parking spaces may need to be modified to bring up to code with any new improvements.

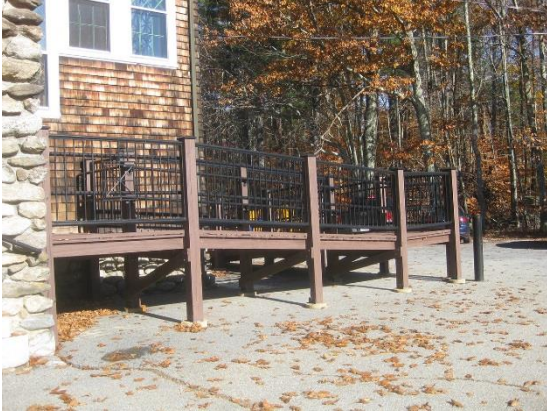
Accessibility Generally

- A ■ Many levels within the building aren't accessible in spite of ADA ramp

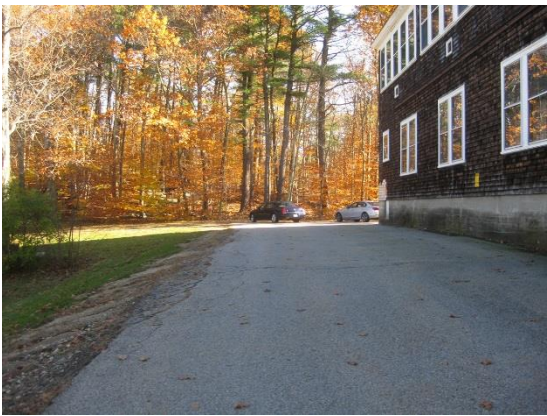
Pavements – Rear of Building

- A ■ Pavements at the rear of the building may need replacement within 0-3 years. Some erosion taking place at the top of slope.

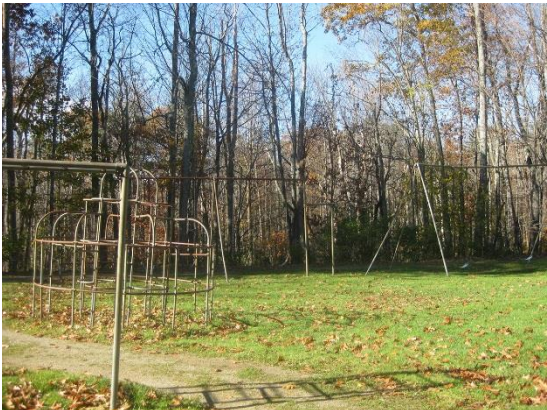
- A ■ Play Equipment no longer meets safety guidelines. Top bar on one of swings is broken.

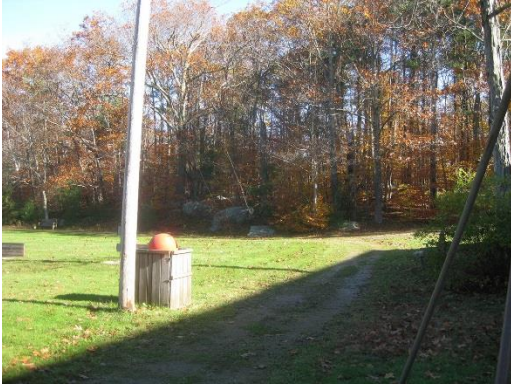
Site Furnishings Generally

- B ■ Fair to poor
- A ■ Many of the site furnishings are nearing the end of life.

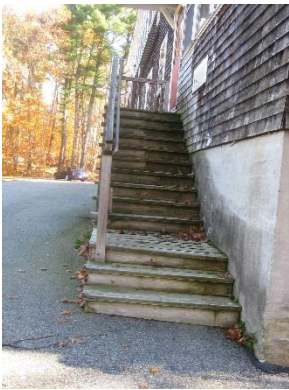
Exterior Stairs

- A ■ Don't meet accessibility requirements for railings

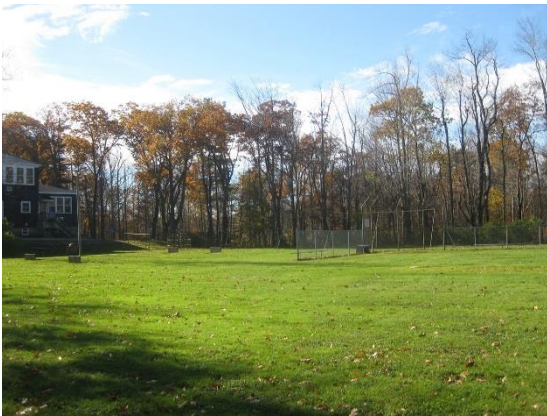
Ball Fields

- C ■ Good Condition overall

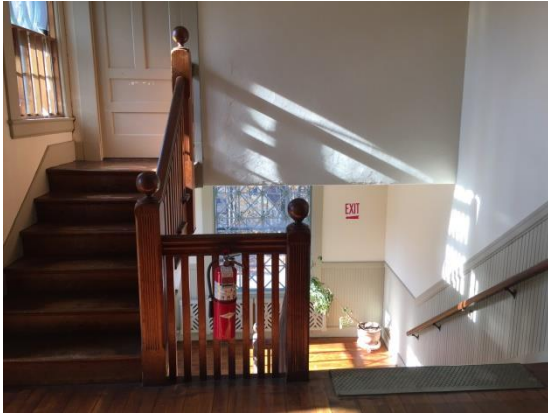
Stairs:

Although the existing stairs do not comply with all of the dimensional requirements for new construction, regardless of the level of renovation they do not have to be brought into full compliance (other than potentially handrails and nosings as discussed below).

- B ■ For a Level 2 renovation stairs within the work area must be enclosed in 1 hour rated construction (IEBC 803.2). Although if the building is fully sprinklered a rated enclosure for the stairs is not required (IEBC 803.2 Exception 5).
- C ■ A Level 3 renovation requires full enclosure of all stairs in 1 hour rated construction at all levels, unless the building is full sprinklered (IEBC 903.1). All stair handrails and nosings must be altered or replaced to comply with 521 CMR (521 CMR 27).

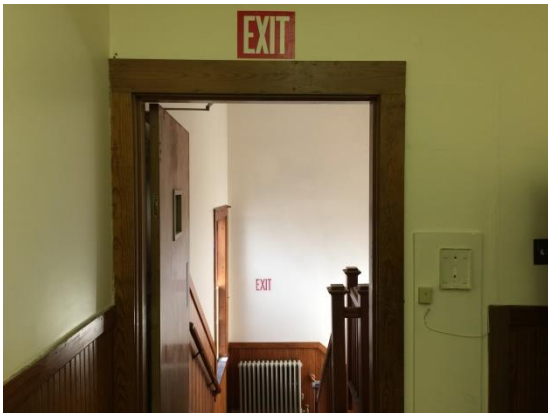
Exit Signs & Emergency Lighting

- B ■ The building includes non-illuminated exit signs throughout. Illuminated exit signs with battery back-up must be provided as required for new construction in any renovated areas.
-
- B ■ Existing emergency lighting fixtures were not tested or evaluated for adequate coverage but may need to be replaced or supplemented in any renovated areas to comply with current code requirements (780 CMR 102.6.4).

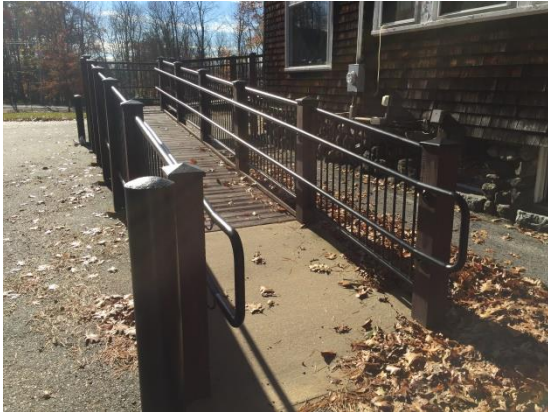
The existing building includes a ramp at the main entrance and accessible toilet room on the first floor. The remainder of the building is generally not accessible.

- B ■ The existing ramp is generally compliant, however the clear width between handrails in some locations is as narrow as 46.5", less than the 48" minimum required (521 CMR 24.3). The side grab bar in the accessible toilet room is also only 36" long, less than the 42" minimum required (521 CMR 30.8).
- C ■ If full compliance is required (due to cost of alterations exceeding 30% of the assessed value) significant alterations would be required including the addition of an elevator or multiple elevators and lifts to provide wheelchair access to all floor levels. All toilet rooms and entrances would also have to be made accessible. The existing Basement toilet rooms are not accessible and the route leading to them includes various changes in level.

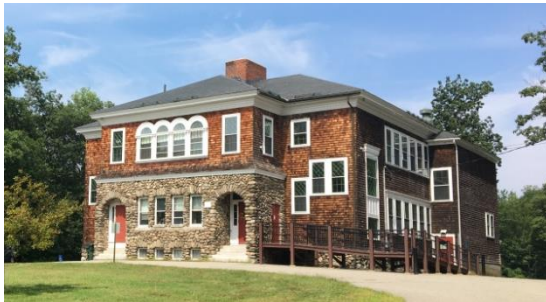
Roof:

- A ■ The roof was repaired in 2012, but no roof barrier was installed - ice dams occur and cause water damage to the windows.
- A ■ Roofing paper has deteriorated and roof is not weather tight

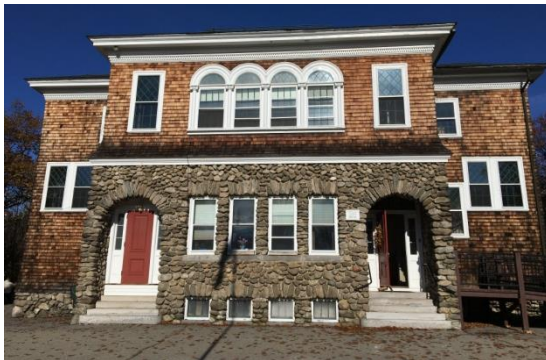
Walls:

- B ■ Areas of original wood shingles are in fair to poor condition. Areas that have recently been repaired look good. Some areas still need repair.
- B ■ South side - wood trim is in fair condition.
- A ■ North side - wood trim is in poor condition.

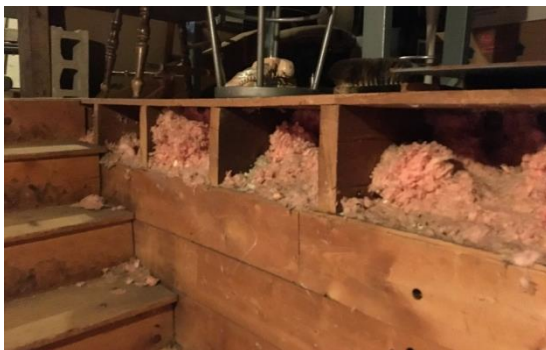
Insulation:

- B ■ Blown in fiberglass. Looks to be in good shape
- A ■ Additional air sealing needed

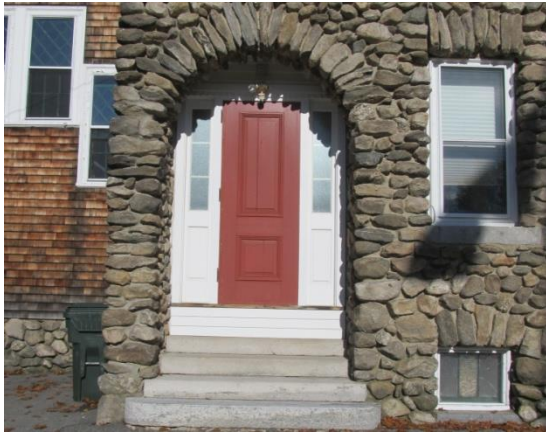
Windows:

- B ■ Fair to poor
- A ■ Windows are drafty, some joints are exposed, many sashes need to be replaced
- B ■ Windows added in 1977 did little for thermal insulation

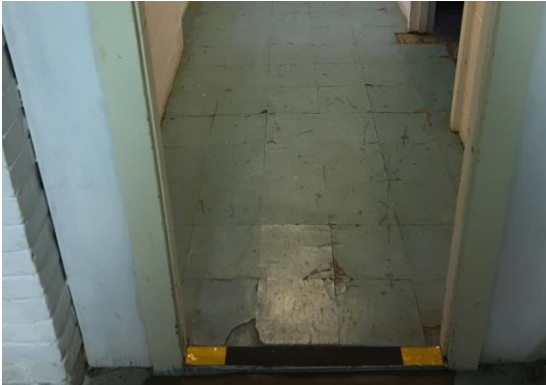
Floors:

- B ■ Fair to poor
- A ■ The floors are uneven in many places, resulting in doors not being square.

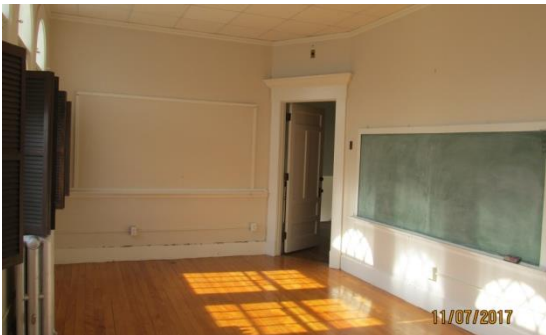
Ceilings:

- B ■ Fair to poor
- A ■ Water damage can be seen on second floor, paint is peeling in several locations due to the original calcimine painted plaster ceilings

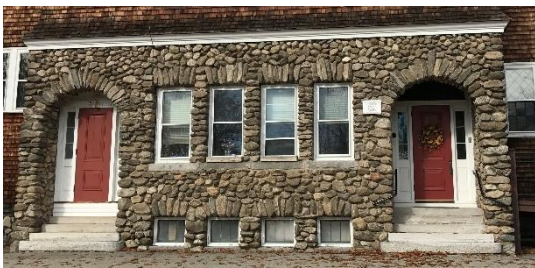
C ■ Scattered masonry deterioration

There are randomly scattered pits and small cracks in mortar joints on fieldstone portion of the exterior. These are from a combination of early workmanship, shrinkage in the original mortar, and, to a greater extent, weathering deterioration. The pits should be filled, all softened mortar cut out and replaced, and the cracked joints should be cut and repointed. Roofing paper has deteriorated and roof is not weather tight.

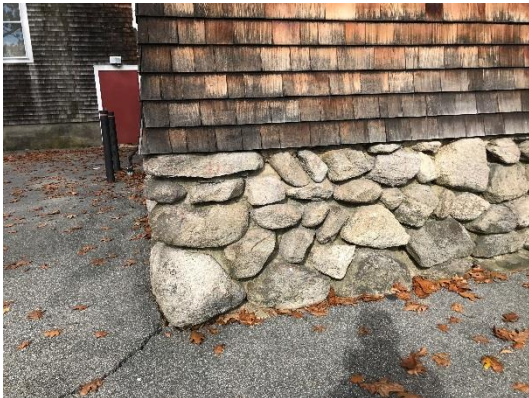
B ■ Loosened stones

There are some loosened stones at the corners of front foundation wall. These should be removed and re-set.

B ■ Crack in stonework

There is a crack running through the stonework directly over right front door arch. Any loose stones along this crack should be removed and re-set, and the crack should be jet cleaned, pointed and injection grouted.

B ■ Chimney damage

There is some weather related joint erosion and some loose bricks at top of main chimney. The loose bricks should be re-set and the eroded joints cut and pointed.

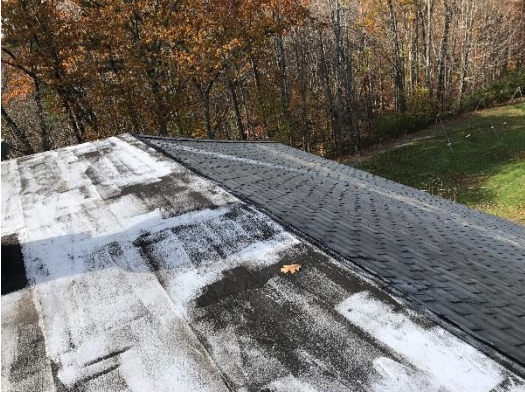
B ■ Sagging roofs

The roof surfaces of the rear addition and science wing sag. The roof framing of the addition is visible from below and appears to be lightly constructed. The framing over the science wing are hidden by finishes but assumed to be lightly constructed as well.

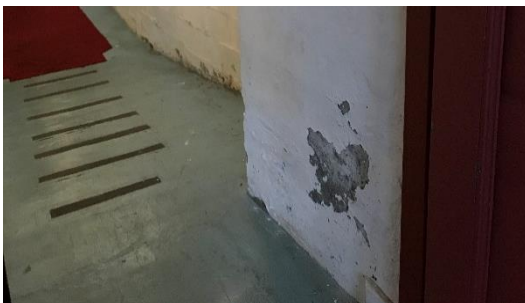
B ■ Basement water damage

The basement wall and ceiling finishes have been damaged by water infiltration at the following locations:

- At the back end of the left side hallway
- At the heads of the repeating basement windows.

Both of these conditions are likely to be from water that has seeped through the windows and wall structures above, since they occur below suspect areas at the first and second floor.

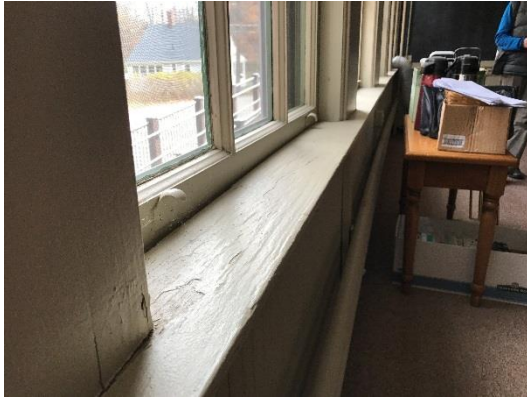
B ■ First and second floor water infiltration

We were told during our site visit that there are frequent ice dams at the building eaves and associated water infiltration at the repeating windows of the first and second floors below the eaves. While no outward sign of significant wall finish damage was visible, other than some staining, the sills

of several of the windows are uneven as the mullions between windows appears to be compressing into them at the left side, first floor. This compression may be caused by normal drying shrinkage in the wood, but could also be caused by hidden rot or at least softening, due to the water saturation.

The framing below the suspect areas should be exposed and inspected, and repaired or replaced if needed.

The ice damming and water leakage should be addressed at the exterior.

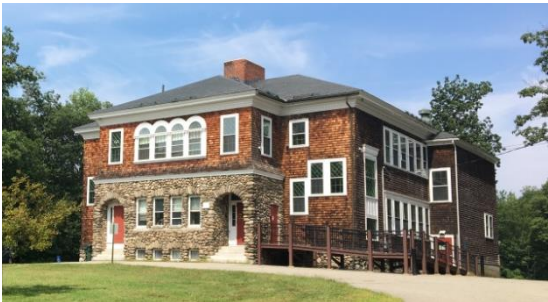
The building does not have an automatic sprinkler system.

In general, Massachusetts General Law M.G.L. c.148, s.26G requires that any existing building over 7,500 square feet that undergoes **major** alterations or building addition must be sprinklered. Examples of major alterations are demolition or reconstruction of existing ceilings or installation of suspended ceilings; removal of sub flooring; demolition and/or reconstruction of walls, doors, or stairways; or removal or relocation of a significant portion of the building’s mechanical or electrical systems. Alterations are considered major when such work affects 33% or more of the building area or when total work (excluding sprinkler installation) is equal to 33% or more of the assessed value of the building.

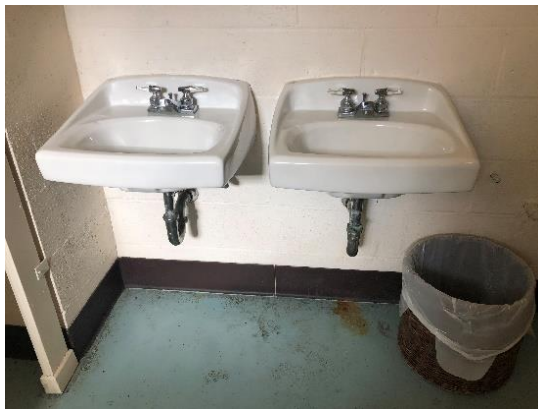
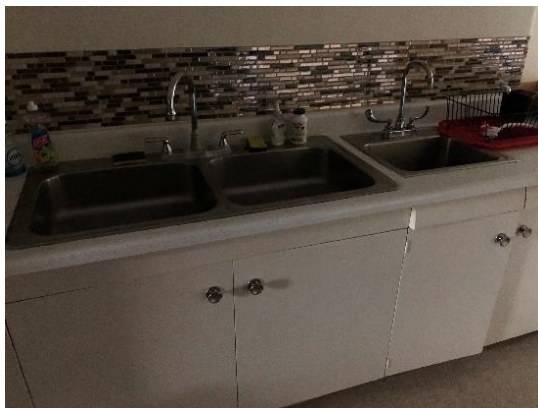
Lavatories are wall hung vitreous china with manual faucets. Lavatories do not have a mixing valve to limit temperature to below 110 deg F.

Basement service sink is generally trap standard mounted, enameled cast iron sink. Faucet is equipped with vacuum breaker.

Sink on Second Floor is out of service.

- A Plumbing fixtures are in poor condition and are not accessible. Recommend replacing all plumbing fixtures.

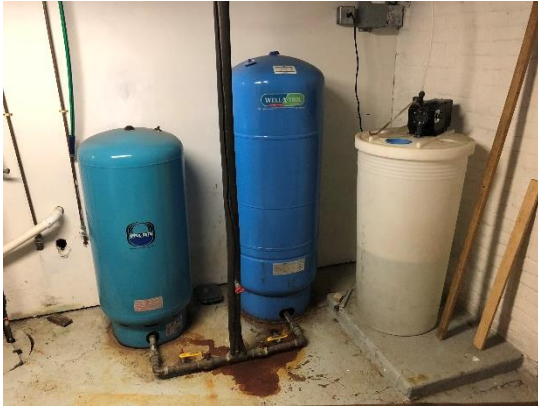
The building is supplied with well water. There are two (2) pressure tanks located in the Basement Corridor. One tank is a Well-X-Trol WX-252 with a volume of 86 gallons. The other tank is Flexcon WR200R with a volume of 62 gallons.

Domestic water piping is copper tubing with sweat joints. The piping is not insulated. The piping and shutoff valves are in poor condition.

- A Provide thermostatic mixing valve and recirculation system on water heater.
- A Provide new domestic water piping throughout.
- A Insulate all domestic water piping.

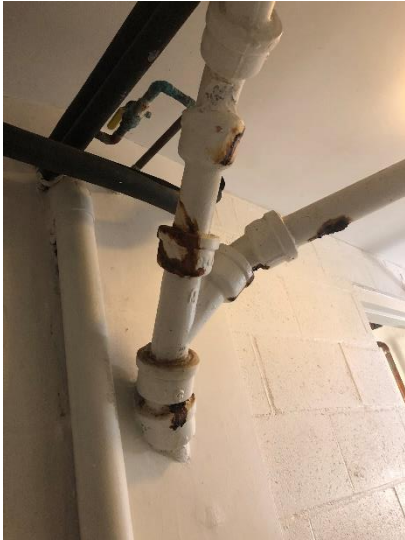
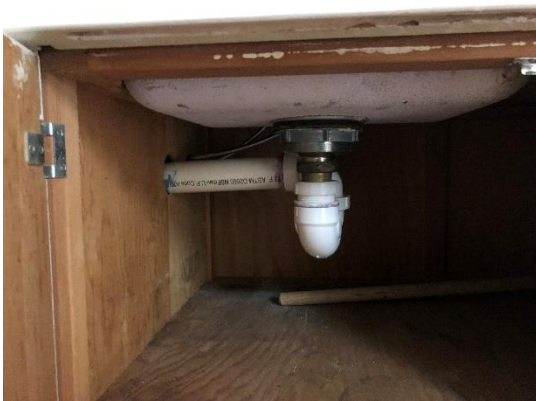
Cast iron is used for sanitary drainage. Smaller pipe sizes appear to be copper.

- A PVC piping is used at some sinks. To be code compliant PVC must be replaced with copper piping.
- A Where visible, the cast iron pipe appears to be in poor condition. Recommend all new cast iron sanitary piping.

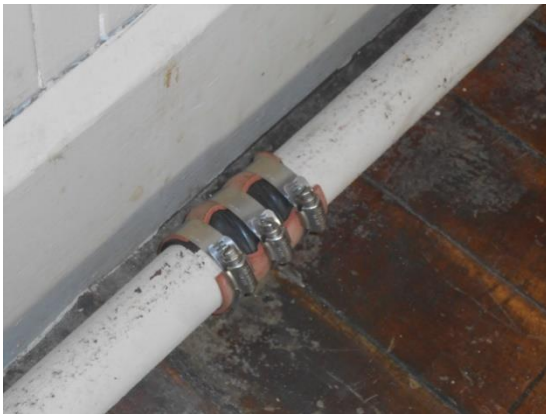
Temporary Piping Repair

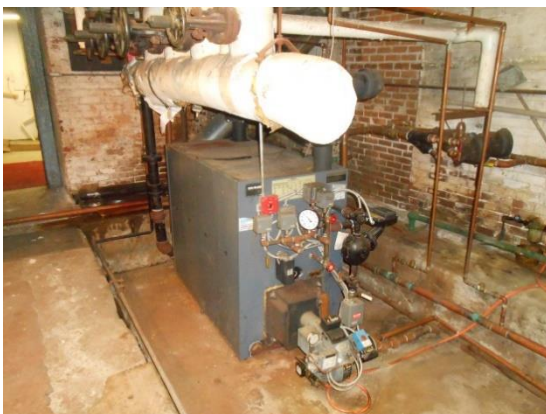
Oil Fired Steam Boiler

There is one oil-fired cast iron steam boiler manufactured by Weil McLain, Model 880 with a gross output capacity of 872 MBH and a net IBR steam output of 654 MBH. The boiler fires #2 fuel oil via a Carlin power burner. The boiler is provided with a dual low water cut-off and all operating and safety controls. Fuel oil is stored in two 275 gallon basement oil tanks. The boiler is vented to a masonry chimney via a single wall galvanized stove pipe. Combustion air is provided by a 34x22 louver in a basement window ducted to a 24x12 open ended duct that terminates 18" AFF. There are three temperature zones in the building controlled by 2-way zone valves at the boiler steam header. The zones consist of original building, addition, and the science labs. Condensate drains by gravity to a Hoffman 50HBFD-B duplex boiler feed unit with 50 gallon condensate receiver with two 1/3 HP pumps rated for 15 GPM at 20 psi. Steam is distributed throughout the building via insulated steel piping. Thumbwheel valves at the radiators can be manually adjusted to control the temperature to each room. These valves appear to be frozen in their current positions, so each room has no way of individually and manually adjusting the heat output of the radiators, for as long as the main 2-way zone valve is open. Some of the classrooms have local 2-way zone valves which are likely locked in the open position.

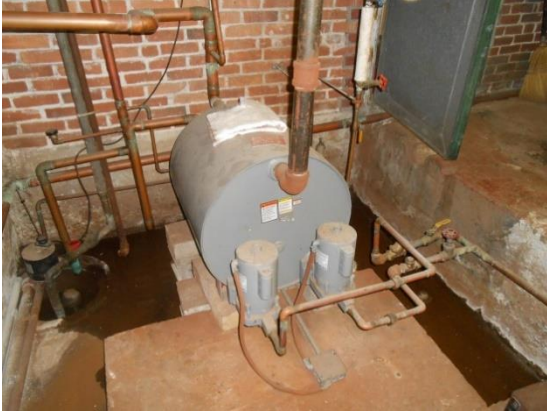
Feedwater Tank

Most of the original section of the building is single pipe steam, as the steam and condensate travel in the same pipe. The addition is 2 pipe steam, as the condensate has its own dedicated piping system. Condensate piping is largely insulated steel piping but is partially copper piping in the boiler room. This copper piping is troublesome, as it is more susceptible to corrosion by hot caustic condensate. On 11-7-17, a pinhole leak in a section of 2" copper condensate piping that drains a steam riser, was leaking a considerable amount of condensate. This section should be immediately replaced. On such a mild day, it appears that condensate was backed up fairly high in the system.

It should be investigated why the condensate is so backed up, as perhaps the strainers at the main F&T traps are plugged. It has been reported that due to the age of the piping system, there have been many condensate leaks throughout the building.

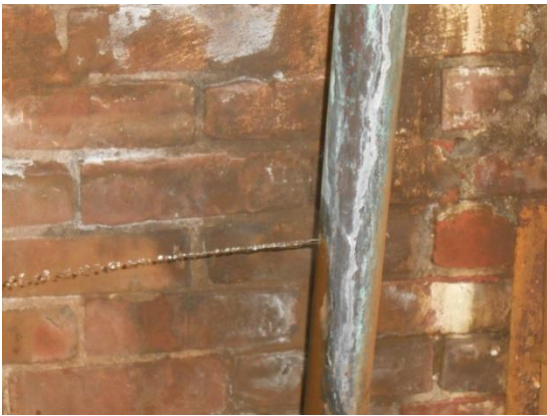
Substantial Pinhole Leak in Copper Condensate Piping

- A ■ Fix leaking copper condensate piping behind boiler.
- A ■ Investigate why condensate is backed up so much, clean strainers before main F&T traps.
- A ■ Keep boiler maintained and regularly blown down to remove solids.
- A ■ Entire heating and ventilating system needs to be replaced.

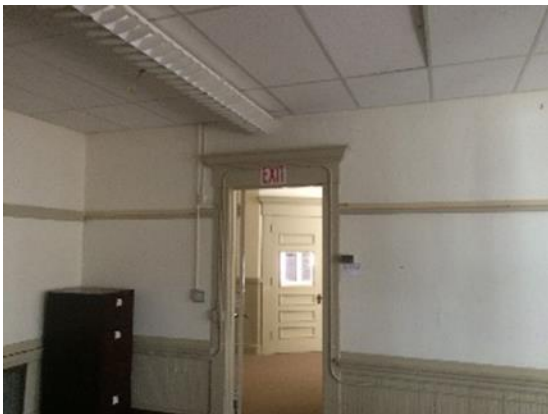
Absence of Egress Lighting:

- A ■ Replace Fire Alarm System, means of egress lighting and signage and add initiating devices: smoke, heat, CO and pull stations per code.

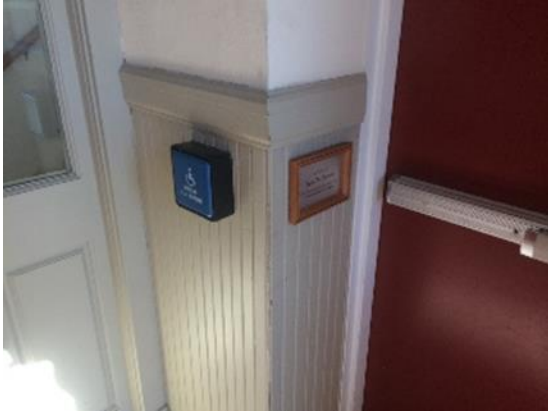
Absence of Pull Stations:

- A ■ Replace Fire Alarm System initiating devices: smoke, heat, CO and pull stations per code.
