# Rehabilitation of Mechanics Hall

A Major Qualifying Project By

Mechanics Hall is an historic building built in 1852 in Princeton, Massachusetts. The project goal was to develop a plan to bring Mechanics Hall into compliance with current building code requirements. A field inspection was performed to gather data used to develop a Building Information Model. Due to the extensive use of building code, a Code Review was developed, along with a design and cost estimate for two proposed uses. The results were presented to the Friends of Mechanics Hall.

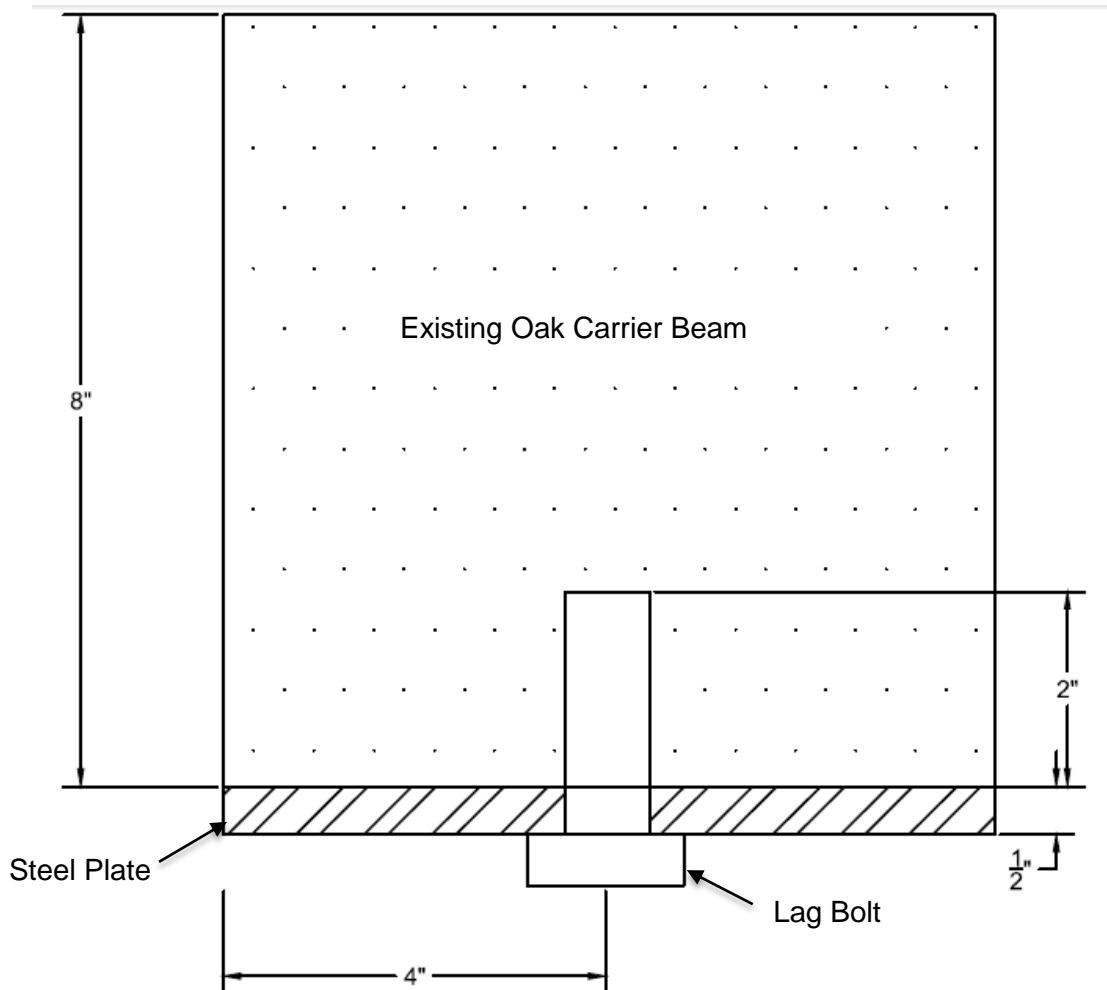
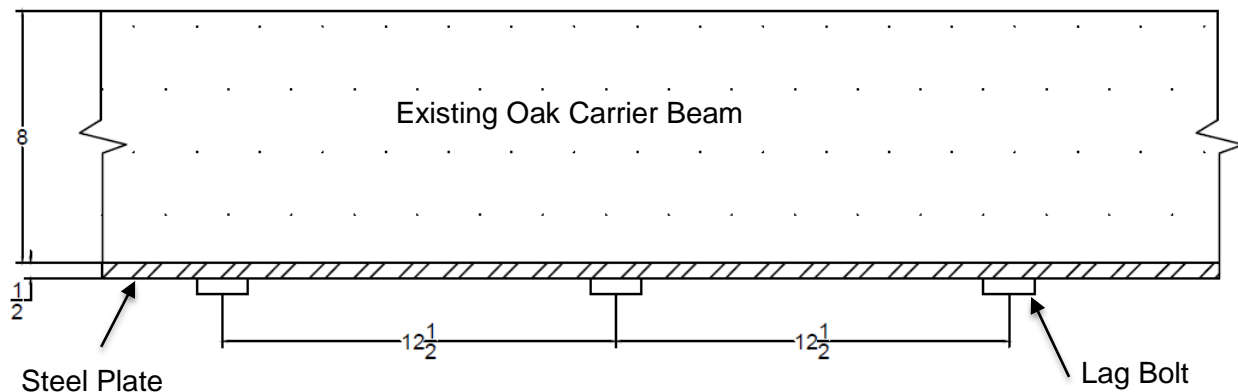
Figure 29: Composite Beam Section View

The carrier beams were determined to fail primarily in bending and deflection. Because the beams are attached to the floor deck above, and because the joists are flush with the face of the beams, the decision was made to reinforce the existing beams rather than replace them. This will allow the current joists that do not need replacing to remain in place.

To adequately reinforce the beam, a steel plate should be bolted to the bottom of the beams. The cross section should be 8 inches wide by one half inch in depth, and the material should be grade A36 Steel, as seen in Figure 29. The plate will be secured to the beam by 7/8" diameter lag bolts spaced every 12.5" on center, as depicted in Figure 30. The steel sheets will require 15/16 inch diameter holes to allow for adequate space for the lag bolts.

The cross section for this beam was designed using the method of composite sections, as described in Section 2.2.2.2. The calculations for this design can be found in Appendix F.

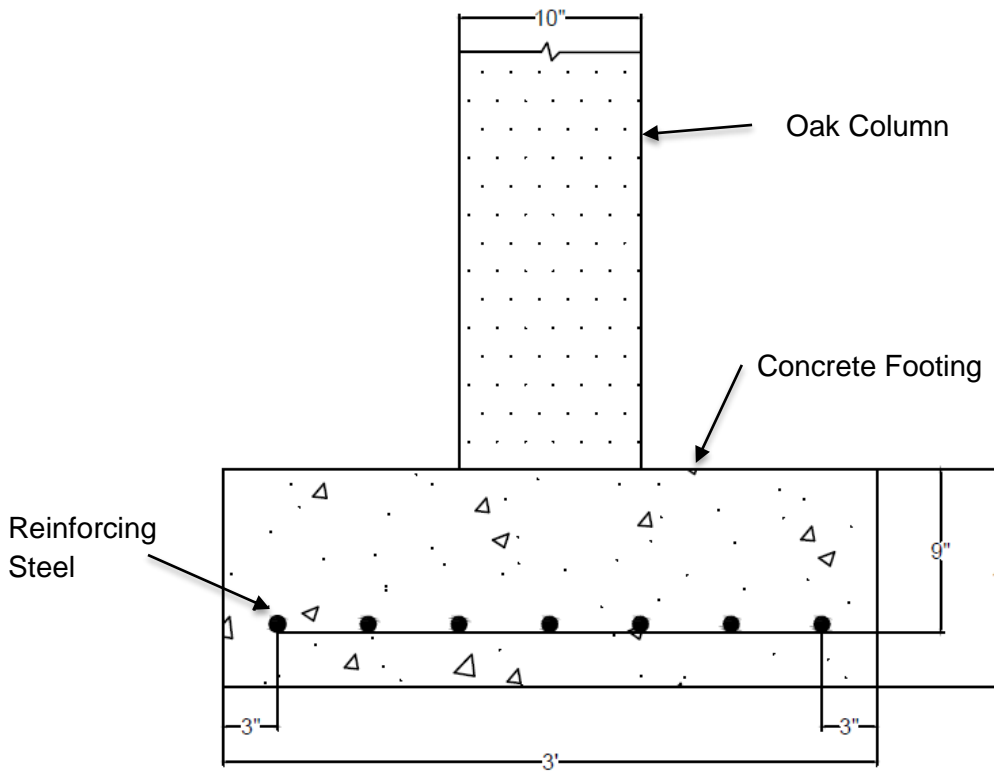
Figure 31: Column and Footing Elevation View

The four wooden support columns have sustained damage as identified in Section 4.2.3 and can no longer carry the required load. The footings for these columns are also inadequate. To solve these issues, the old columns should be removed and replaced, and new concrete footings for the columns should be poured.

The replacement columns should be square Northern Red Oak beams with a 10" x 10" cross section. These columns will have a larger cross sectional area than the existing columns, which will allow them to support the required loads. At the same time, the dimensions are similar to the existing structural members, and will allow for easy installation. It is important to note that these given dimensions are exact measurements, not nominal. When ordering a 10x10 timber beam, the actual dimensions will be less than 10" x 10". Installing a nominal 11x11 may be necessary to provide the required cross sectional area. Figure 31 depicts the base of the new column as it meets the new footing.

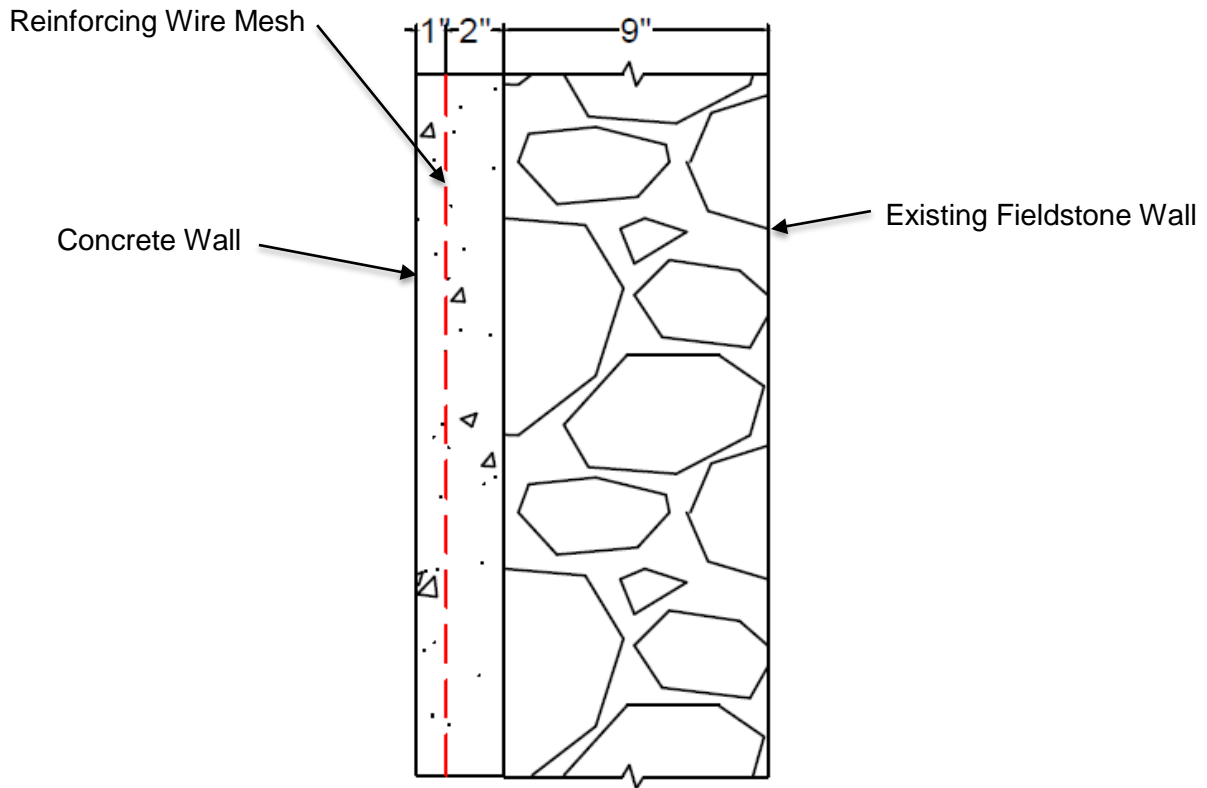
Figure 33: Section View of the Reinforcing Foundation Wall

It was found that the significant water damage found in the basement was due to poor drainage and holes in the foundation wall. A French Drain system was proposed to seal off the holes in the foundation wall and redirect the water out of the basement. To increase the accessibility of the building, it was recommended that a landing and a handicapped rail should be installed on the staircase. This will increase the accessibility of Mechanics Hall, but there will still be accessibility issues. For example, certain measures such as handicapped restrooms are impractical due to the nature of the building. While not every aspect of accessibility can be met, a building can still be approved by the code official if an effort is made to make the building as accessible as possible. The Princeton bylaws are vague regarding the requirements for parking. Building expansions in a business district in Princeton must be approved by the town planning board.

Every hole in the foundation must be filled with 3000 psi concrete. A reinforced concrete wall should be cast on the inside of the field stone. The wall should be 3" thick, and should be reinforced with a 6 X 6-W4.0 X 4.0 welded wire reinforcement placed no closer than ¾" from the interior face of the wall, and no closer than 1.5" from the field stone. The concrete should fill every gap in the existing foundation wall so adequate transfer of stresses occur. The concrete should be cast monolithically. The 3 inches of concrete will provide enough cover to prevent the reinforcement from corroding. This will provide a full depth foundation wall thickness of 12". The reinforcement

satisfies the requirements specified by IBC 1807.1.6.2. Supporting reasoning and calculations can be found in Appendix F. Figure 33 illustrates a section view of the reinforcing wall acting with the existing foundation. The dotted red line indicates the steel wire mesh placed greater than  $\frac{3}{4}$ " from the basement interior and greater than 1.5" from the existing fieldstone foundation wall.

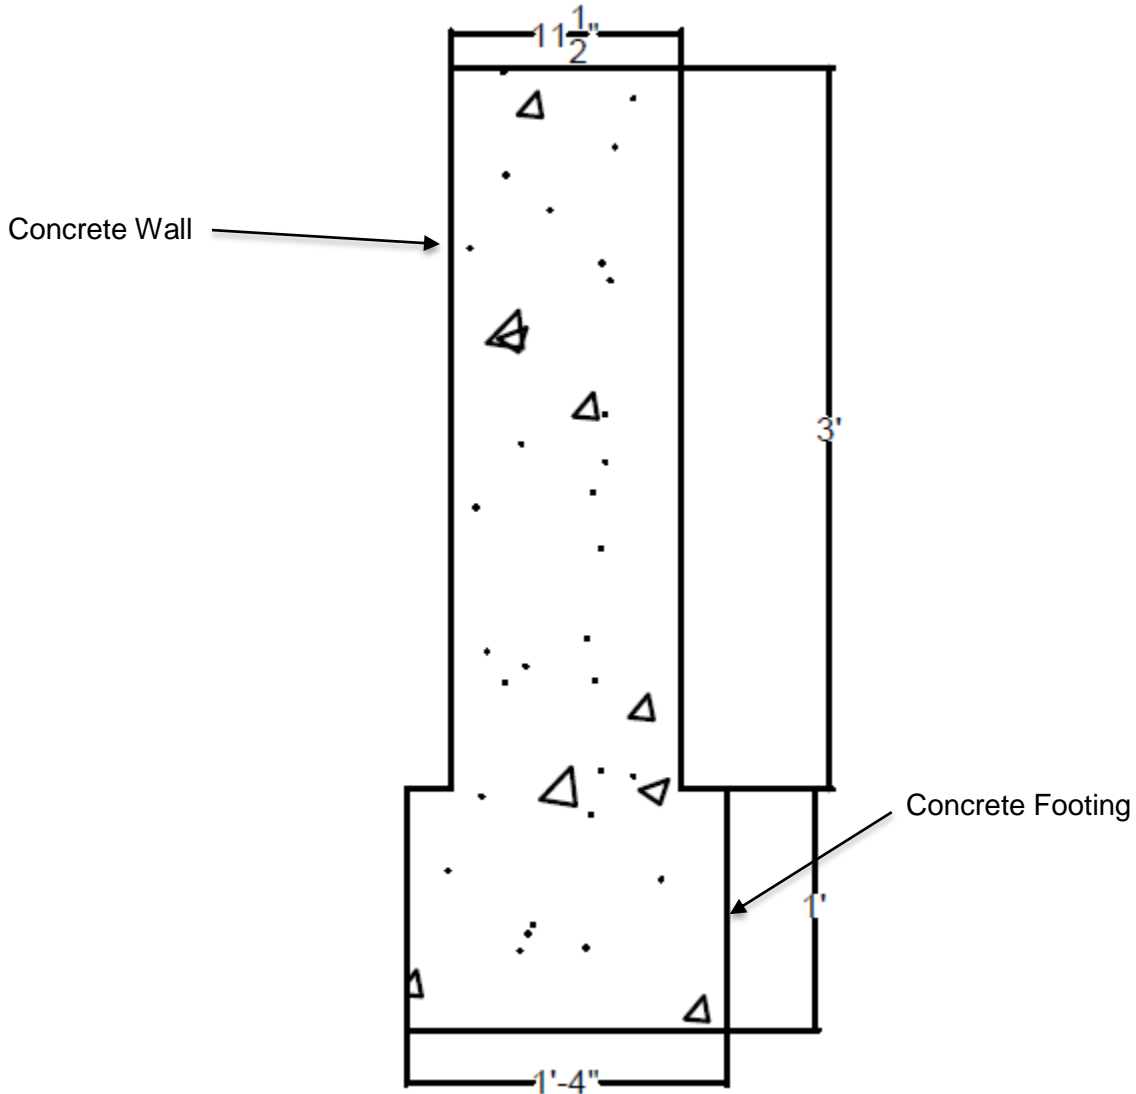
Figure 34: Section View of the Proposed Strip Footing Supporting the Addition.

The joists in the addition were determined to have insufficient strength, as did the carrier beams. The foundation for the entire addition was also inadequate. It was recommended to replace each joist and carrier beam with larger structural members. A concrete strip footing and small foundation wall was designed to support the rear and sides of the addition.

A new foundation for the addition was designed to support the required loads from the first and second floor of the building and to protect the columns and sideboards from moisture and rot. To comply with IBC 1809.5, a concrete wall is required to ensure that the footings for the building are placed below the frost line to prevent frost-heaving. According to *Massachusetts State Building Code* (780 CMR 5403.1.4.1), all footings must extend at least four feet below the existing grade to protect against frost. To do this, the area underneath the addition walls must be excavated to a depth

of 4 feet. Starting at 4 feet below the existing grade, a concrete footing measuring 16" wide by 1 foot thick should be placed. On top of the footing, an 11.5" thick by 3 feet tall concrete wall should be cast. All concrete should be rated at a compressive strength of 3000 psi. No steel reinforcement is required for this foundation. Design calculations can be found in Appendix F. A section view of the proposed wall and footing can be seen in Figure 34.
