PRINCETON PUBLIC BUILDINGS FACILITIES ASSESSMENT

Princeton, Massachusetts

FINAL REPORT

April 2015

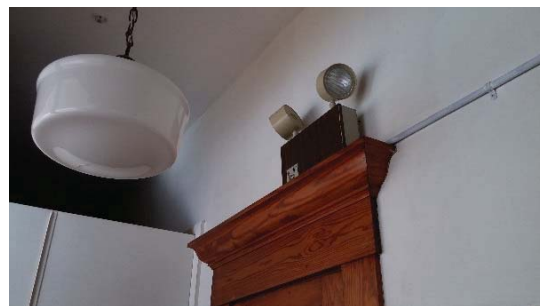
Emergency Egress Lighting

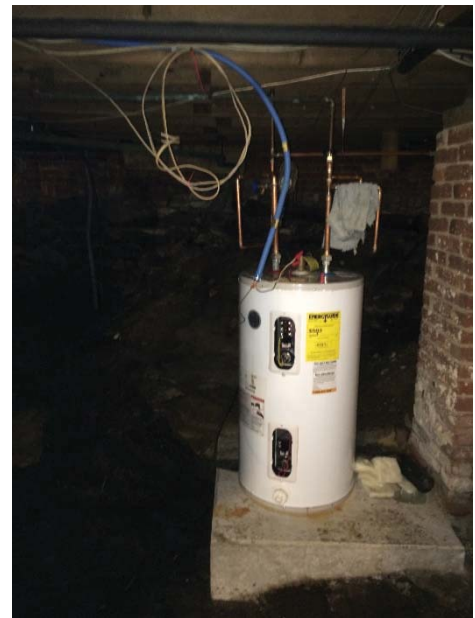
Photo 2 Hot Water Heater

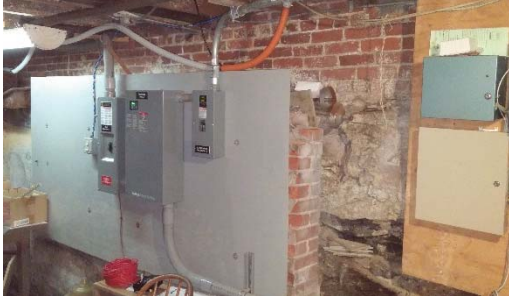
Service Entrance Equipment – 1

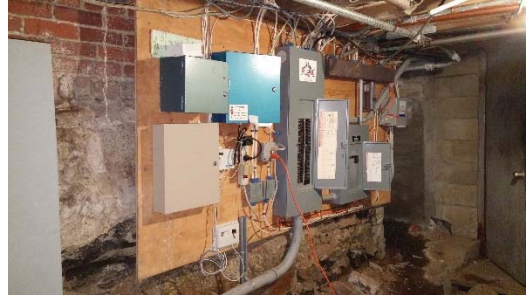
Service Entrance Equipment – 2

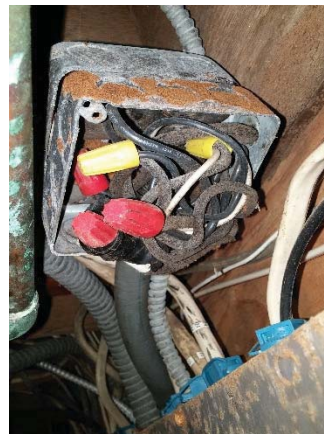
Junction Box / Wiring Sample

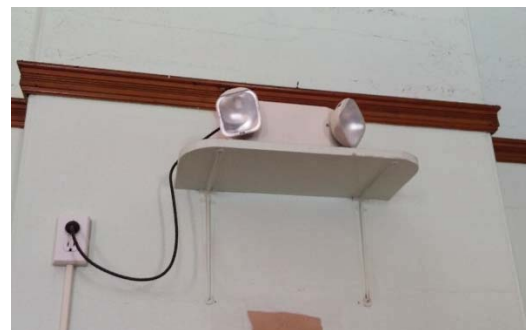
Emergency Egress Lighting

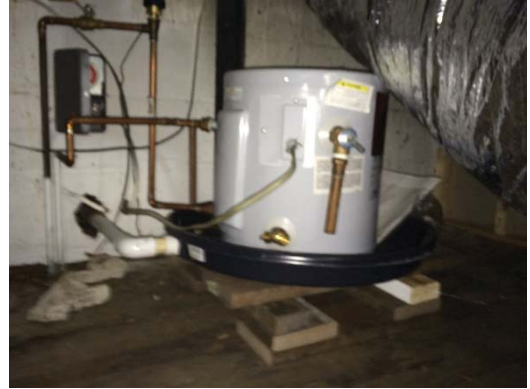
Photo 2: Hot Water Heater

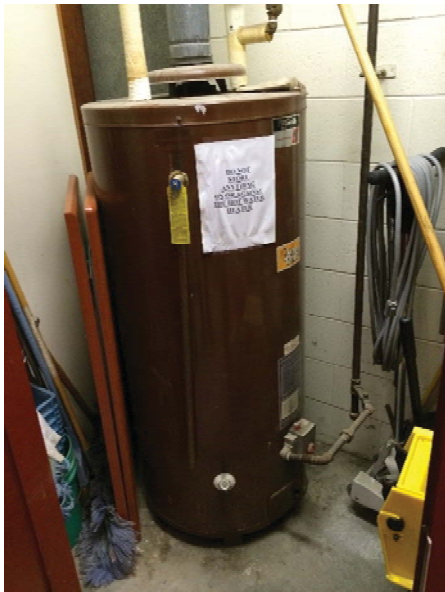
Photo 3: Hot Water Heater

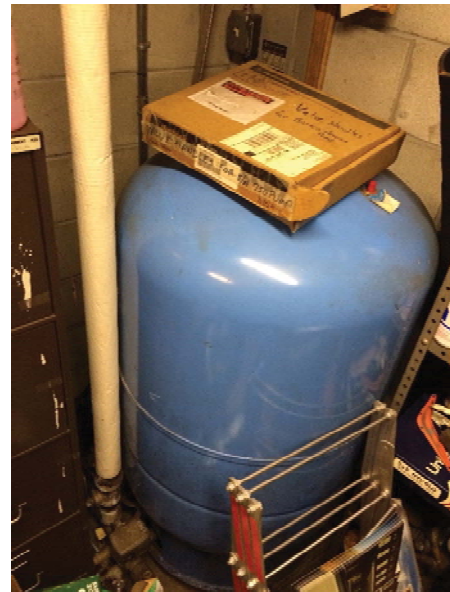
Photo 4: Well Pump Tank

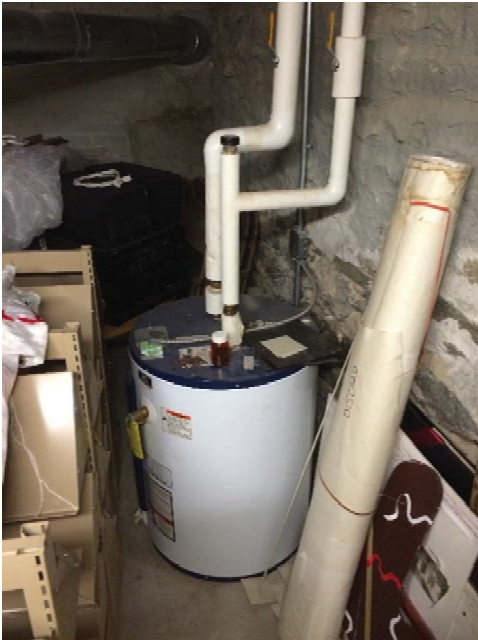
Photo 3: Hot Water Heater

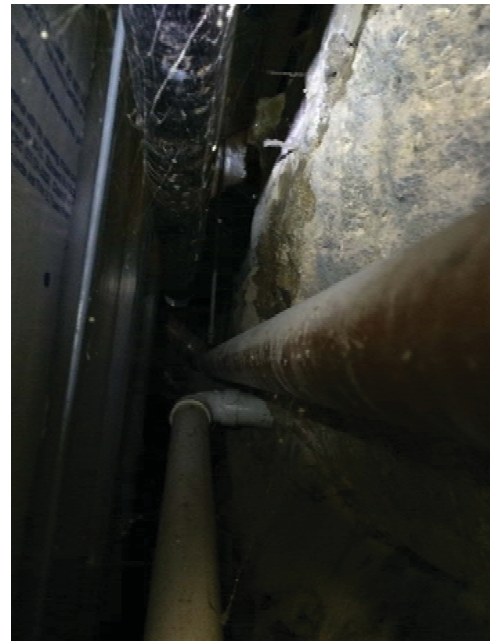
Photo 6: Piping in Cavity

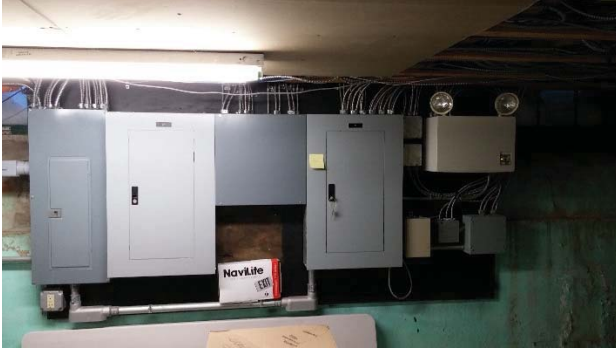
Service Entrance Equipment – Normal

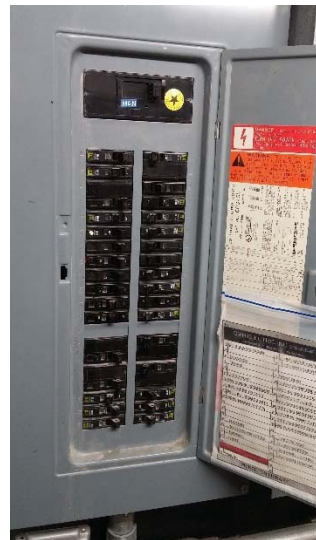
Main Distribution Panel

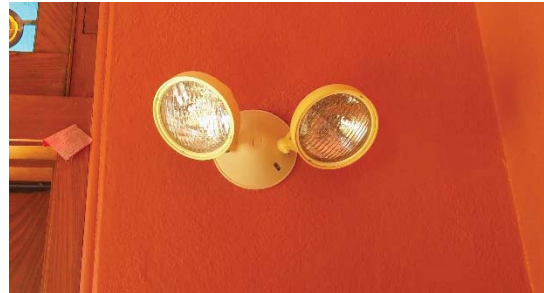
Emergency Egress Lighting

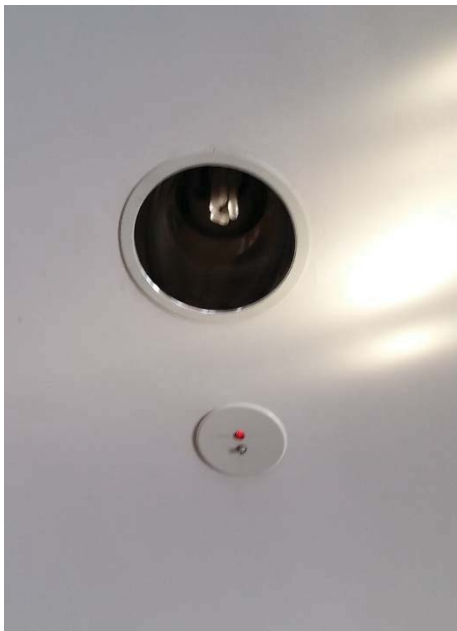
Emergency Egress Lighting

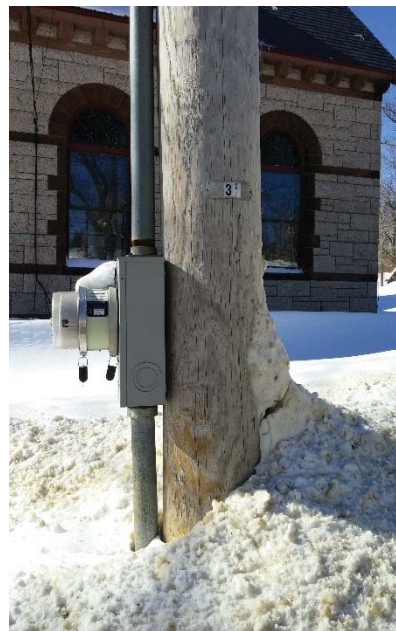
Meter Socket on Utility Pole
