PRINCETON PUBLIC BUILDINGS FACILITIES ASSESSMENT

Princeton, Massachusetts

FINAL REPORT

April 2015

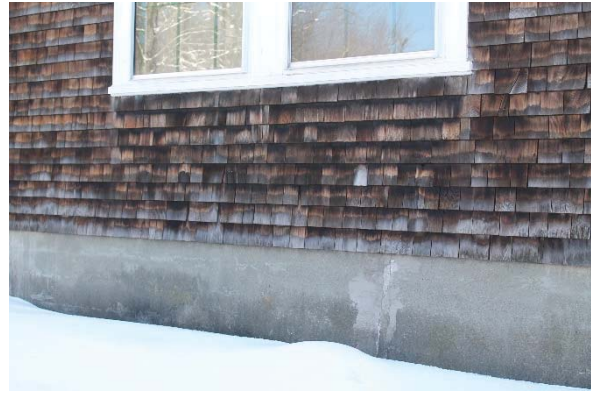
Photo No. 2

Wall Condition: Wood shingles are Fair to poor. (Photo No's. 2, 3) Exterior trim is in fair condition on the south façade (Photo 4) and poor on the north side (Photo 5).

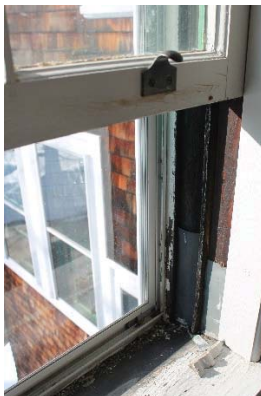
Photo No. 7

Window Conditions: Fair to poor. Some sash are in rough shape with open joints and various attempts at repairs. (Photo No. 7) The windows are drafty. The storm windows were added in 1977 and they actually provide little thermal isolation (Photo 8).

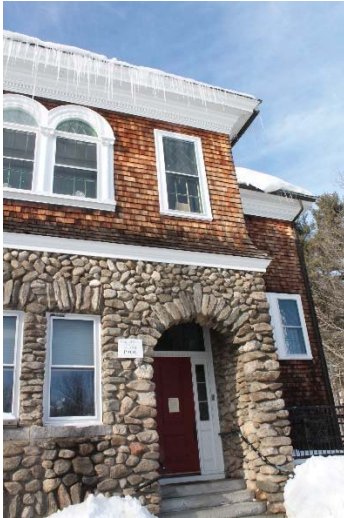
Photo No. 9

Door Types(s): Entry door on the southeast corner is a wood panel door, probably original. (Photo No. 9) The original entry door on the southwest corner has been modified as a non-operable door and moved forward so that the recess is not equal to the door on the southeast (Photo No. 10) An accessible toilet was installed in the space behind the door. (See the narrative on the handicap toilet). There is a new door metal flush door with a narrow lite at the head of the ramp to the front entry lobby (Photo No. 11). There is one with a lite on the west side and one solid metal door on the east side for egress from the gymnasium (photo No. 12). There is a third metal door at the basement level on the west side which is an egress from the kitchen with a large lite above the mid-rail. (Photo No. 13)

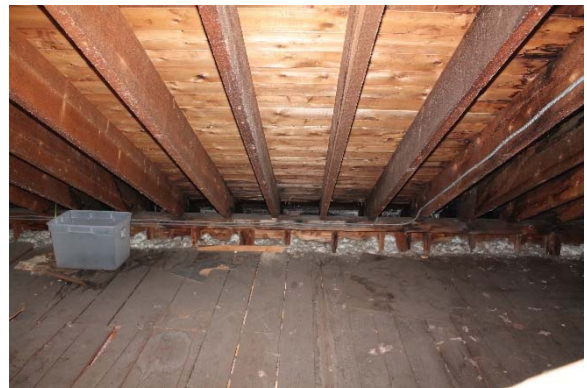
Photo No. 14

over the years and is no longer keeps the roof weathertight. There is some foam insulation at the eaves in the attic (Photo No. 14), but there are ice dams (see below).

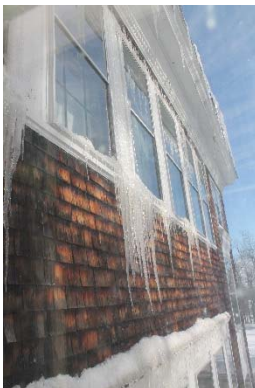
Photo No. 15

Other Ext. Issues: There are severe ice dams. (Photo No. 15) It appears that most of the resulting damage is to the windows, although there are ceilings on the top floor that show signs of water stains.

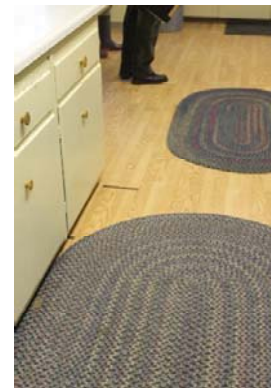
Photo No. 16

Floor(s): Wood floors on the upper levels with carpet in most of the rooms. The gym floor and parts of the original basement is wood. There is wood veneer tile in the kitchen and bare concrete in the basement utility spaces. (Photo 16)

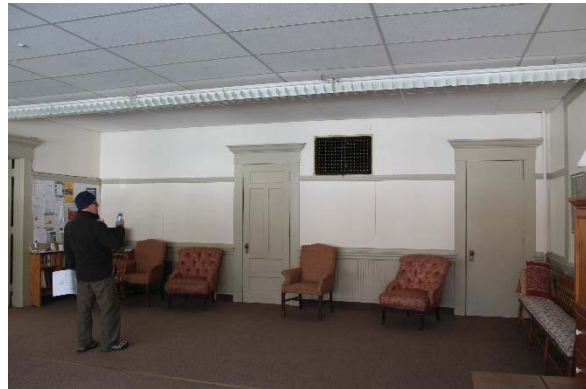
Photo No. 18

Wall Types(s): Original plaster and wainscoting in the original building. The gymnasium has a stucco plaster finish over the concrete wall for the first 7' or so on the north wall and wood wainscoting of the same height on the remaining walls. The upper walls are covered with painted celatex board (Photo 18). There are some miscellaneous painted CMU walls in the basement as well.

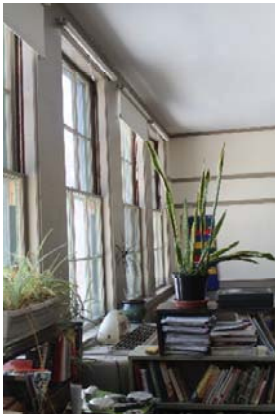
Photo No. 19

Wall Conditions: Good to fair, inasmuch as they have been well maintained. (Photo No. 19).

Ceiling Types(s): Lay-in acoustic tile (see Photo No. 19) and some original plaster ceilings (Photo No. 20).

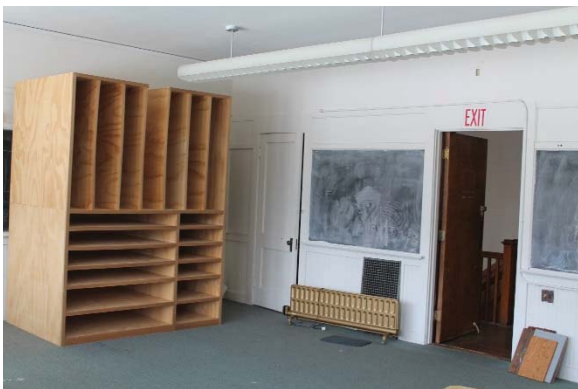
Photo No. 22

Doors: Mostly original panel doors. (Photo No. 22) Some newer flush wooden doors. (Photo No. 23)

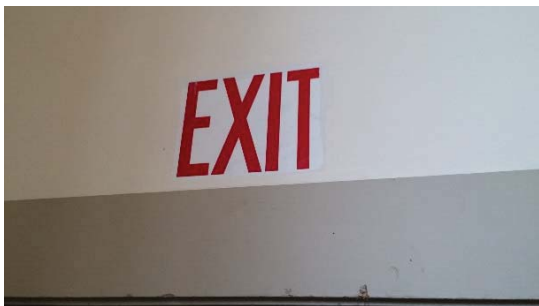
Non-Illuminated Exit Signage

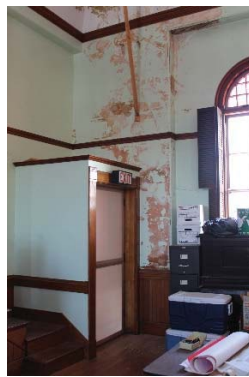
Photo No. 11

Wall Types(s): First Floor-Plaster with wood wainscoting. Interior partitions are believed to be wood stud walls. (Photo No. 11)

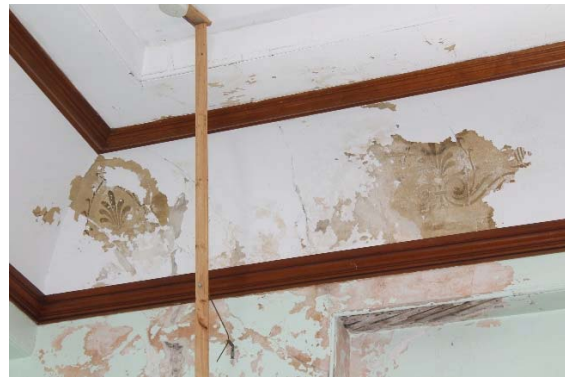
Photo No. 12

Second Floor-Plaster with wood wainscoting. (Photo No. 12)

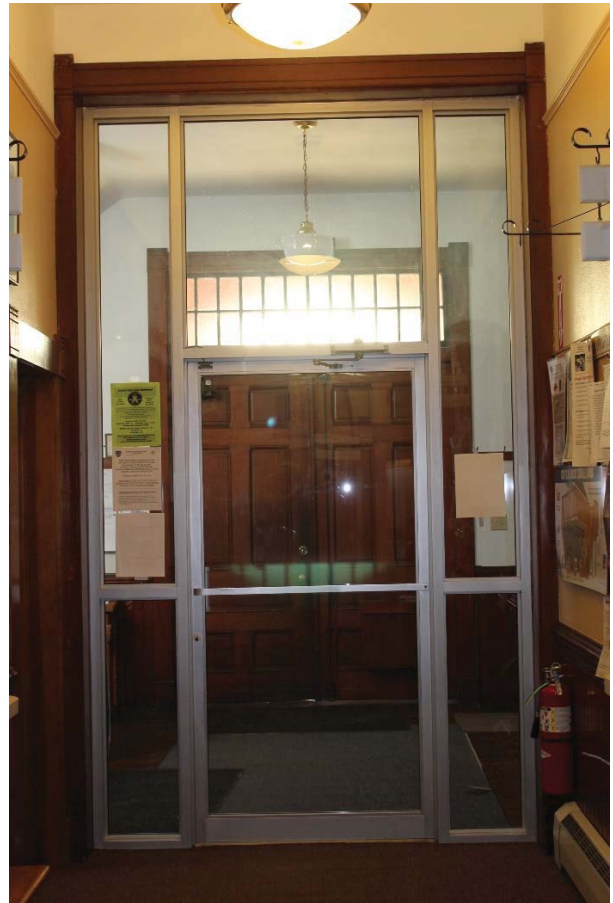
Photo No. 16

Doors: Many of the original doors exist. On the first floor they are in decent shape, although the hardware is non-ADA-compliant. (Photo No. 16) There are some newer flush doors that do not fit historically and the hardware is non-ADA compliant. The aluminum storefront at the entry is also not historically compatible (Photo No. 17)

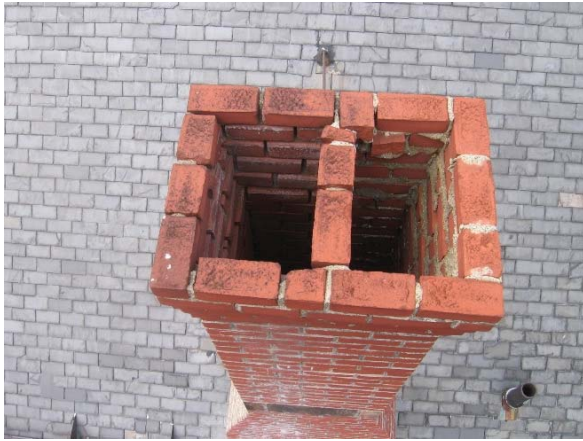
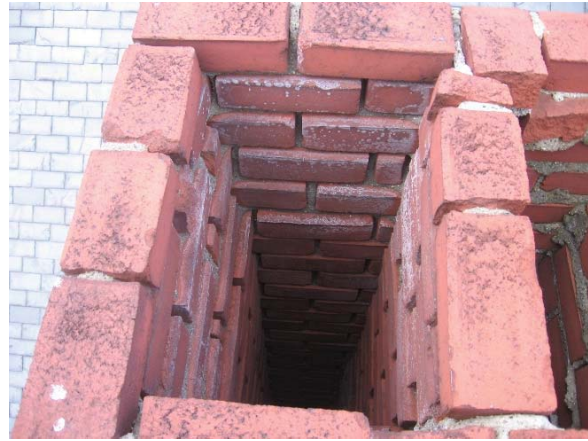
Brick flue is un-lined and not weather-protected:

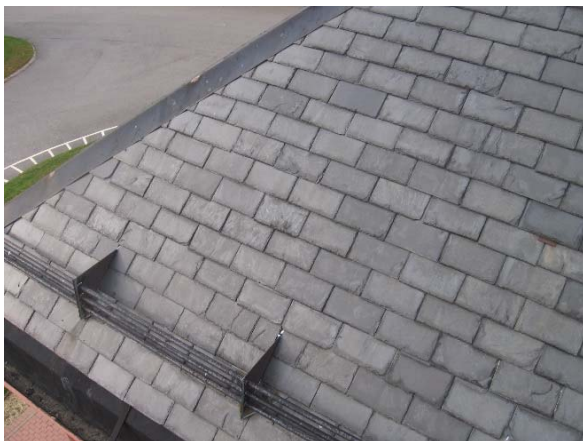
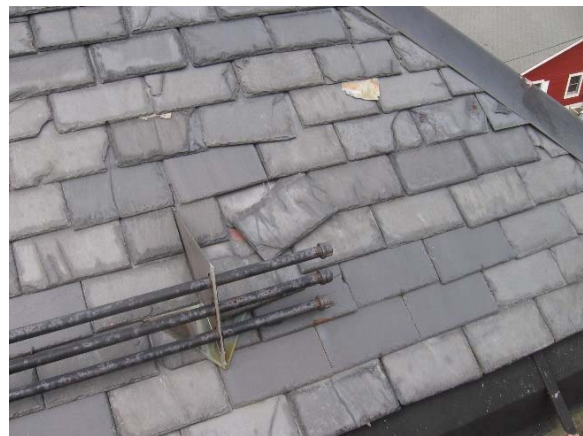
Insufficient snow guards:

The snow guards are not continuous and they should be placed in multiple rows further up the roof slope in order to keep the snow in place without falling to the ground.

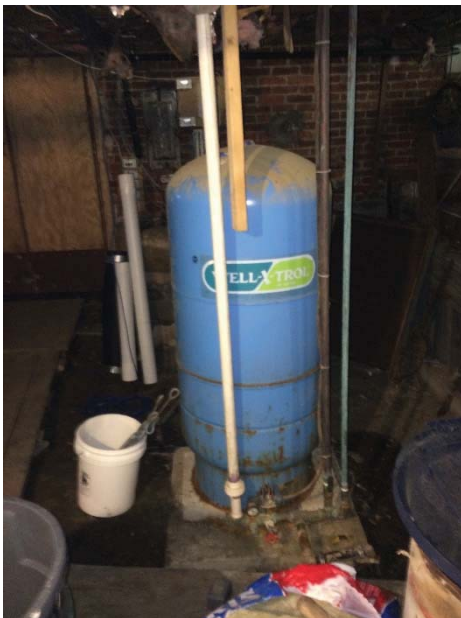
Photo 1: Well Pump

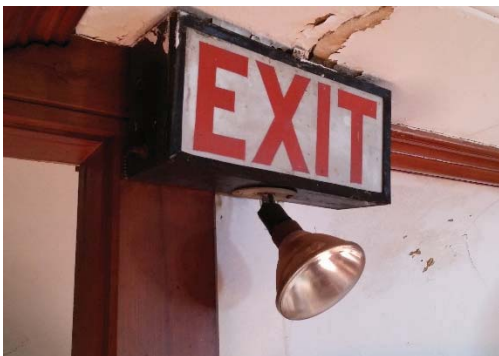
Exit Sign

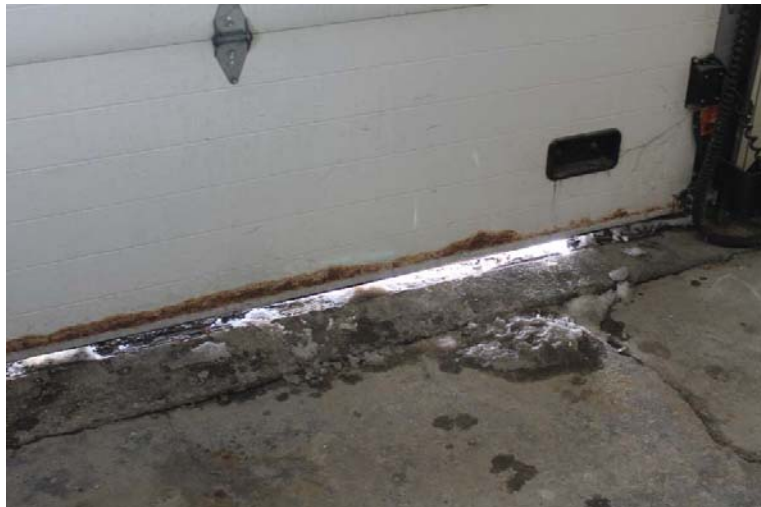
Photo No. 11

Door Conditions: The egress door interior stairway does not close properly. There is daylight between the metal frame and the wall (Photo No. 11). The door has been hard to close. The overhead doors have a gap at the floor and are rusting at the sills. (Photo No. 12)

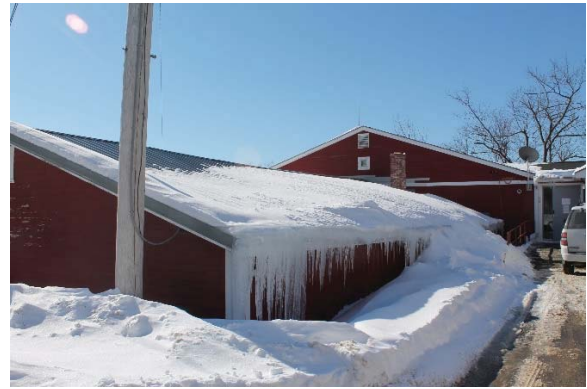
Photo No. 13

Roof Type(s): Asphalt shingles on police station, metal roof on fire station with aluminum gutters and leaders. There is batt insulation at the bottom cords of the roof trusses. (Photo No. 13)

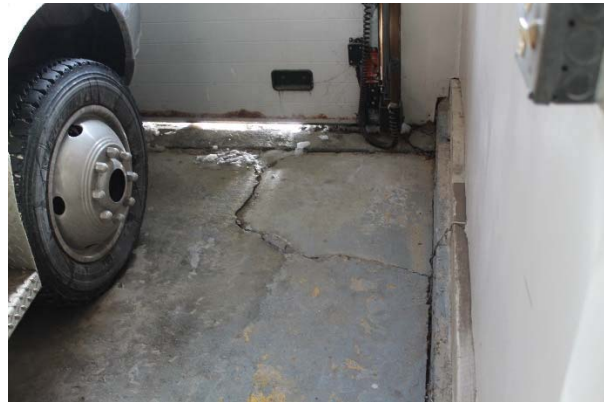
Photo No. 20

Floor Conditions: The VCT is in fair condition, although the joints are opening up in some locations (Photo No. 20). There is a crack in the tiles in the rear of the police office area near the kitchen. The crack is minor. The concrete slabs on grade are cracking in many places (Photo No. 21). The structural slab on the sally port garage bay is allowing water to penetrate to the basement space below. While this does not appear to be a structural issue (See structural report) it is causing damage to the CMU wall below. (Photo No. 22)

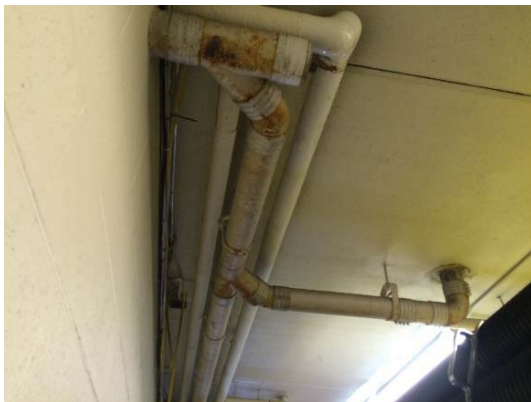
It was reported that the underground sanitary piping is slow draining and has had numerous blockages.

Photo 9: Plumbing Piping

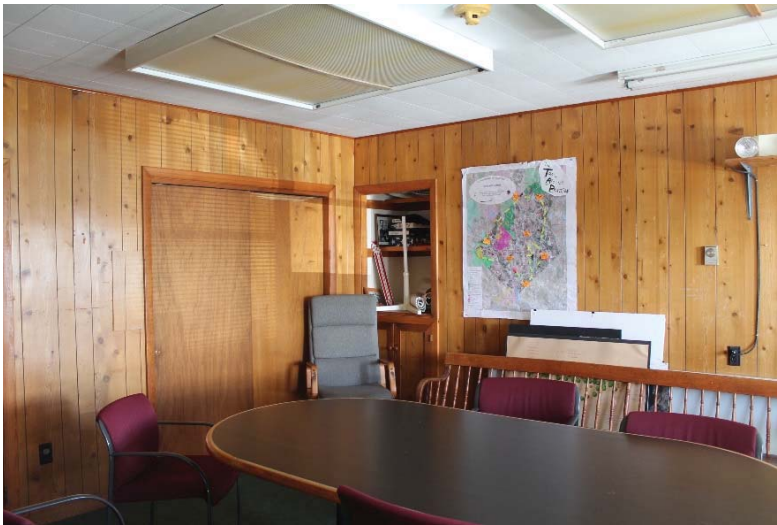
Photo No. 9

Ceiling Types(s): Acoustic tile with a lay-in grid in the meeting room (Photo No. 9) and direct glue in the office and conference area (Photo No. 11). Unfinished homosote board in the storage area (Photo No. 12).

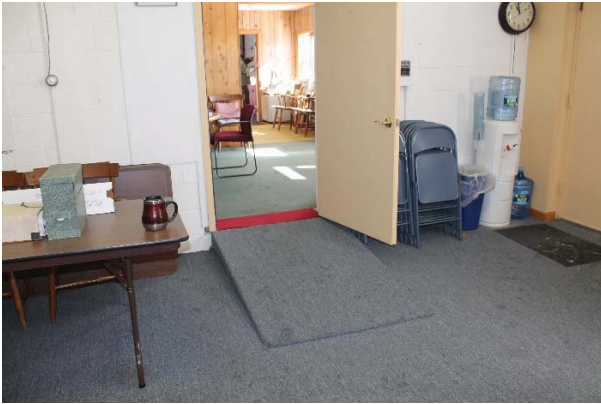
Photo No. 13

HCP Access: There are two ramps from the large meeting room. One is for access to the handicapped toilet (Photo No. 13) and the second is to bridge the 6" + grade change between the meeting room and the conference room (Photo No. 14). The second ramp is not MAAB compliant. There is no landing at the top and there are no rails. The ramp to the toilet room should have a rail on the wall side. The pitch on ramp to the toilet appears to meet code. The second ramp may not. It should be checked.

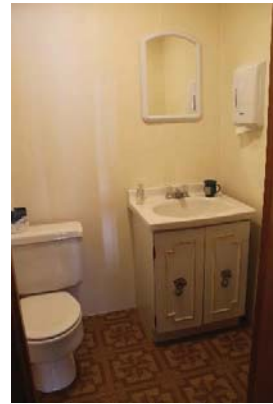
Photo No. 15

Accessible Toilets: One Accessible unisex toilet room (Photo No. 15). The lavatory does not meet MAAB or ADA requirements for legroom (Photo No. 16).

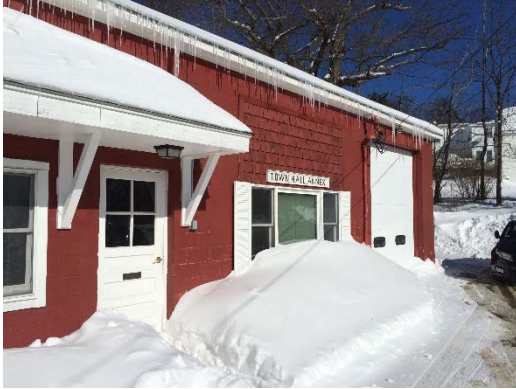
Photo 1: Building Construction

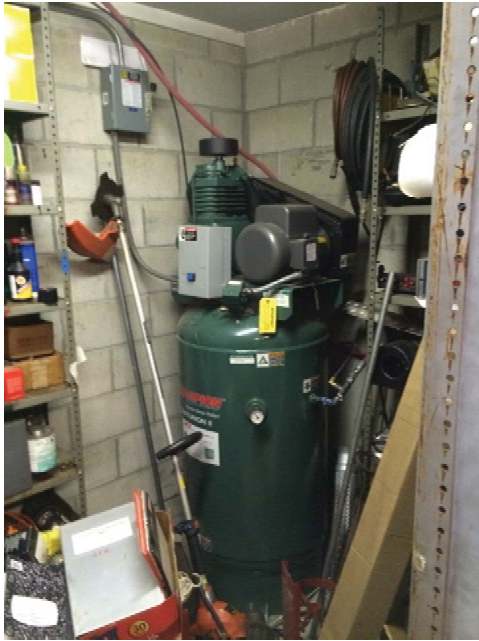
Photo 11: Air Compressor

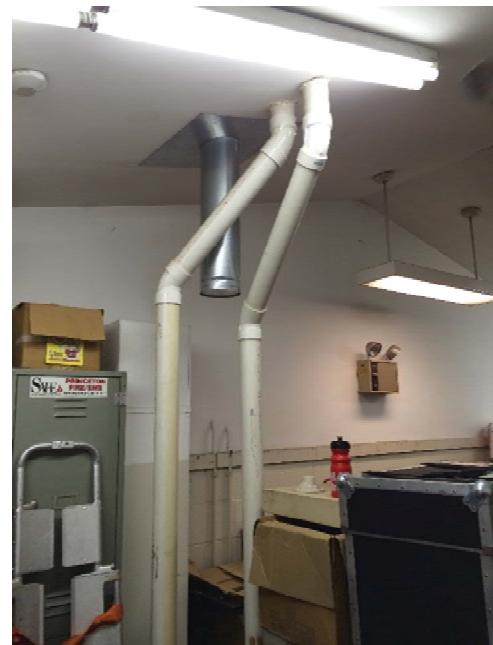
Photo 12: Sanitary Piping

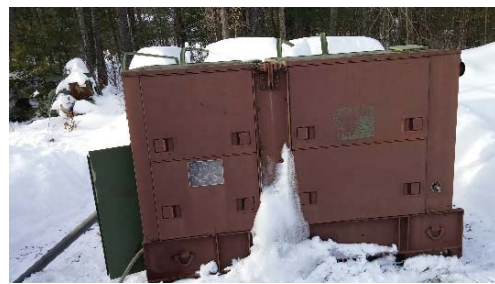
Generator

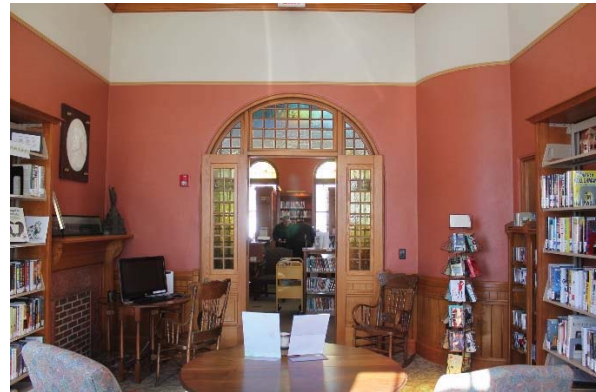
Photo No. 11

Wall Types(s): Original plaster on furring and lath on the original walls on first and second floors. Steel studs and gypsum wall board on new partitions. (Photo No. 11)

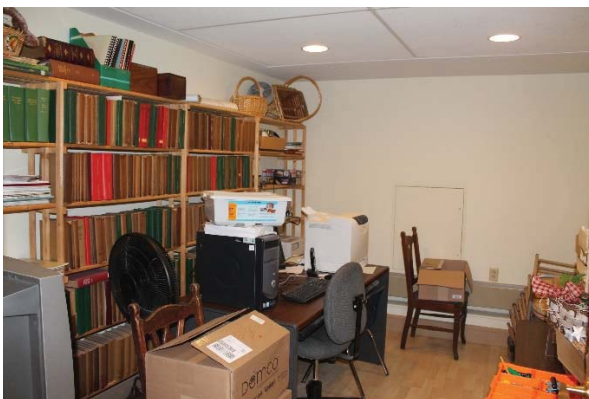
Photo No. 12

Ceiling Types(s): ATC (Photo No. 12) and gypsum board (Photo No. 13) in basement, combination of original vaulted plaster ceilings and new gypsum board on the main and upper level.

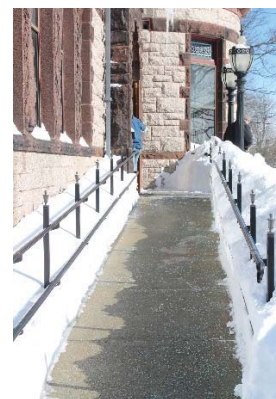
Photo No. 14

HCP Access: Building is fully accessible with an exterior ramp that leads to the main entrance. (Photo No. 14)

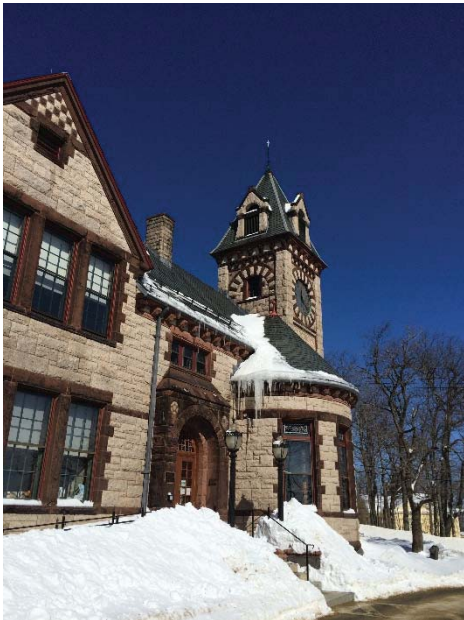
Photo 1: Building Construction

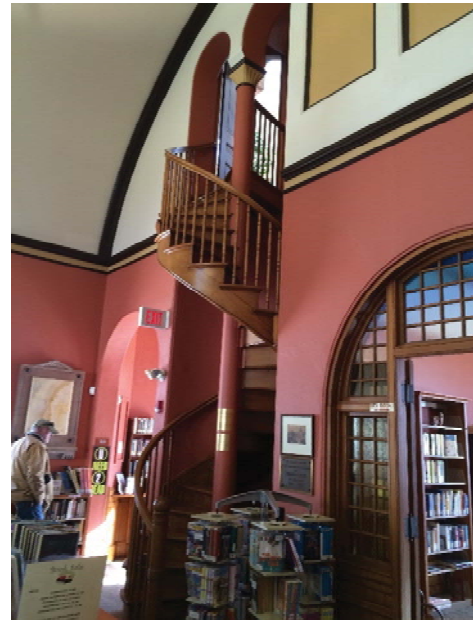
Photo 2: Building Construction

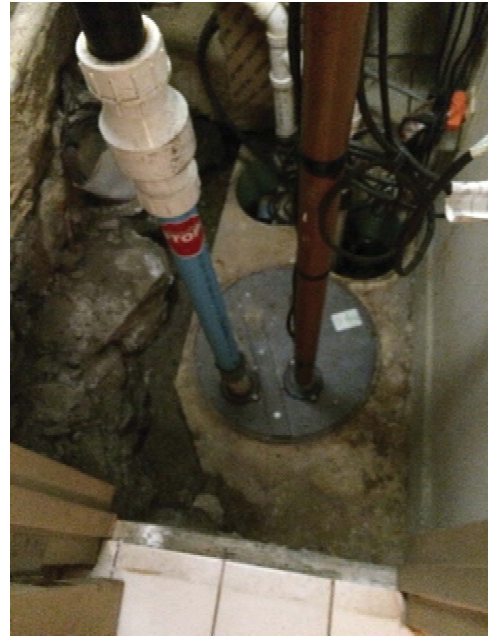
Photo 4: Sewage Ejector

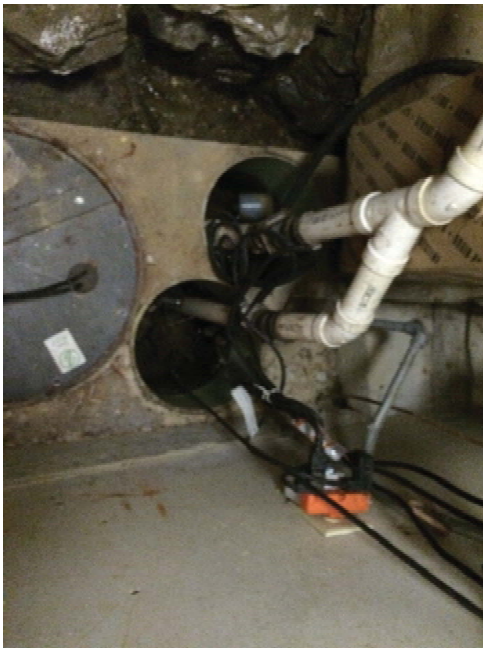
Photo 5: Sump Pump

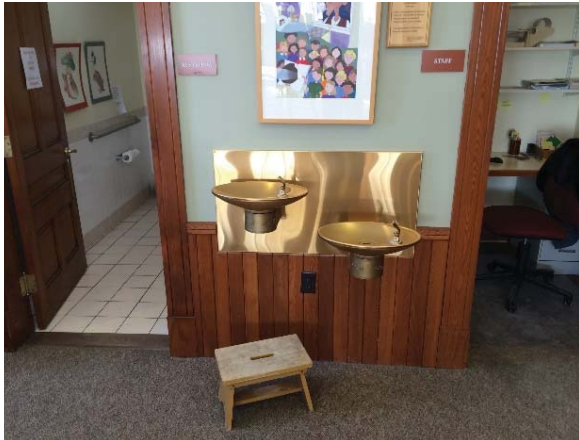
Photo 7: Drinking Fountain

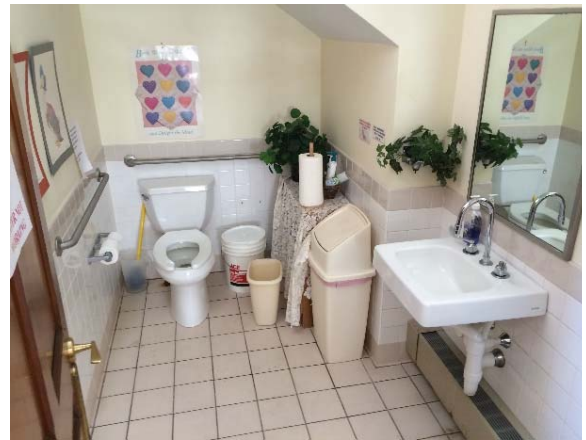
Photo 8: Fixtures

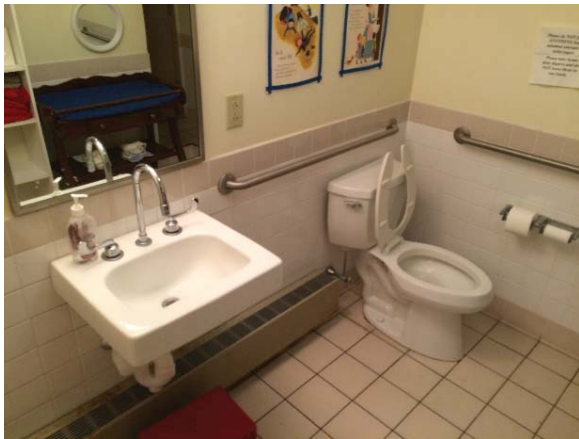
Photo 9: Fixtures

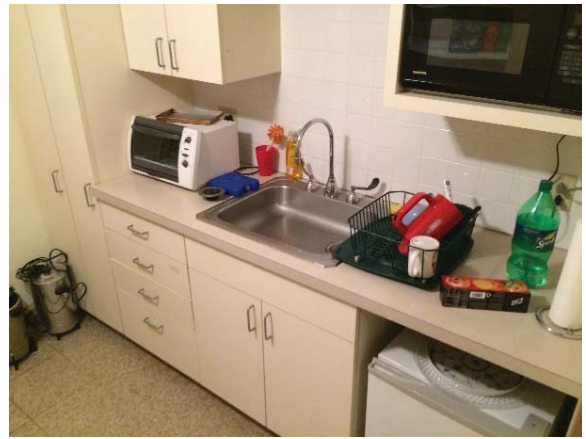
Photo 10: Fixtures

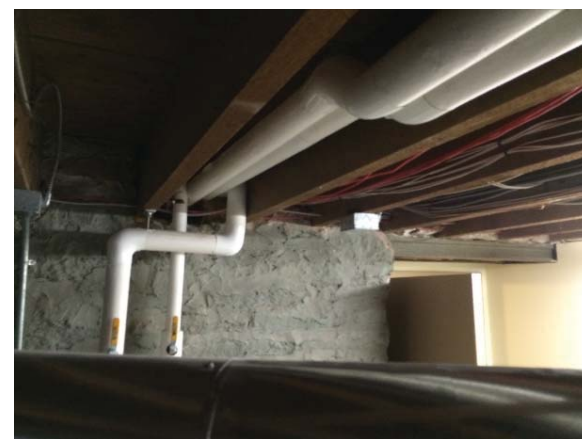
Photo 12: Water Piping

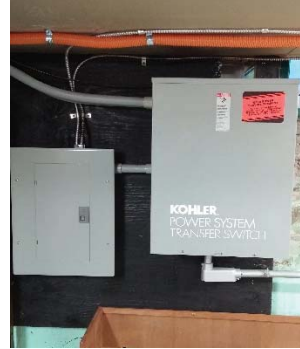
ATS & Stand-By Panel

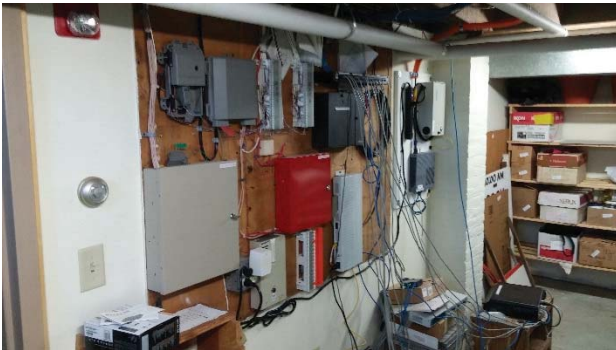
Voice/Data Equipment
